**G.W.P. 3117-09-00**

**LAUZON PARKWAY IMPROVEMENTS  
CLASS ENVIRONMENTAL ASSESSMENT**

**FINAL  
STRUCTURAL CULVERT INSPECTION REPORT**

November 2013

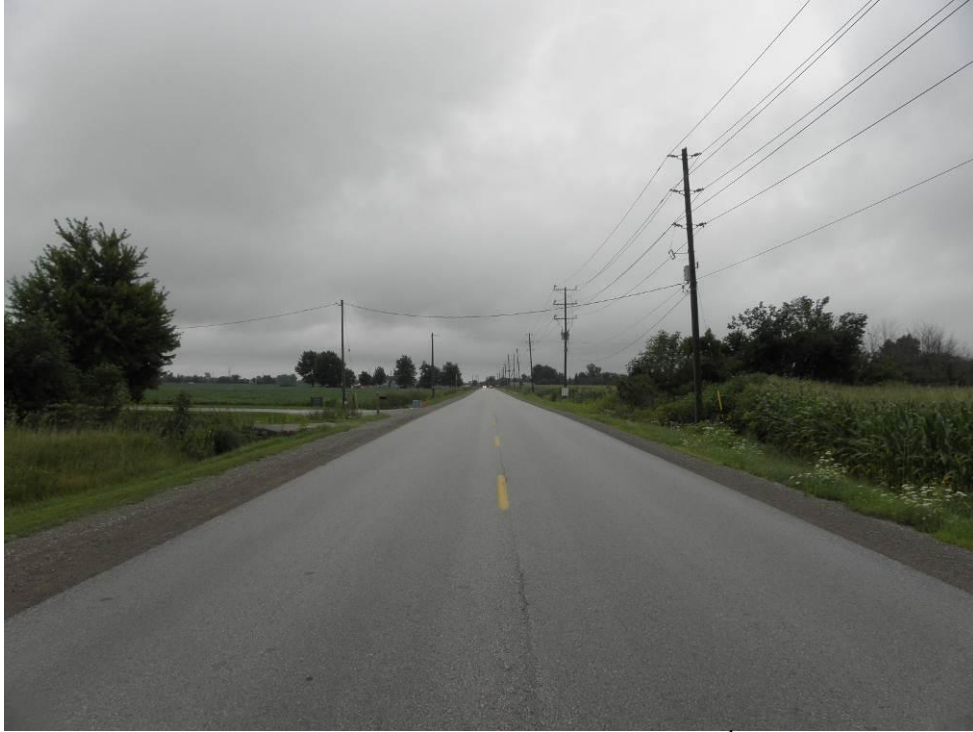
- The culvert runs in the east to west direction on a 45 degree skew to 10<sup>th</sup> Concession Road (see key plan in Appendix A);
- Two (2) through traffic lanes are carried by the culvert (northbound and southbound direction); gravel shoulders exist on each side of the roadway (see Photograph B1 and B2);

Photograph B1. North approach, looking south along 10<sup>th</sup> Concession Road.

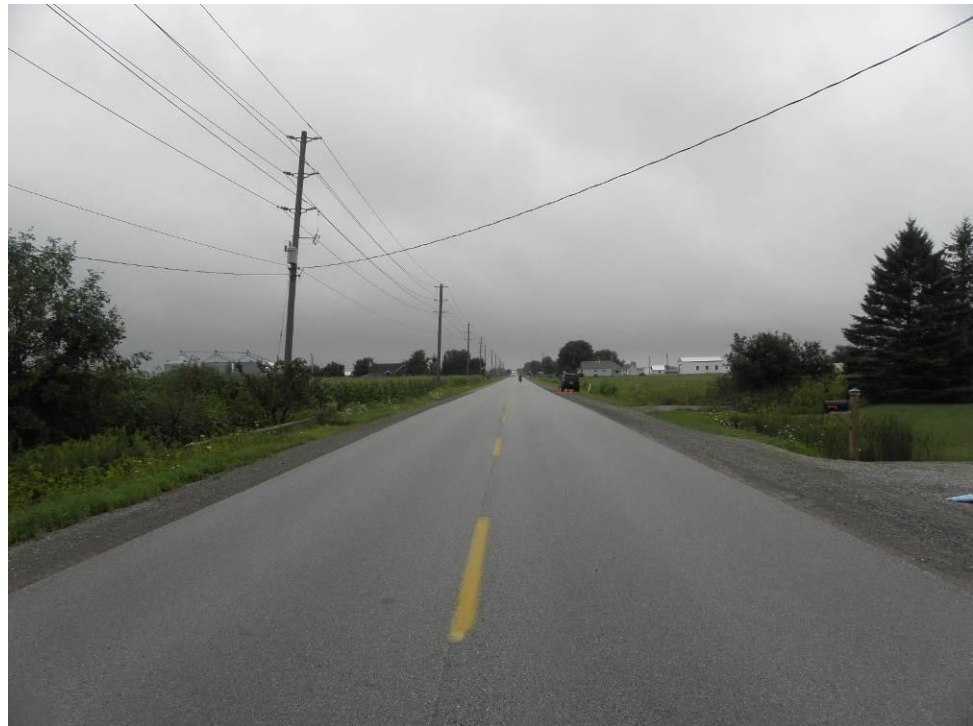
Photograph B2. South approach, looking north along 10<sup>th</sup> Concession Road.

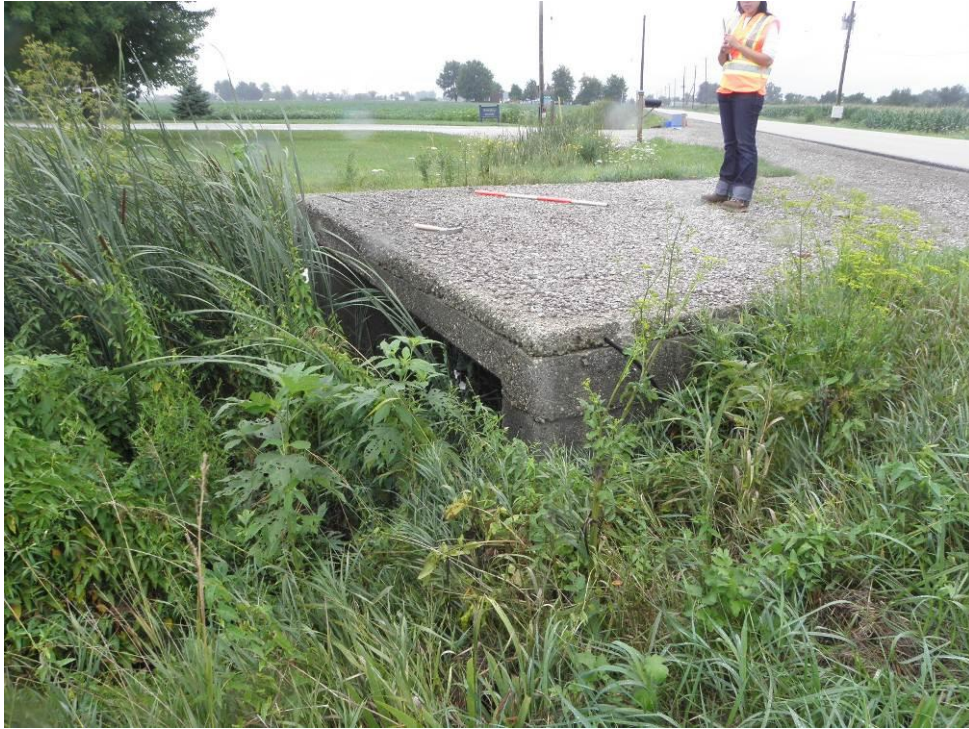
- Medium scaling was noted at the east end of the culvert and exposed top slab at the east end of the culvert (see Photographs B3, B7 and B11);
- The header wall and wingwalls at the west end of the culvert were noted to be in good condition, with the exception of a minor localized area of honeycombing in the southwest wingwall (see Photographs B4 and B8);

Photograph B3. East elevation.

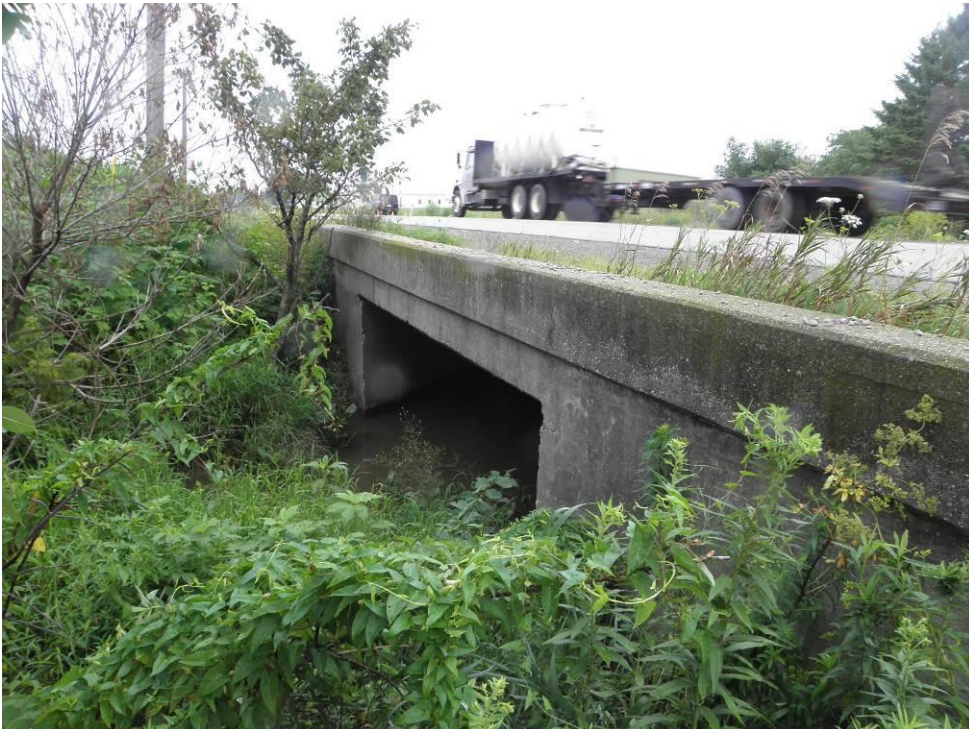
Photograph B4. West elevation.

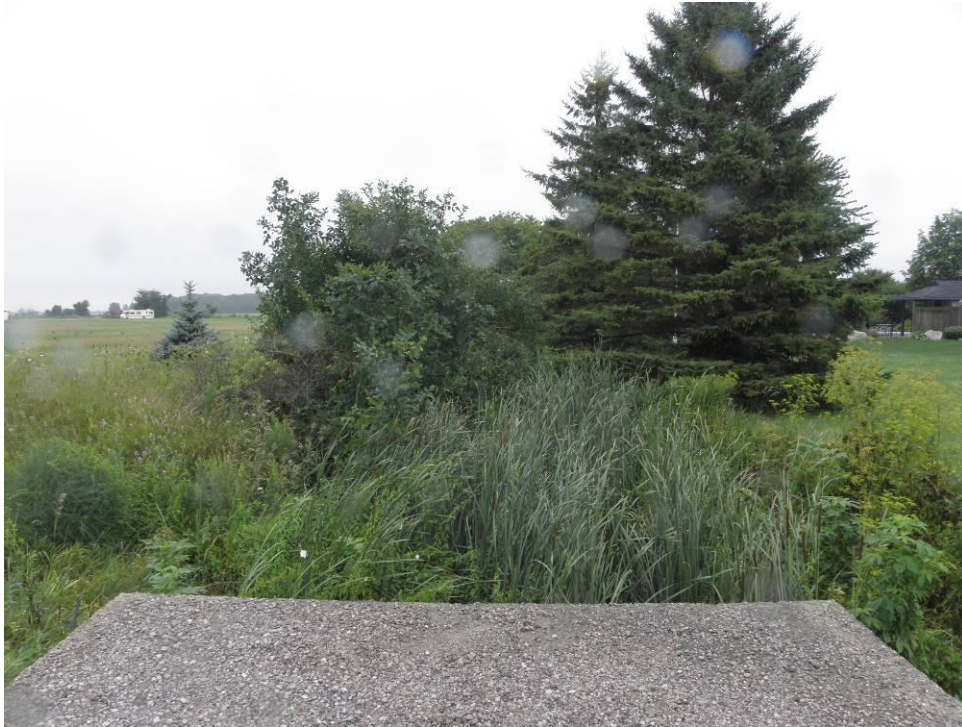
- Both ends of the culvert are vegetated with tall grass and bushes (see Photographs B5 and B6);
- No deficiencies of the waterway were apparent at the time of inspection;

Photograph B5. Looking east from the culvert.

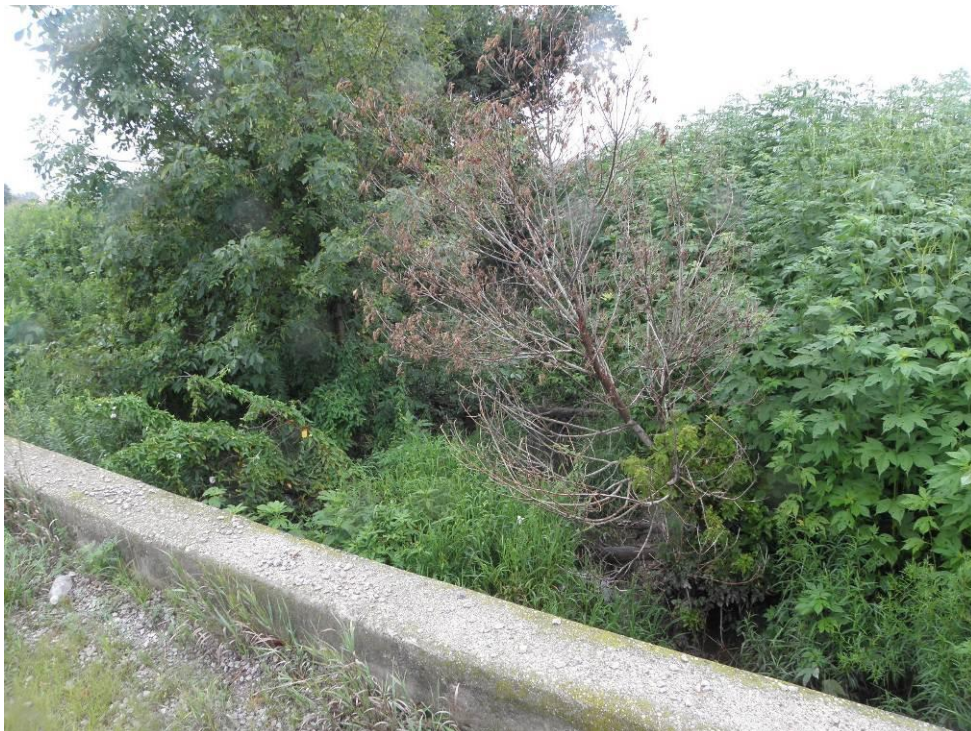
Photograph B6. Looking west from the culvert.

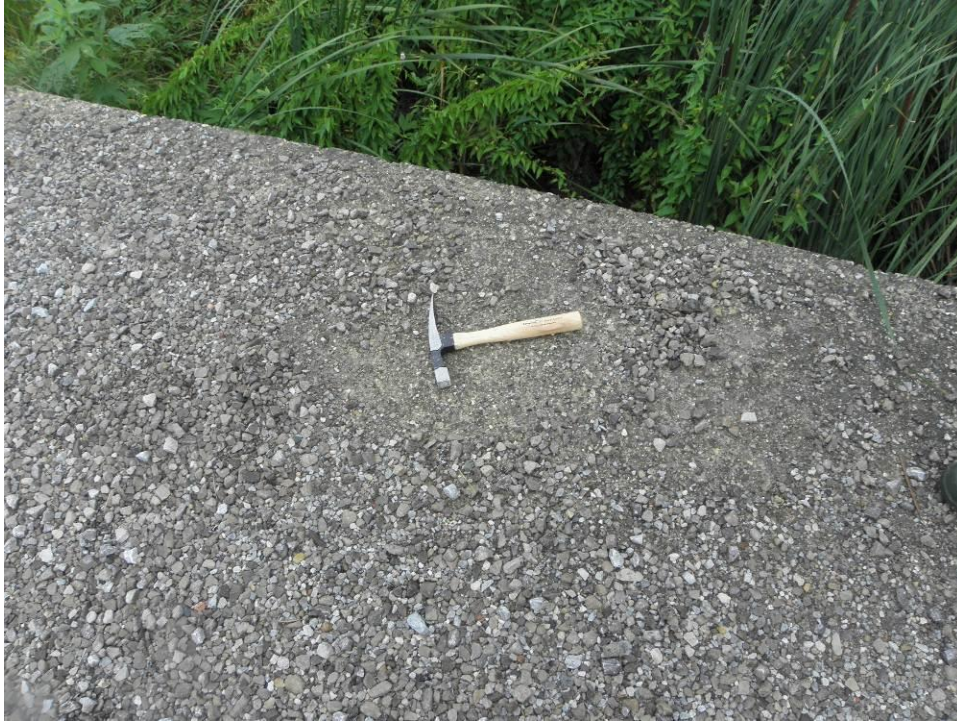
- There is a distribution slab on the culvert which is visible at the east end of the culvert. The exposed portion of the slab is severely scaled; however, the condition of the slab beneath the roadway and at the west of the culvert is unknown. The reason for having the distribution slab is unknown since it is a cast-in-place culvert;

Photograph B7. Exposed top slab of culvert at the east end. Note the medium concrete scaling.

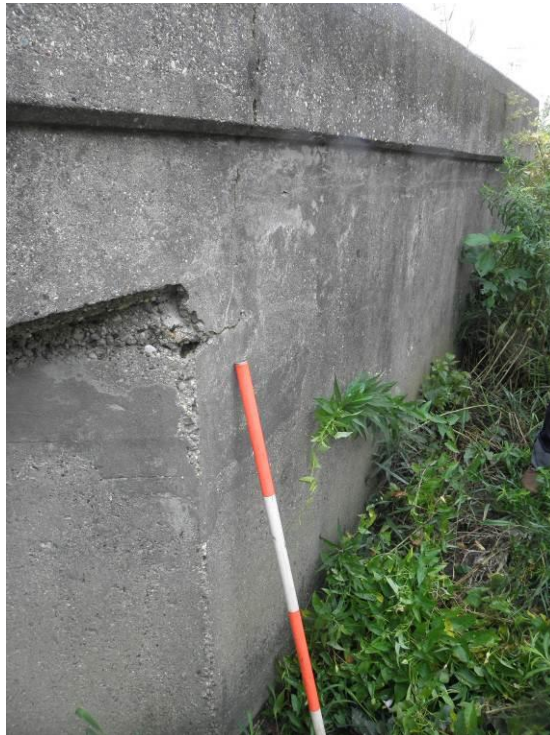
Photograph B8. Southwest wingwall. Note the minor honeycombing.

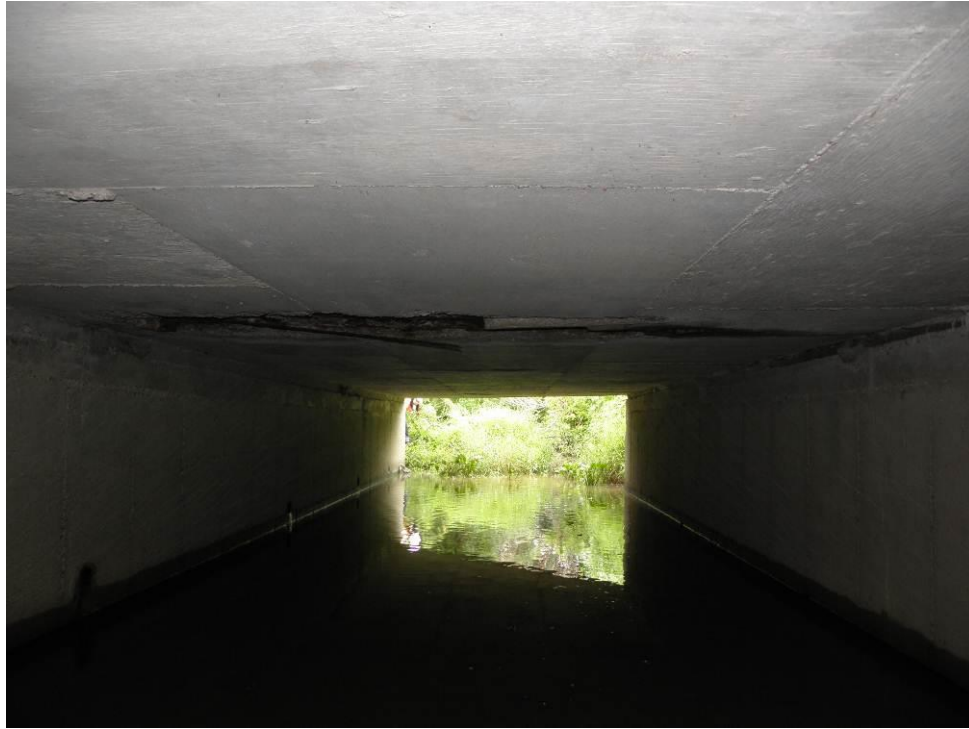
- The culvert was generally in good condition (see Photographs B9 and B10);
- Culvert wall drains were typically partially filled with sediment / debris (see Photograph B13);

Photograph B9. Looking west through the culvert. Note the very severe spall in the top slab.

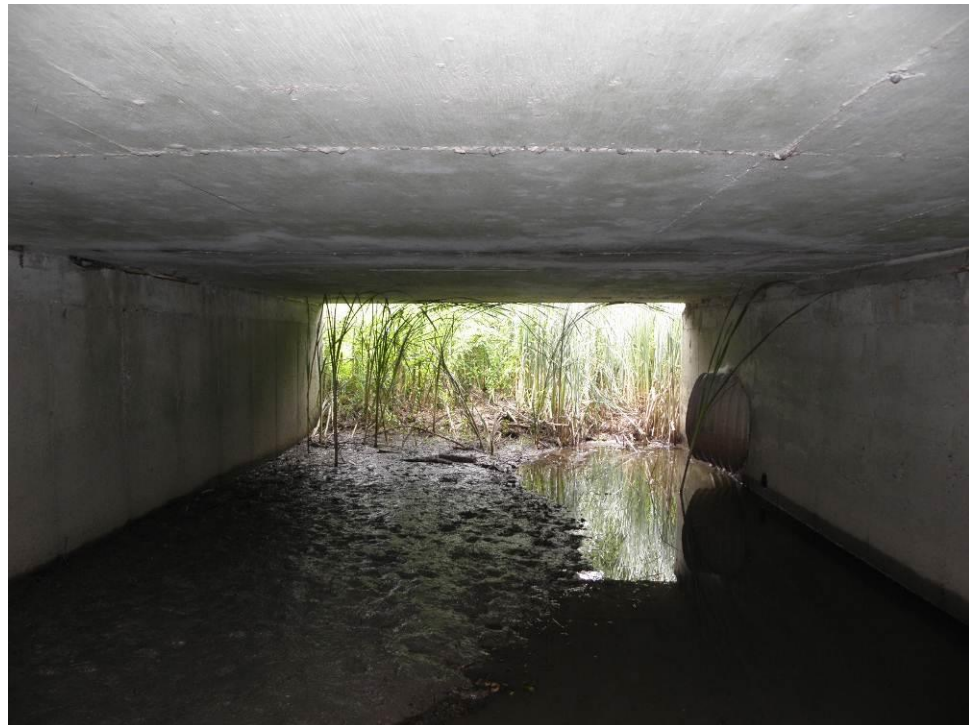
Photograph B10. Looking east through the culvert.

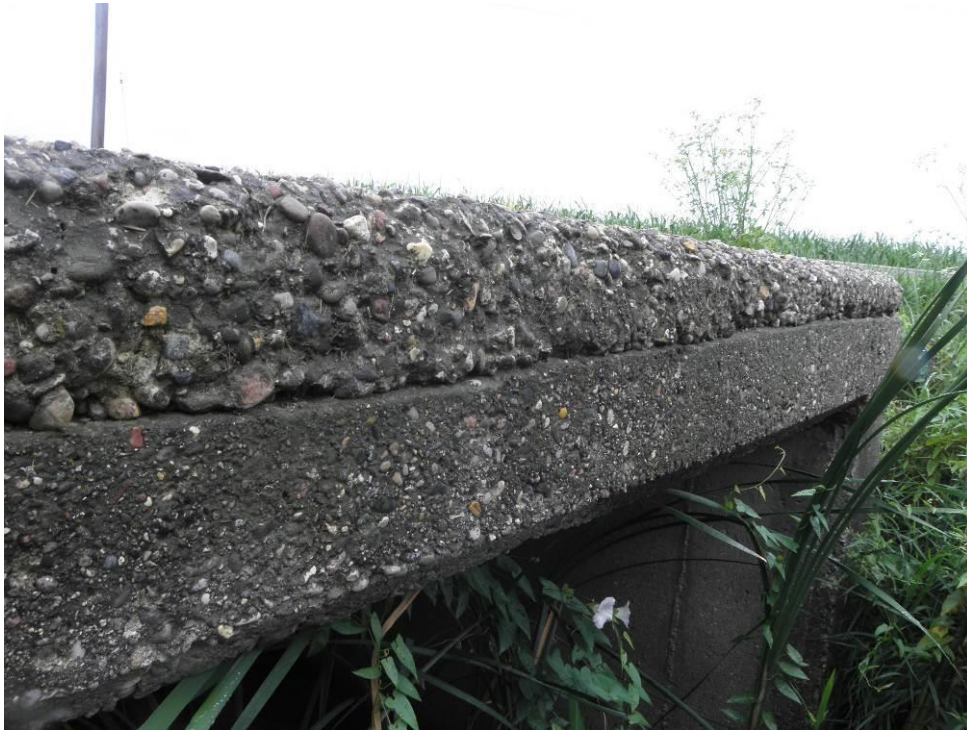
Photograph B11. East end of culvert. Note the medium concrete scaling of the top slab.

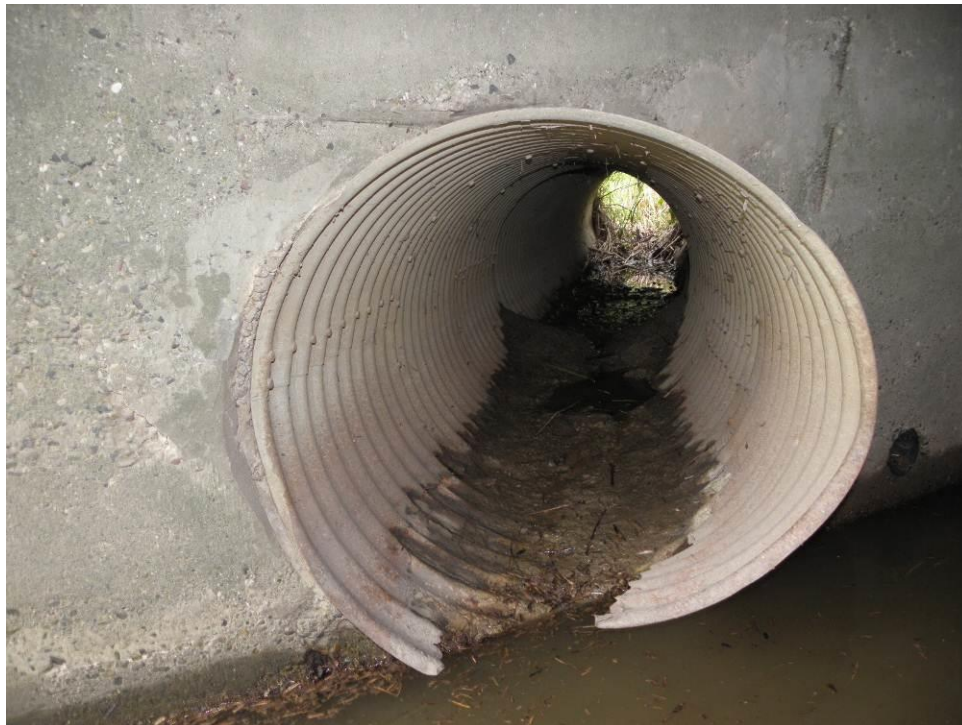
- A drainage ditch corrugated steel pipe (CSP) was present at the east end of the culvert, the CSP was formed within the south culvert wall; the CSP appeared distorted (elliptical shape) and contained several perforations in the bottom portion; the CSP opening measured 800 mm by 700 mm (span by height) (see Photograph B12).

Photograph B12. Drainage ditch CSP through south culvert wall near the east end of the culvert. Note the perforations in the bottom and distorted shape.

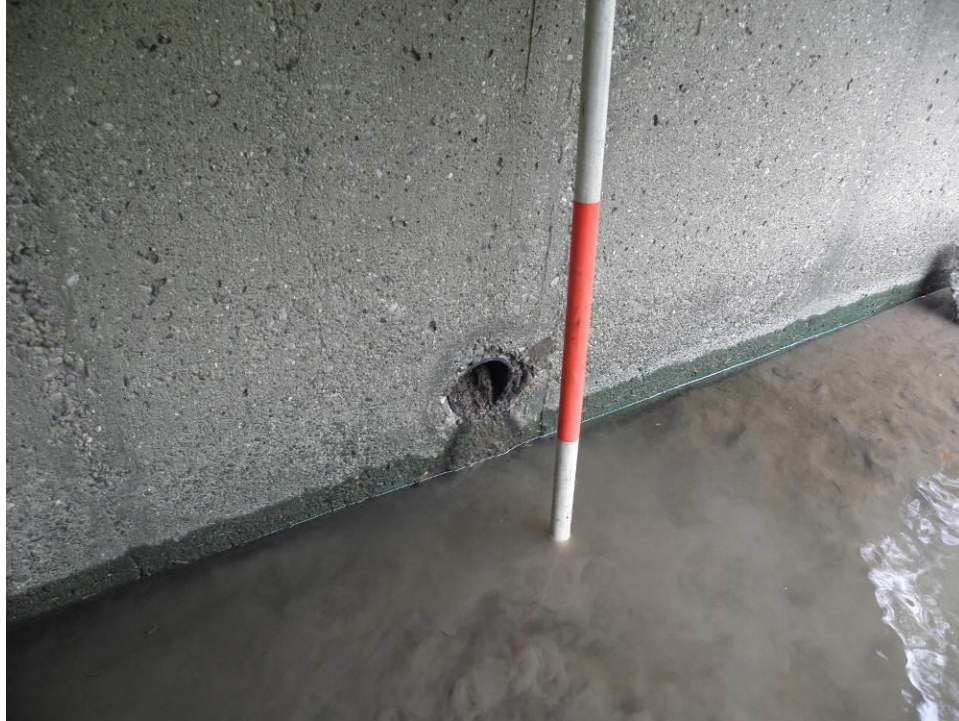
Photograph B13. Wall drain. Typical condition. Note the sediment build-up within the pipe.

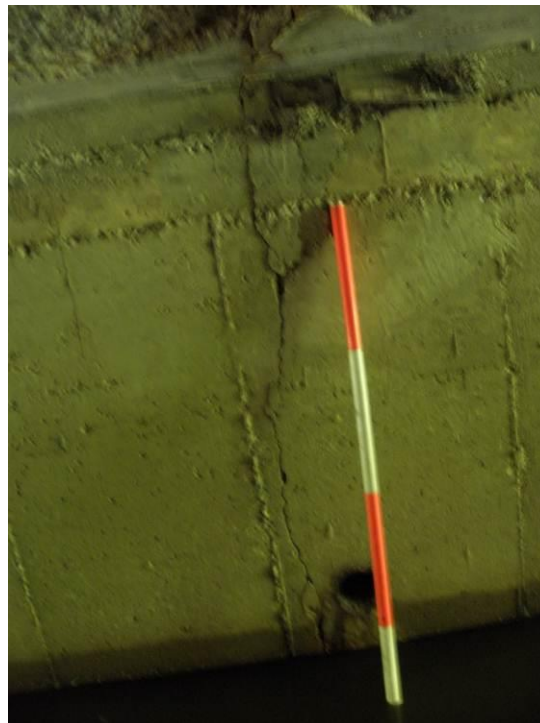
- The culvert walls were generally in good condition, with the exception of two wide vertical cracks noted near the centre of the culvert, one in the north wall and

one in the south wall; in total 2.8 m of wide vertical crack was measured in the culvert walls (see Photograph B14);

Photograph B14. Wide vertical crack within the south culvert wall. Similar crack was noted in the north culvert wall. Both are located near the centre of the culvert.

extensive spalling and damage to load carrying reinforcing steel bars. Immediate recommendations are to repair the deteriorated concrete areas in the culvert walls and soffit. The work would include injecting the vertical cracks with a flexible polyurethane epoxy resin to prevent the ingress of water and sediment and to prevent further cracking. The delaminated and spalled concrete areas in the soffit should be repaired by using conventional methods of removing and replacing the concrete. Additional reinforcing steel and dowels will be needed to repair the damaged section near the centre of the culvert. Repairs to the concrete distribution slab are recommended, as well as waterproofing the entire length of the culvert. Finally, it is recommended that steel beam guide rails be added to improve the roadside safety at the culvert in accordance to current standards.

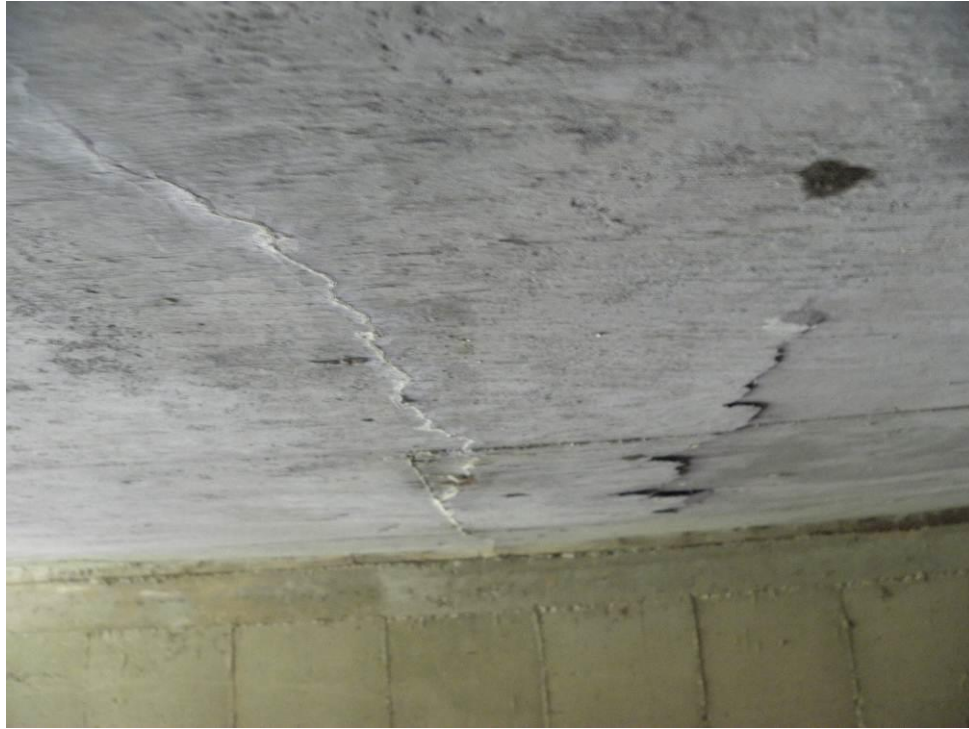
- The culvert soffit contained localized areas of concrete deterioration that includes two (2) large areas of delamination totaling 1.4 m<sup>2</sup> and one (1) large area of spalling totaling 1.5 m<sup>2</sup>; in addition, one (1) longitudinal stained crack 2 m long was noted near the west end of the culvert (see Photographs B15, B16 and B17);

In general, observed deficiencies are localized and do not pose a significant threat to the overall structural integrity of the Sullivan Creek Drain Culvert. However, areas of deterioration are likely to spread, leading to potential structural problems in the future. Punch through failure is a potential hazard to public safety at the culvert due to the

Photograph B15. Very severe concrete delamination in culvert soffit.

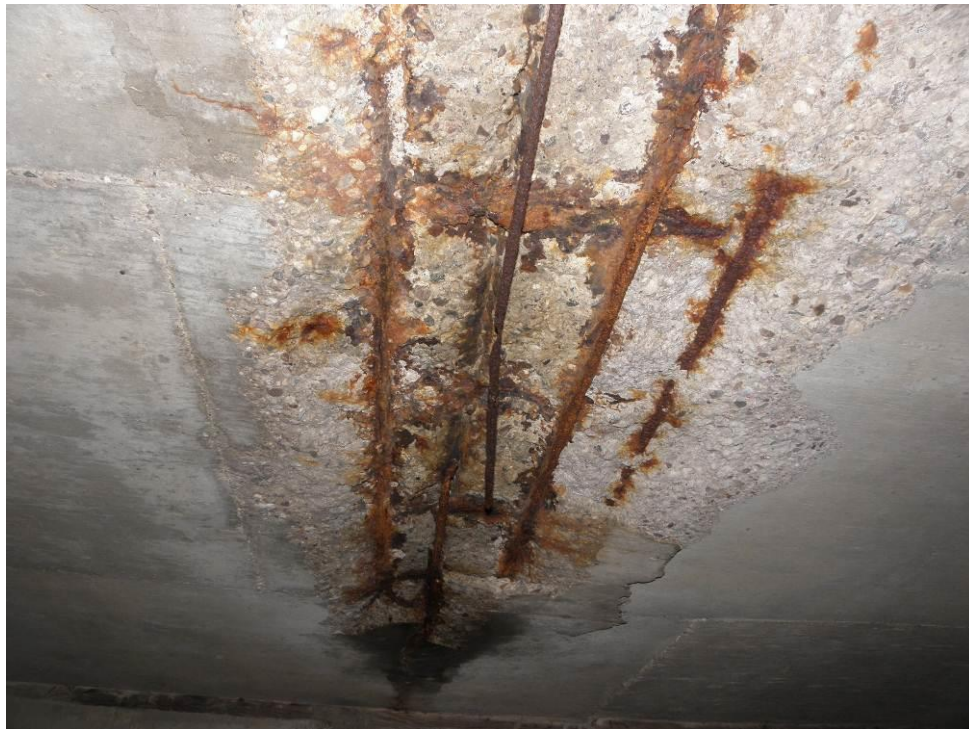
- The spalled area contained four (4) exposed longitudinal reinforcing steel bars that were severely corroded, two (2) of the bars were broken; also a longitudinal crack appeared to be present within the spalled area of the top slab; the location of this spalled area is approximately near the centre of the culvert (directly under 10<sup>th</sup> Concession Road live traffic);

Photograph B16. Very severe concrete spalling. Note the corroded and broken reinforcing steel bars. Looking along the longitudinal direction. Located near the centre.

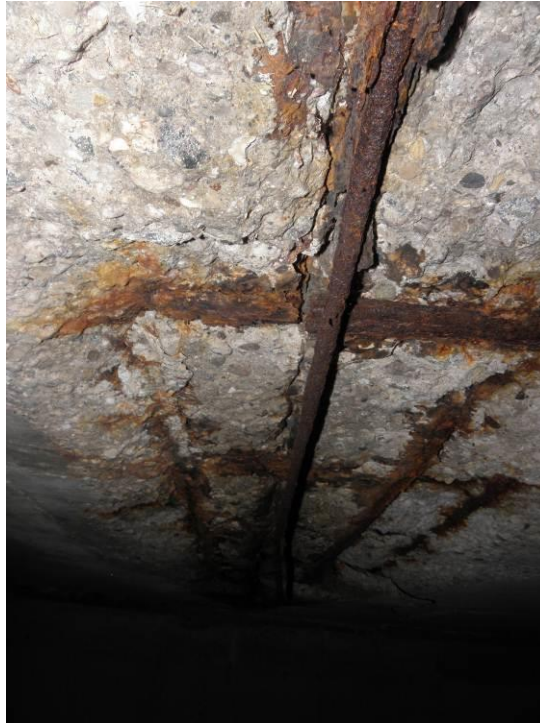
Photograph B17. Close-up view of the previous photograph. Note the longitudinal concrete crack within the top slab.

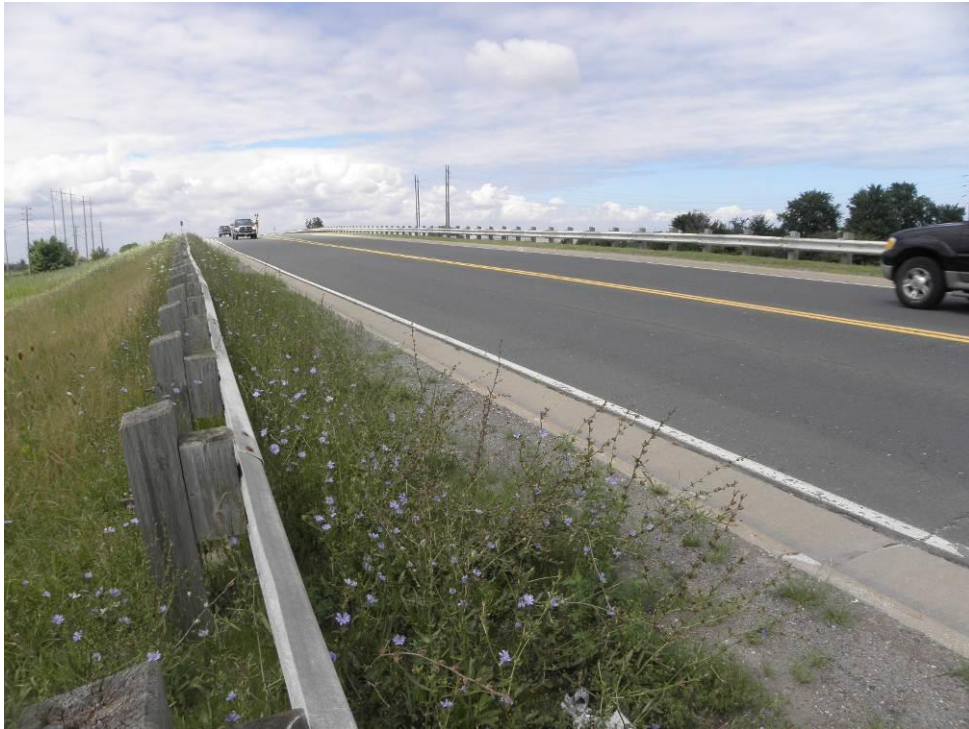
- Single rail steel beam guide rails (SBGR) on wooden posts and wooden offset blocks exist on each side of the roadway at the culvert; this SBGR system extends from the Lauzon Parkway CPR structure (to the north of the culvert location) (see Photograph C1 and C2);

Photograph C1. Looking north from culvert along Lauzon Parkway.

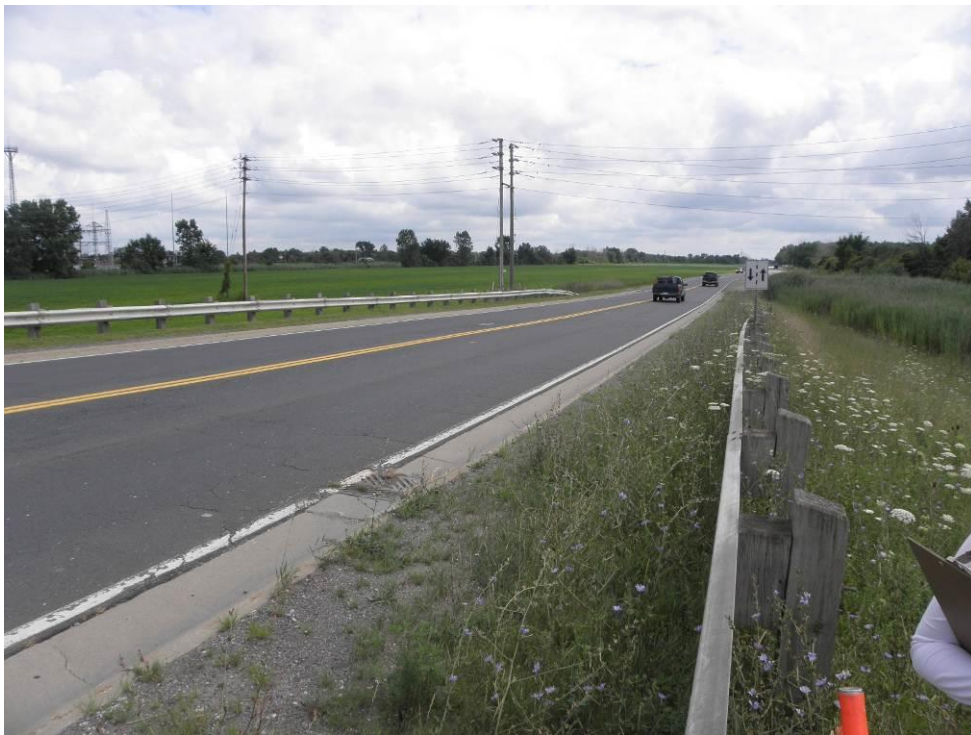
Photograph C2. Looking south from culvert along Lauzon Parkway.

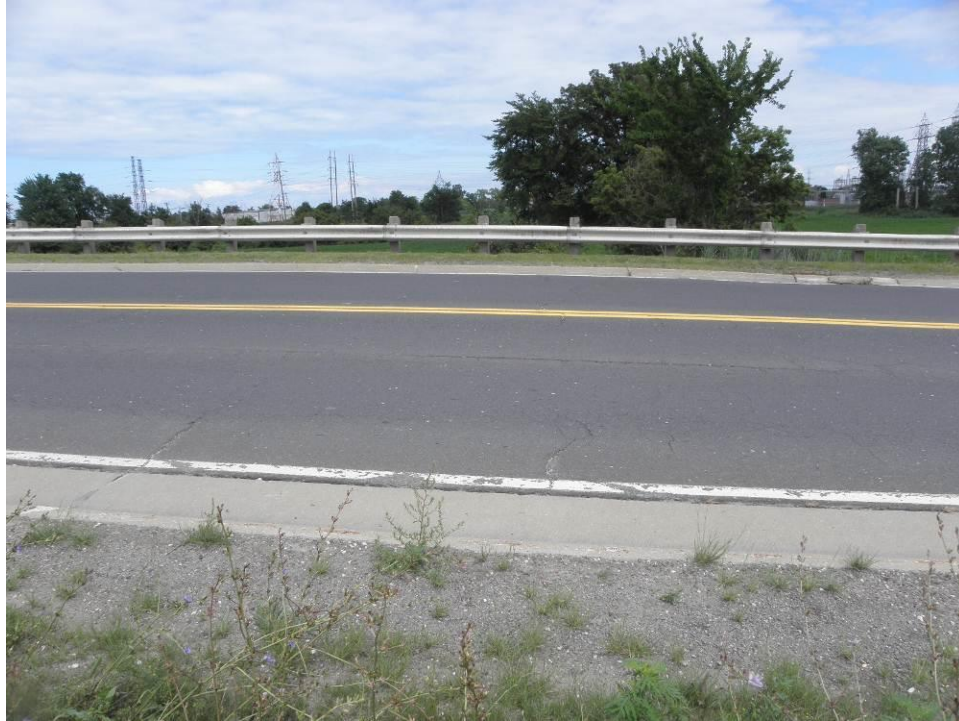
- The culvert is located just south of the Lauzon Parkway CPR structure (Site No. 160);
- Two (2) lanes of through traffic along the Lauzon Parkway are accommodated by the culvert (one northbound and one southbound); there are concrete curbs at the edge of the traffic lanes on both sides of the roadway (see Photograph C3);

Photograph C3. Looking east across Lauzon Parkway. The culvert is directly below in the photograph.

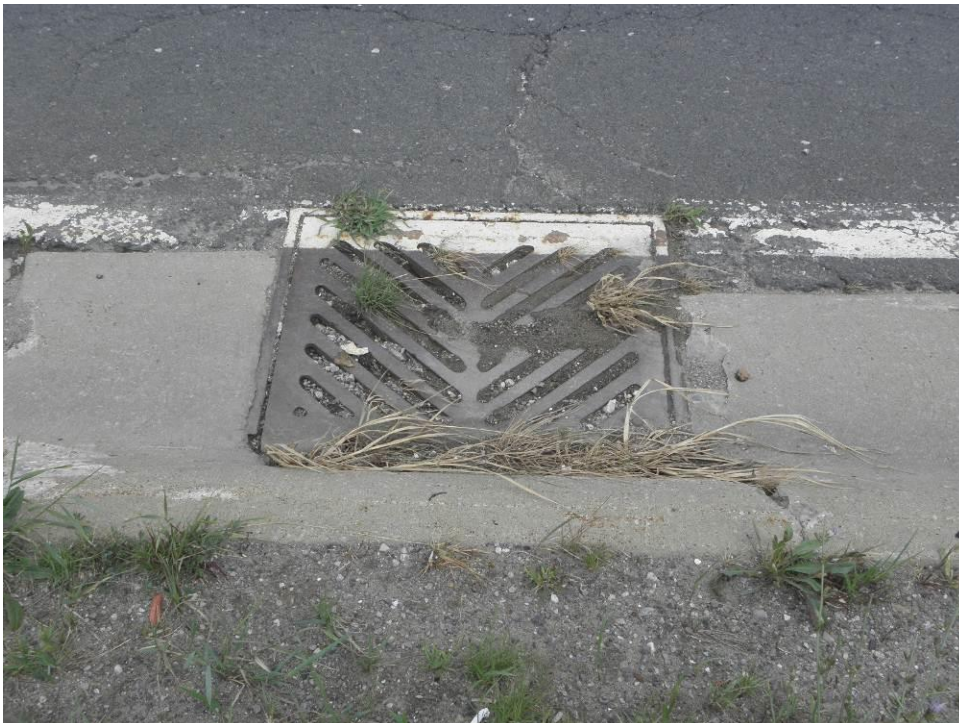
- The asphalt wearing surface over the culvert is in generally good condition with few transverse narrow cracks;
- A catch basin was found filled with sediment / debris just south of the culvert within the southbound lane of Lauzon Parkway (see Photograph C4);

Photograph C4. Catch basin filled with debris. The catch basin is located along the west curb of Lauzon Parkway just a few metres south of the culvert.

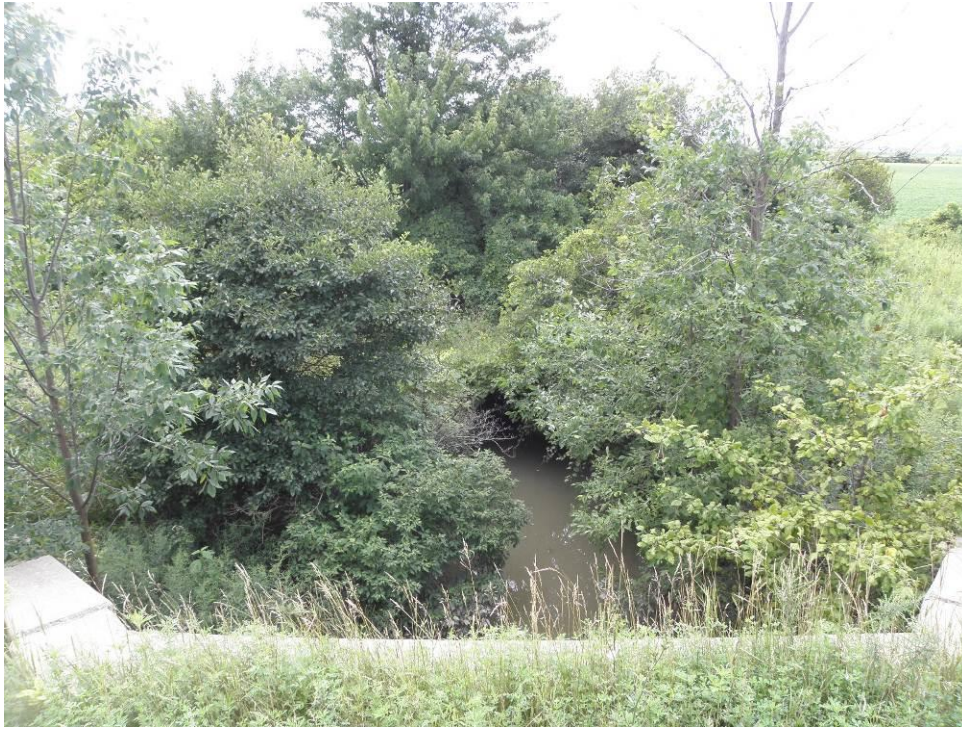
- No deficiencies of the waterway was apparent at the time of inspection (see Photograph C5 and C6);
- The culvert ends were found in good condition (see Photograph C7 and C8);

Photograph C5. Looking west from the culvert.

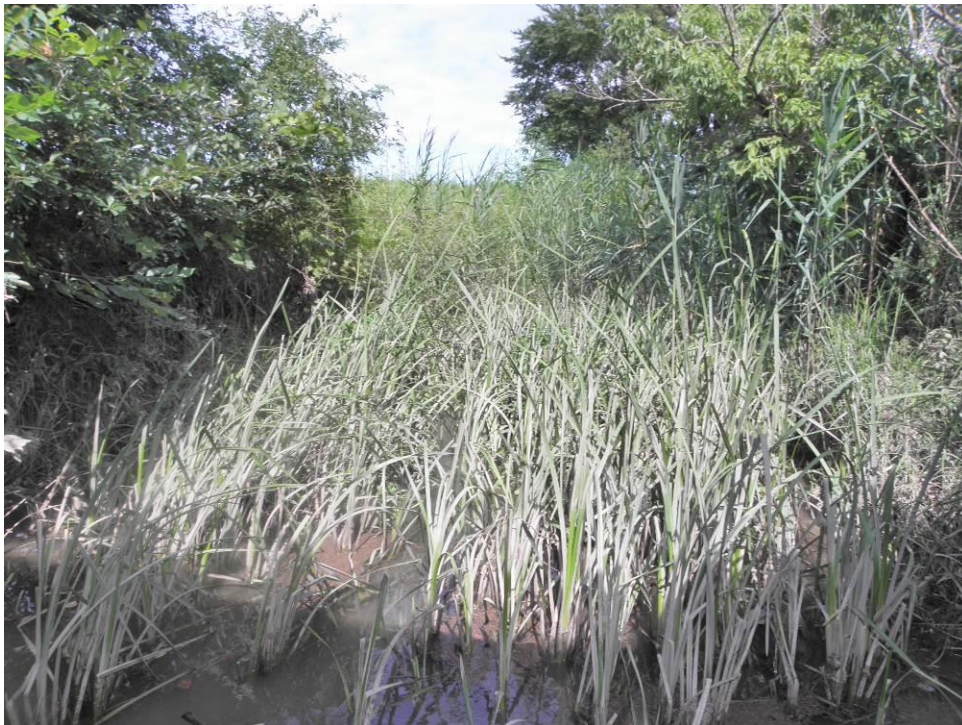
Photograph C6. Looking east from the culvert.

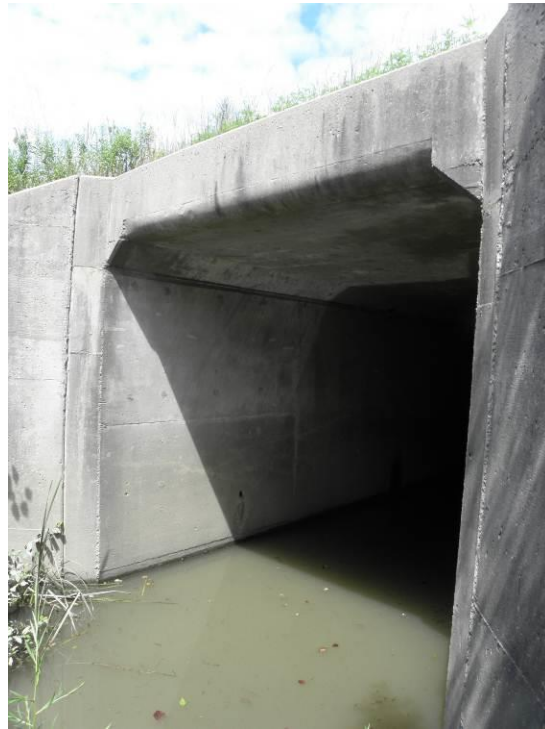
Photograph C7. West elevation.

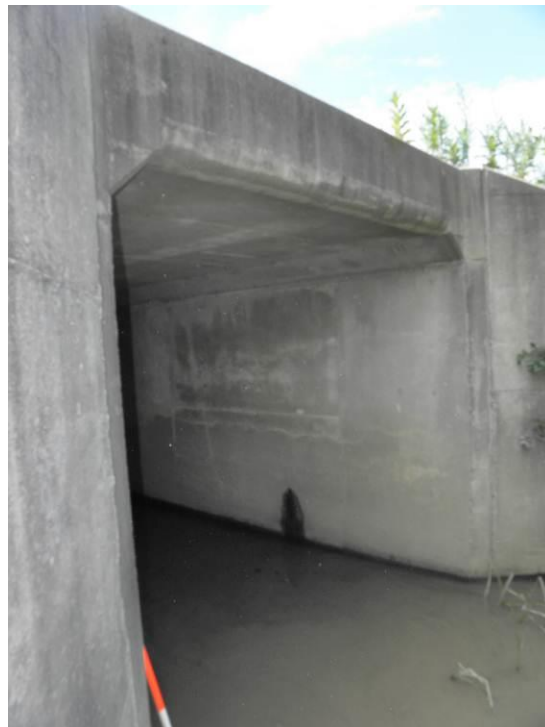
Photograph C8. East elevation.

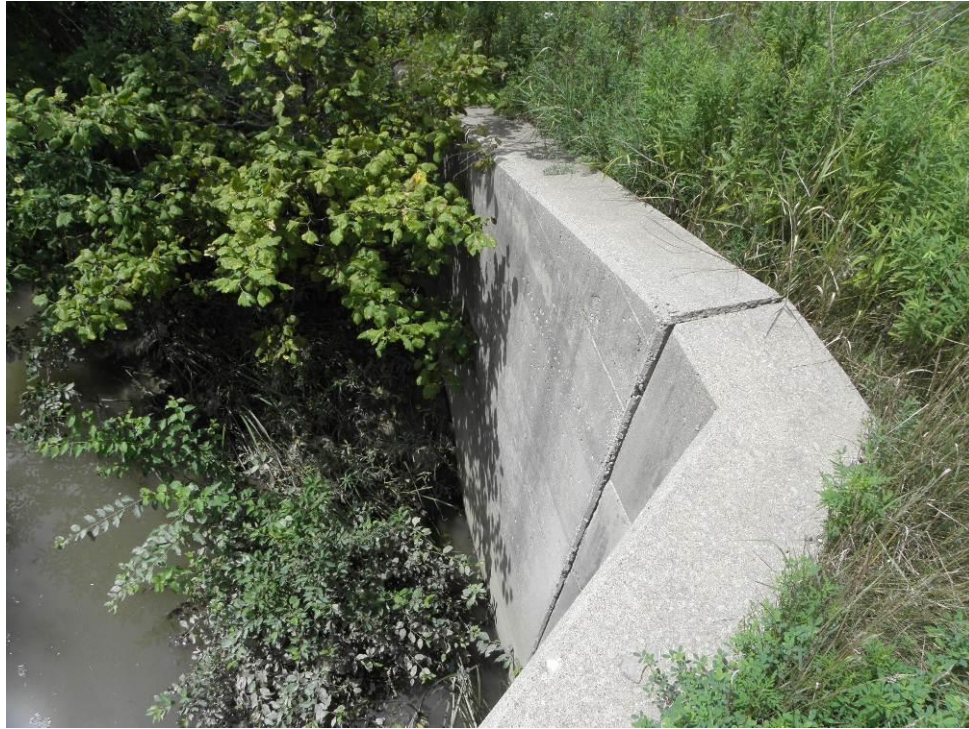
- The retaining wall at each corner of the culvert was noted to be in good condition, with the exception of an outward rotation observed in the southwest retaining wall, an outward displacement of approximately 20 mm was measured at the top of the wall (see Photograph C9, C10 and C16);

Photograph C9. Northwest retaining wall. Typical condition at each corner of the culvert.

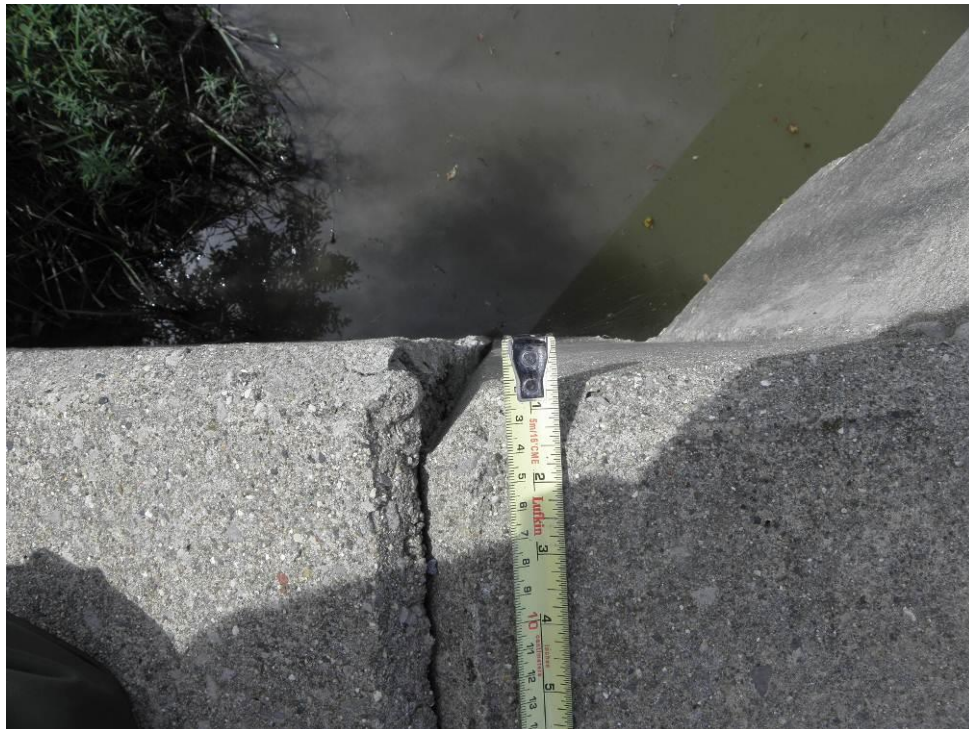
Photograph C10. Southwest culvert corner on the right side and southwest retaining wall on the left side. Note the outward rotation of the retaining wall.

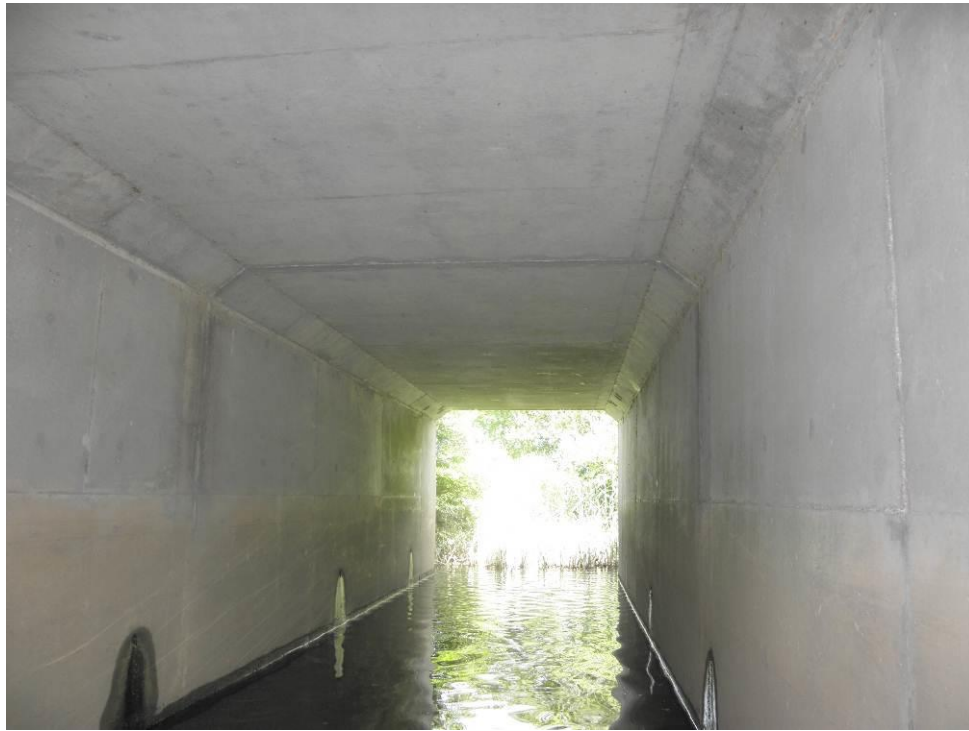
- The culvert soffit and walls were found in generally good condition; two (2) construction joints were found stained with what appeared to be leachate at the time of inspection (see Photograph C11 to C14);

Photograph C11. Looking east through culvert.

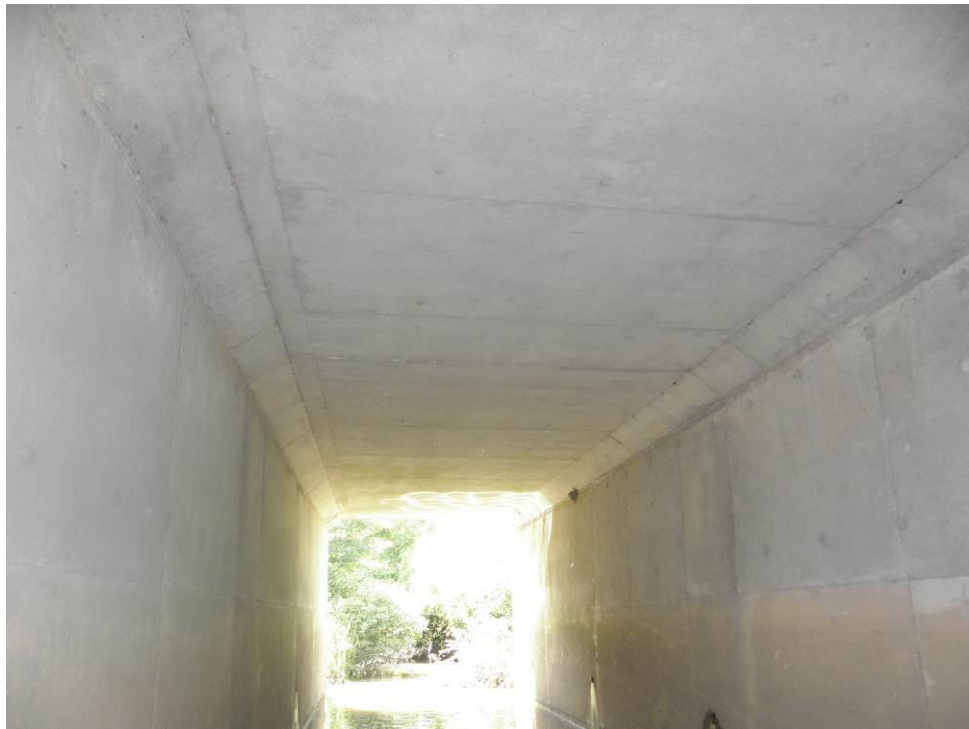
Photograph C12. Looking west through culvert.

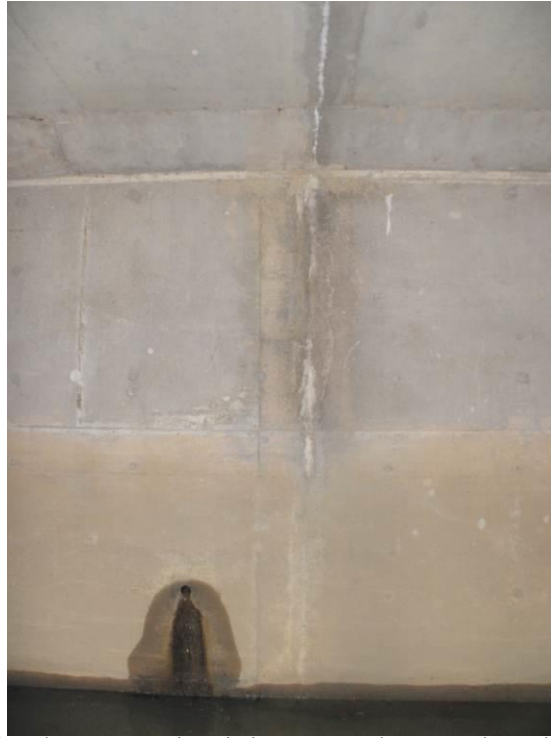
Photograph C13. Stained construction joint. Noted at two locations within the culvert. Photograph shows the typical condition.

The existing condition of the culvert does not warrant any immediate structural deficiency concerns. However, waterproofing of the entire length of the top slab of the culvert is recommended.

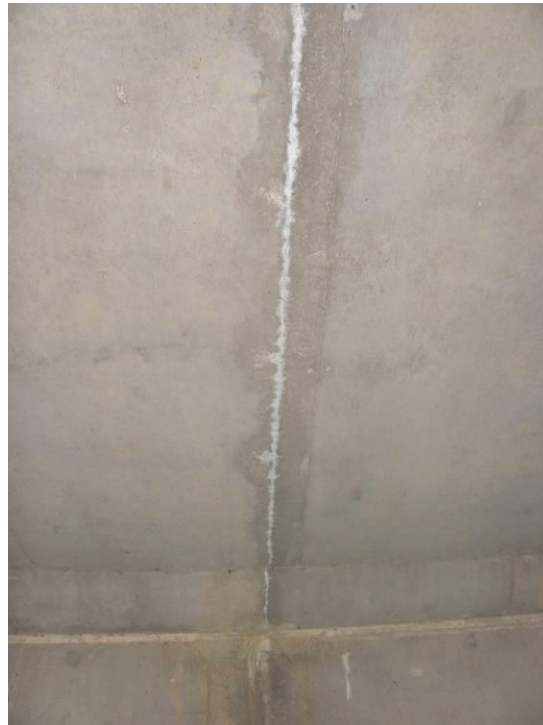
Photograph C14. Stained construction joint. Showing the soffit of the previous photograph.

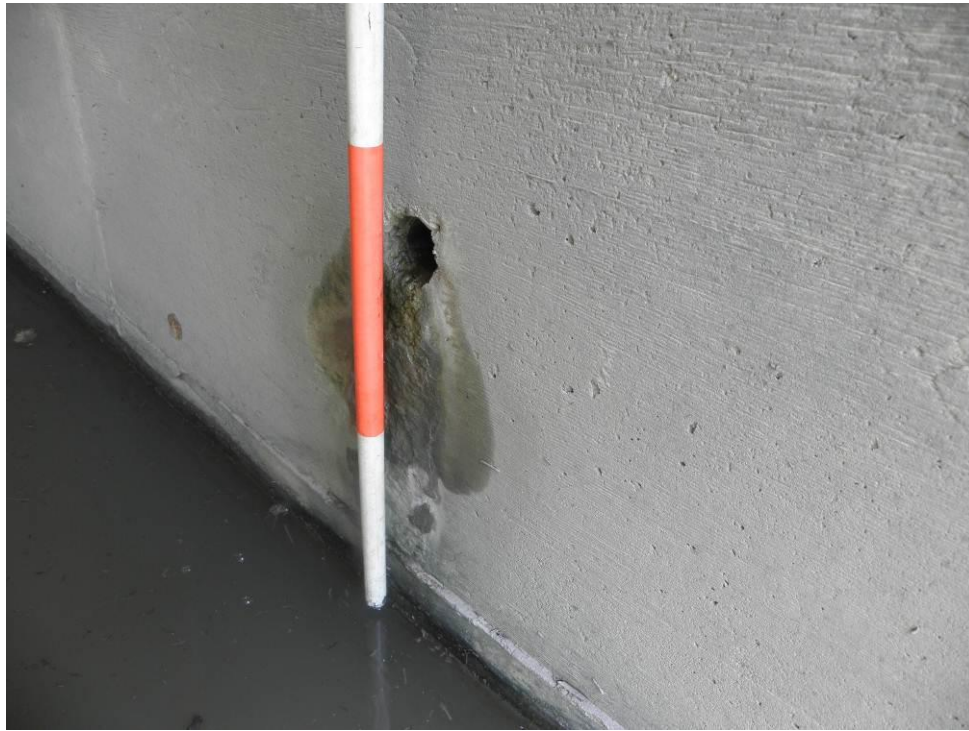
- The wall drains were found partially filled with sediment (see Photograph 15);
- 2900 mm was measured between the culvert soffit and top of water at the west culvert opening (the east culvert opening was similar);

Photograph C15. Wall drain. Typical condition.
