**G.W.P. 3117-09-00**

**LAUZON PARKWAY IMPROVEMENTS  
CLASS ENVIRONMENTAL ASSESSMENT**

**FINAL  
STRUCTURAL CULVERT INSPECTION REPORT**

November 2013

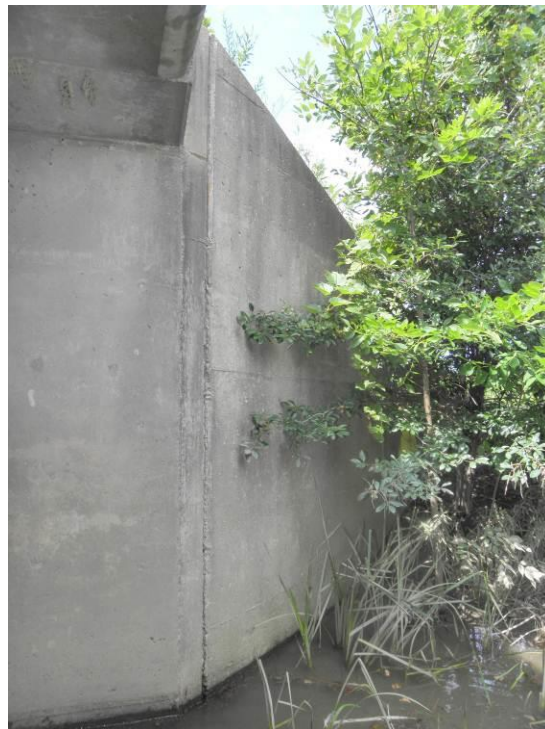
- The retaining wall at each corner of the culvert was noted to be in good condition, with the exception of an outward rotation observed in the southwest retaining wall, an outward displacement of approximately 20 mm was measured at the top of the wall (see Photograph C9, C10 and C16);

Photograph C16. Northeast wingwall.
