Project No. 19-007

**Re: East Riverside Shorewall Assessment & Functional Design
Final Report**

Title KEY PLAN – STUDY AREA Project EAST RIVERSIDE SHOREWALL ASSESSMENT	Date 14 JAN. 2020	FIGURE 1
	Scale NTS	
	Project No. 19-007

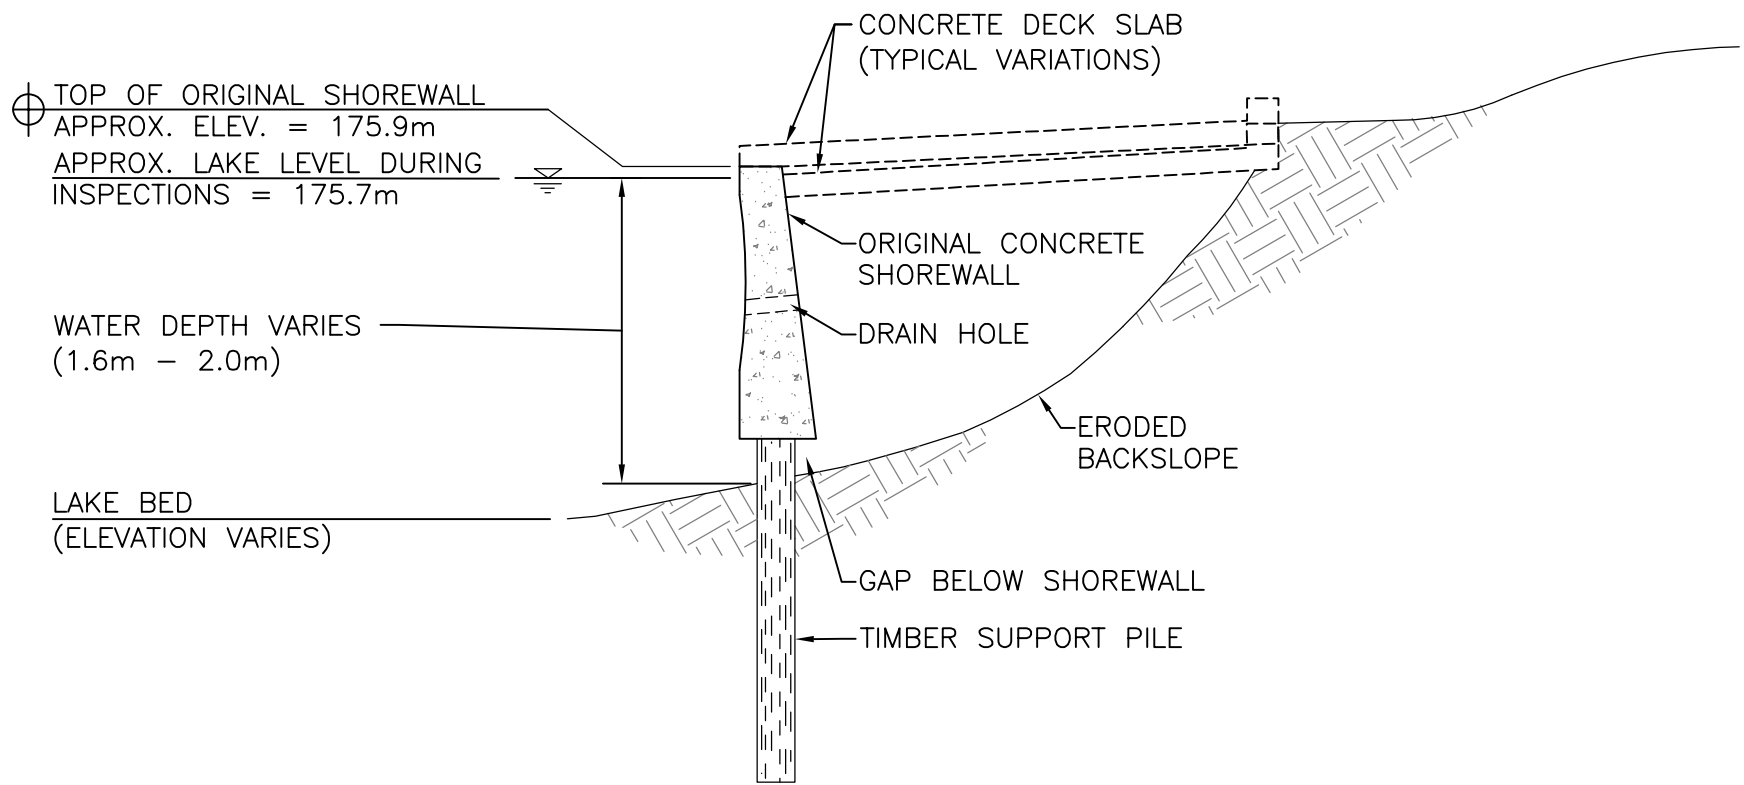
Title	EXISTING CONDITIONS (TYPICAL)	Date	14 JAN. 2020	FIGURE 3
	Project	EAST RIVERSIDE SHOREWALL ASSESSMENT & FUNCTIONAL DESIGN	Scale	
		Project No.	19-007

A cross-section depicting the typical configuration of the existing shorewall and shoreline deck slab is attached as Figure 3. This figure was prepared based on the field observations and measurements documented by Watech and Landmark.

As depicted in Figure 3, the existing shorewall structure along the Lake St. Clair shoreline generally consists of a 1.8m-tall vertical concrete wall, cast in-place over timber pilings. The cast-in-place concrete shorewall appears to have been constructed with a slightly concave vertical curvature along its lakeward face, and was constructed with 100mm-diameter drain holes located near mid-height at intermittent locations along its length. The shorewall is generally approximately 0.3m wide along its top edge.

The primary concern regarding the condition of the shorewall is that it appears to have been undermined by wave action along a significant proportion of its length, exposing the supporting timber piles and allowing the retained backfill to erode through the gap at the base of the wall. The intermittent drainage holes through the concrete wall could also be providing a pathway for wave action to erode the retained fill materials behind the shorewall.
