## Conservation Report on "Anne" Sculpture by Artist Leo Mol

**SCULPTURE:** Anne

**ARTIST:** Leo Mol

**PROJECT:** Bronze sculpture, "Anne" by Leo Mol – Patina Restoration

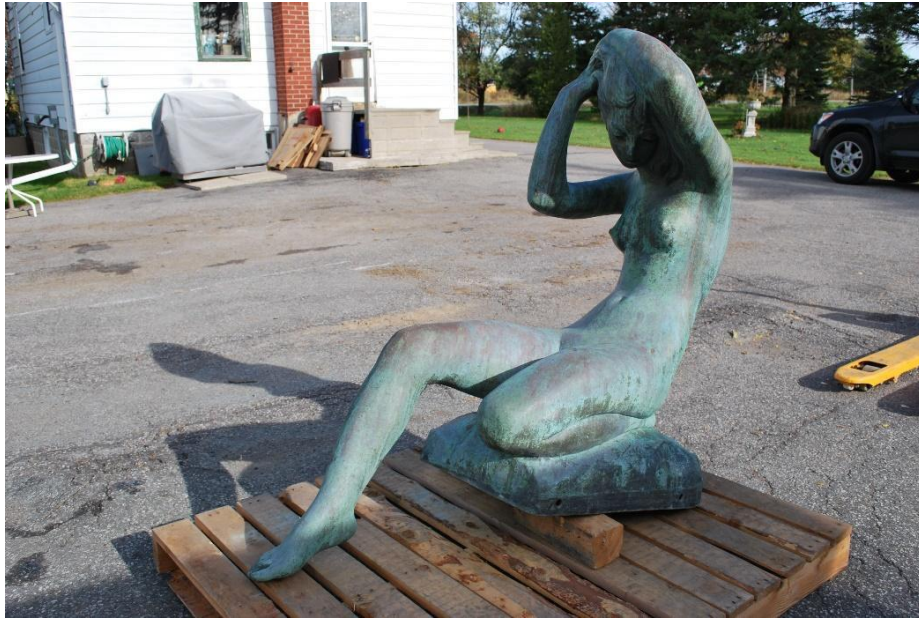
The overall condition of the bronze is good. There appears to be no cracks where the welded joints are and no apparent structural issues with the artwork. Any evidence of the original patina cannot be found. Anne may have been sandcast giving the rougher surface texture of the bronze. Overall, the bronze shows typical signs of exposure to an exterior environment that had not been treated for decades. The patina has been replaced with many layers of active corrosion products giving her open exposure to the elements, and location in the river, which may consist of Sulfates, Sulfides and possibly a Cuprite layer beneath, that are typically found on outdoor bronzes in Ontario. For years, the birds have perched on the artwork leaving obvious staining from their droppings, causing a yellowish-green streaking on many areas of the bronze, which has now become an integral element. Despite the dis-figuring corrosion, on "Anne's" surface, she still maintains a wonderful sense of grace and beauty.

Before treatment - Heavily corroded surface

After initial testing, it was found that pressure washing would help to reduce and remove the surface corrosion. The reduction and removal was quite successful, although there were some areas where the corrosion was more intense that was still noticeable after the pressure washing. This procedure revealed a coppery color in many areas that had developed beneath the corrosion.

While pressure washing, the surface was lightly scoured with a medium Teflon pad to help loosen more of the corrosion, which was followed by a washing of Orvus Paste and water, and rinsed with clean water. Patina testing was carried out on the proper left side of the base to determine the correct chemical or combination of chemicals, as well as mixture ratios that would react with the present surface condition. It was also found that by gently heating the bronze, the chemical responded more effectively and produced a better color.

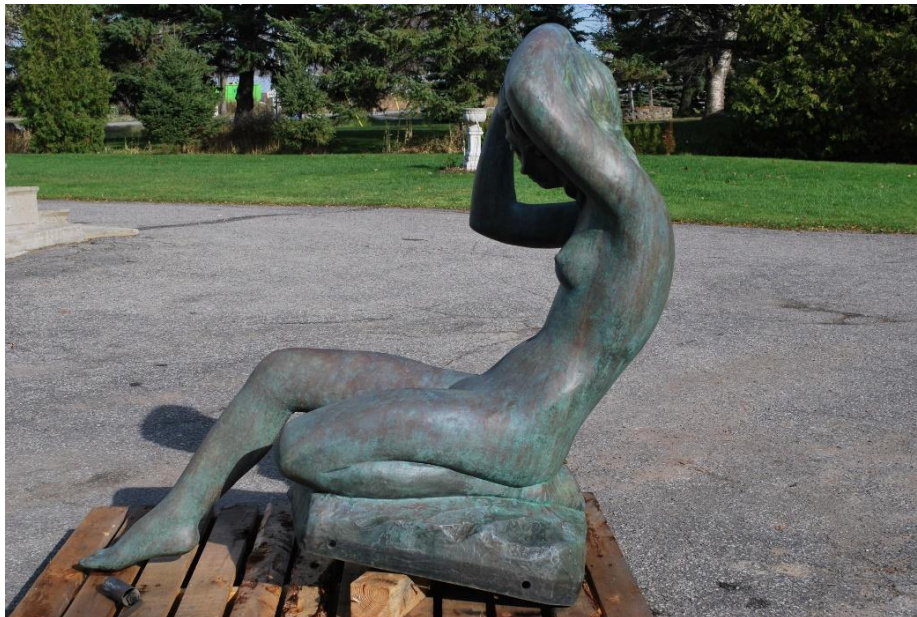
During Treatment - After pressure washing, before patina application

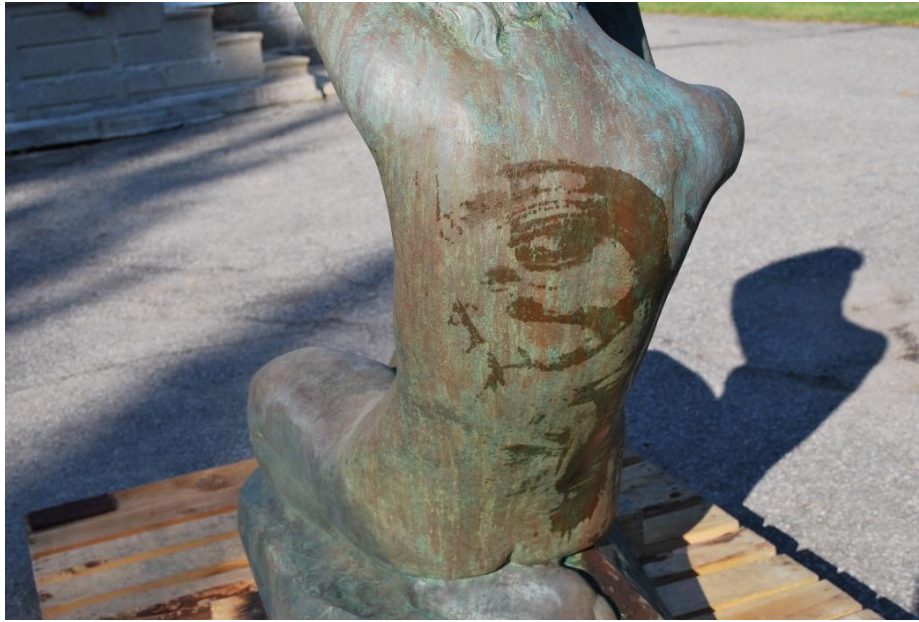
During Treatment - Patina being applied

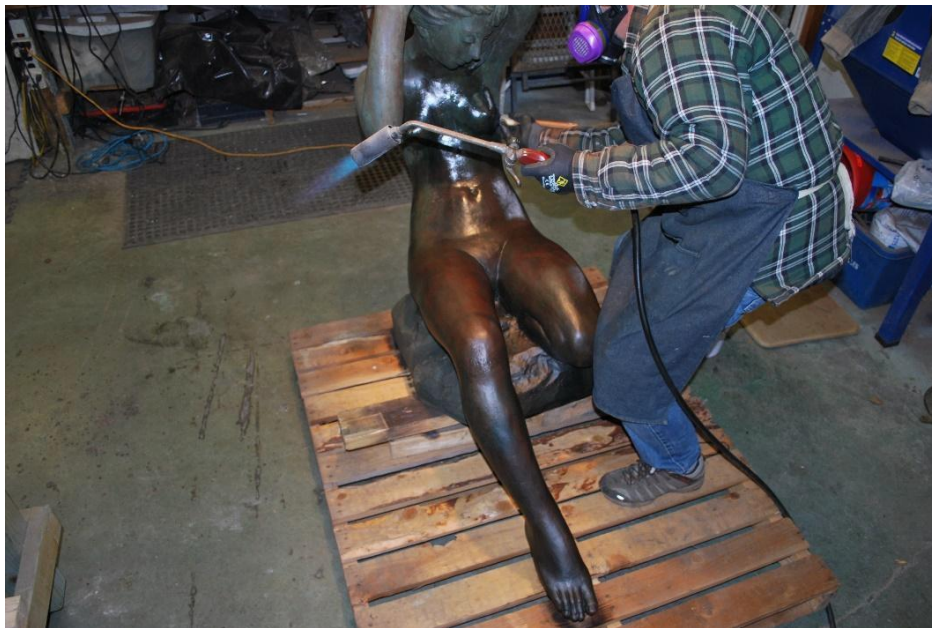
During Treatment - Applying the hot wax treatment – Note the rich color

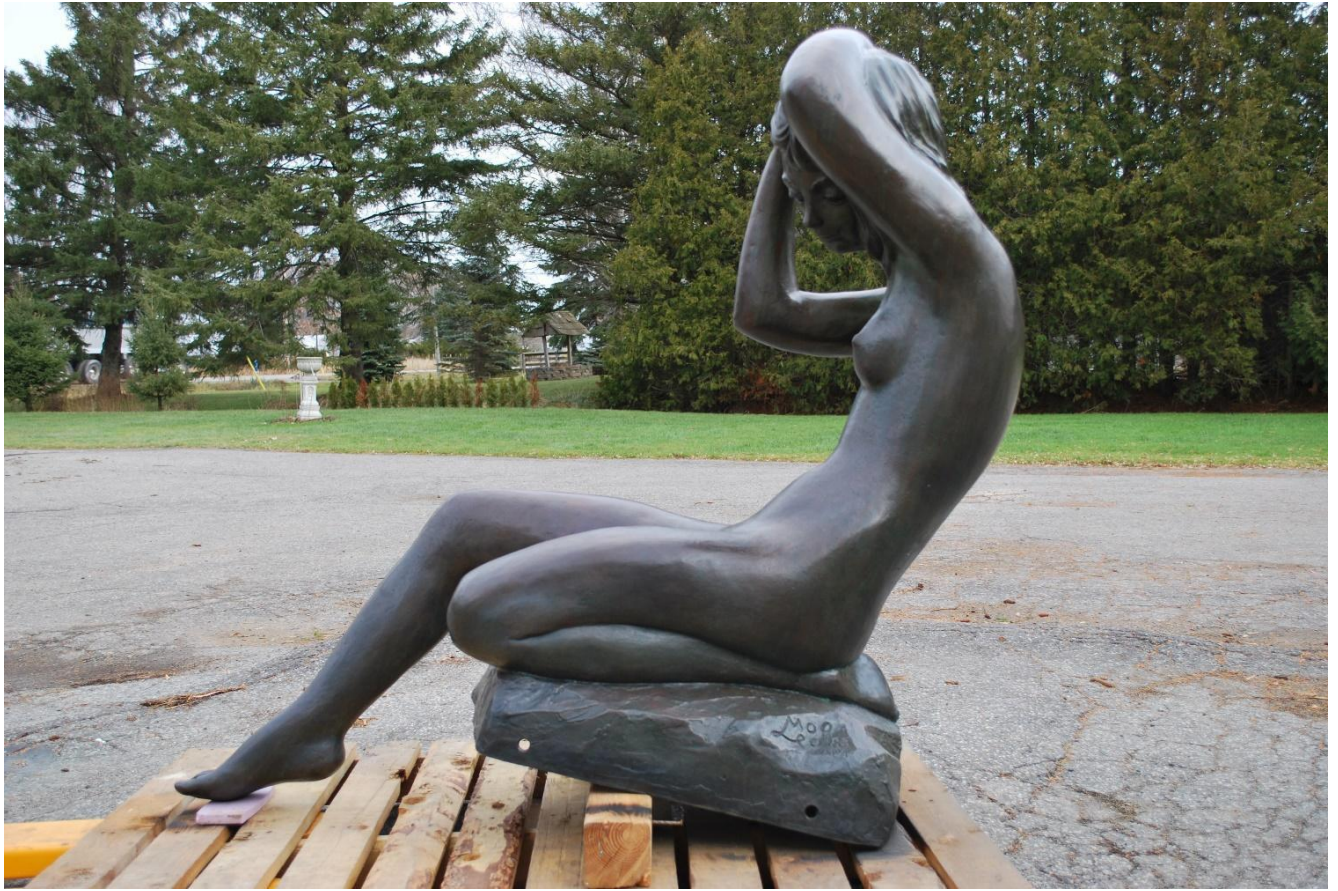
After Treatment - Patina restoration complete

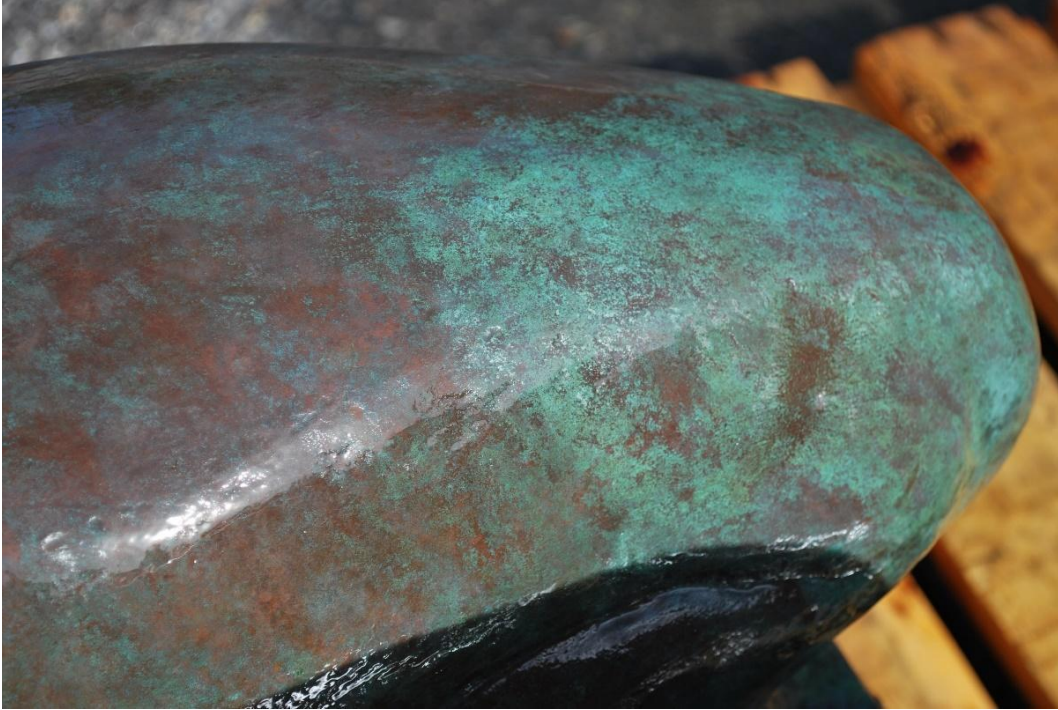
During Treatment – Darker areas denote corrosion removal using pressure washing

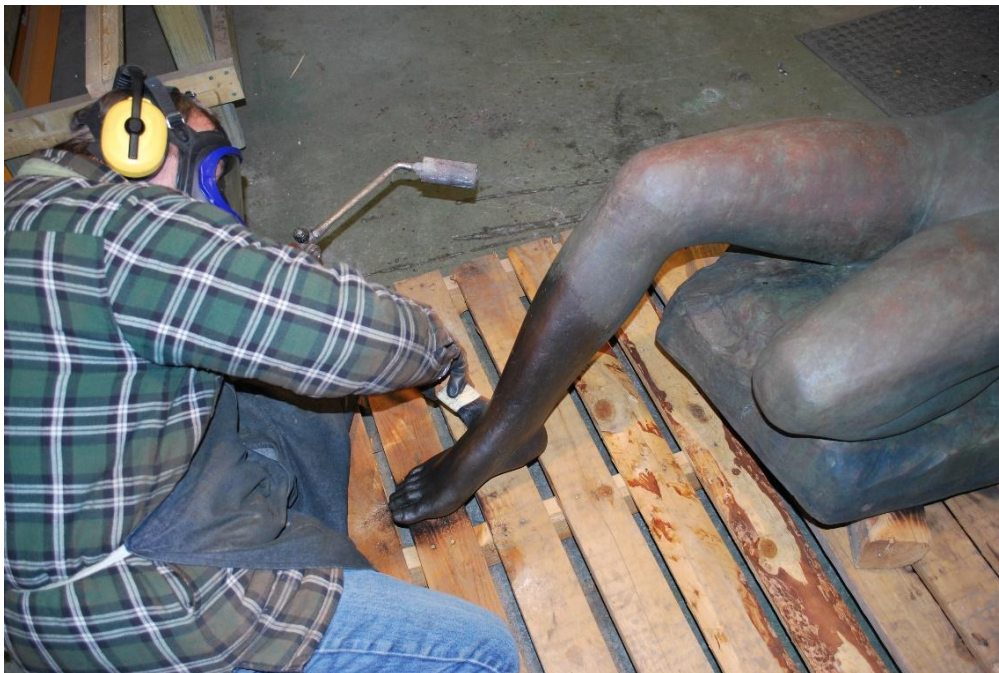
During Treatment - Hot waxing patinaed surface

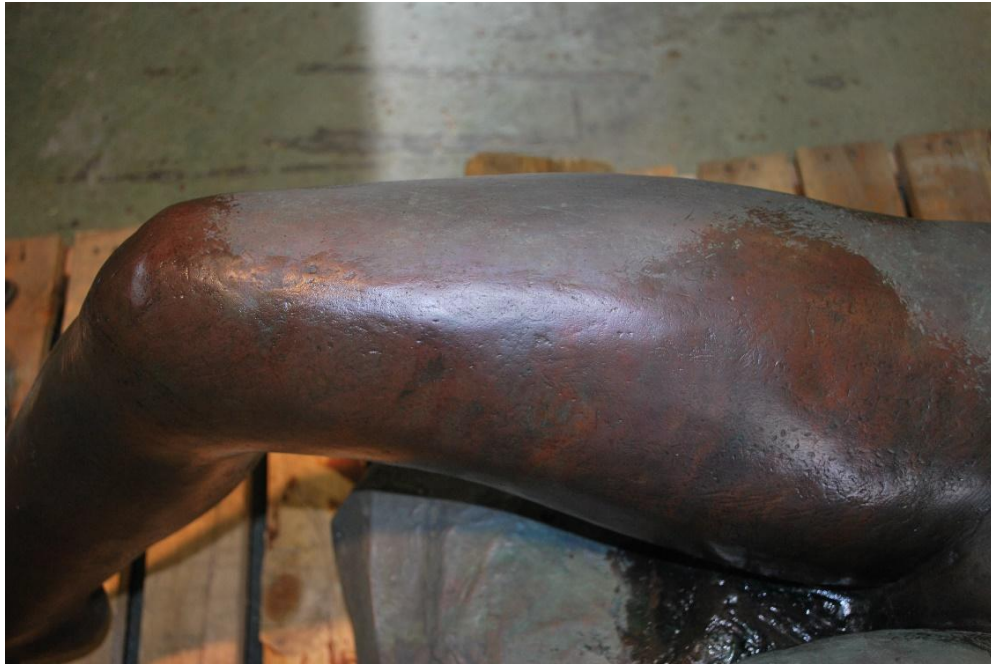
During Treatment - Detail shows richness & depth of patina

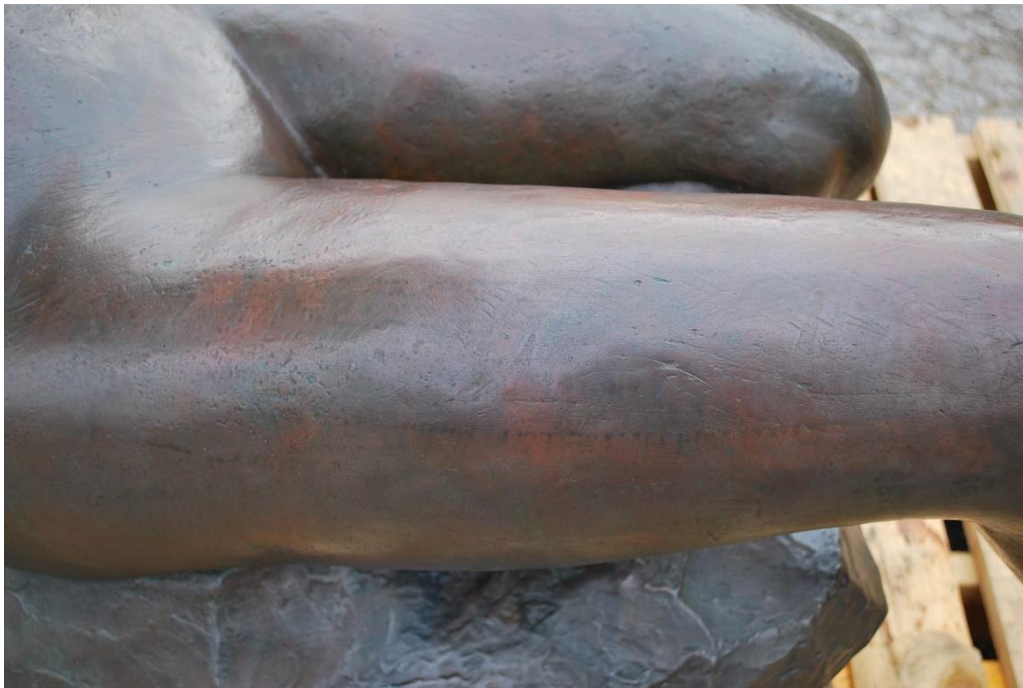
After Treatment – Detail of patina

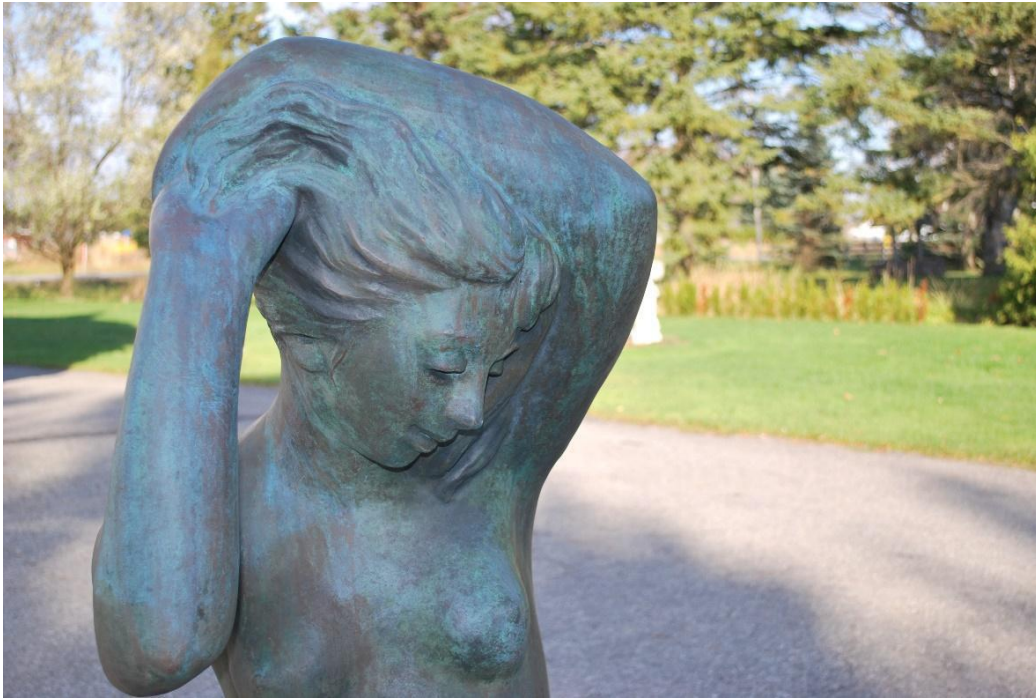
During Treatment – After pressure washing

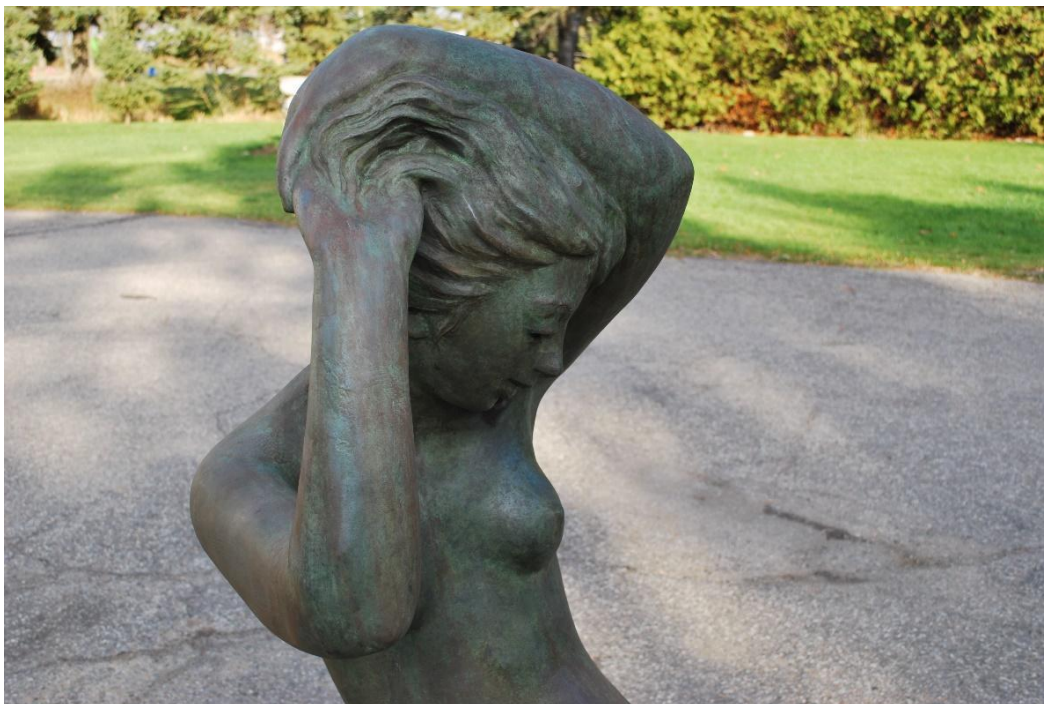
During Treatment – Patina completed - before waxing

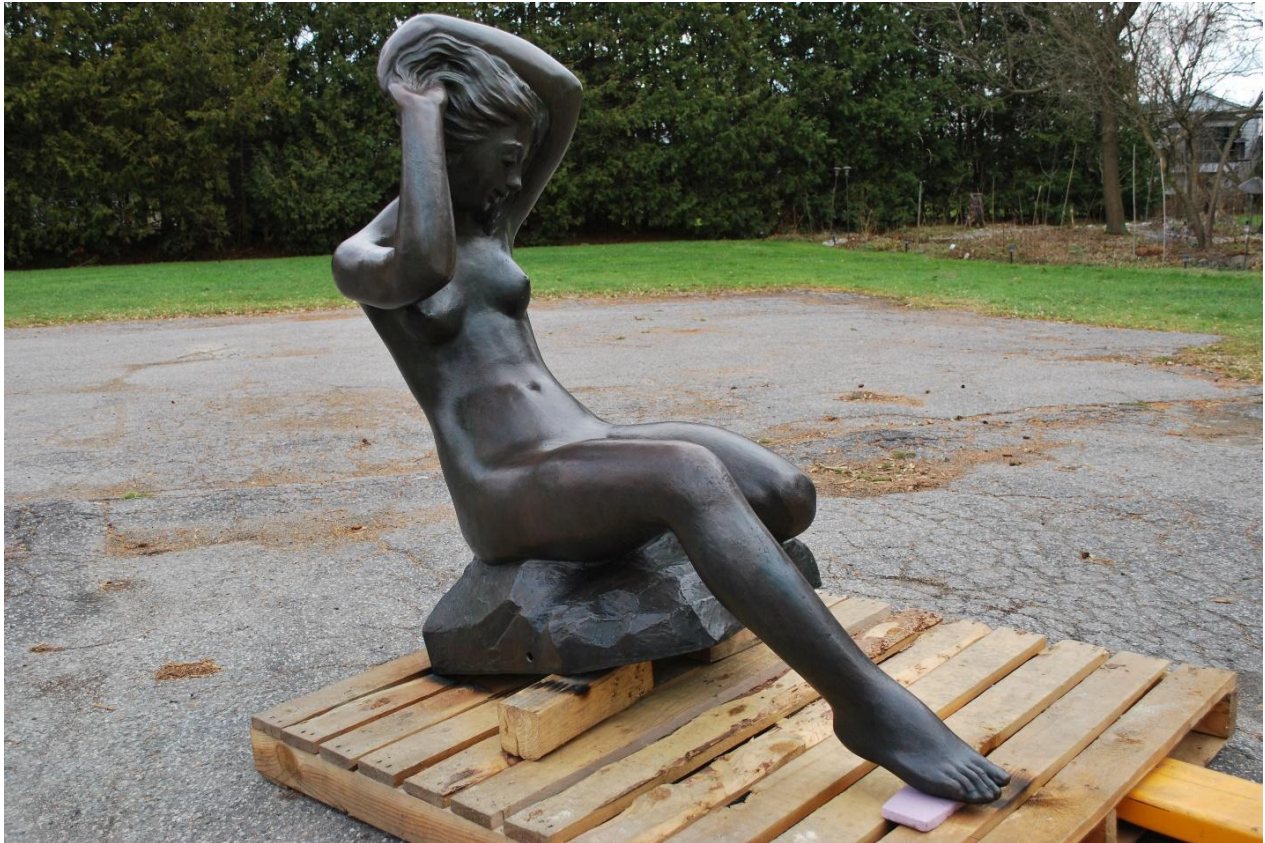
Anne was restored to a brownish color, with slight traces of greenish corrosion still present, making her appear in a more antiquated state. The result was a patina that was close to the original intent of the artist, and a patina that enhances the beauty of the sculpture.
