**Tree Inventory and Preservation Plan Report
Florence and Wyandotte Subdivision
Wyandotte Street East, Windsor, ON**

25 May 2018

Project P129

Tree Inventory and Preservation Plan

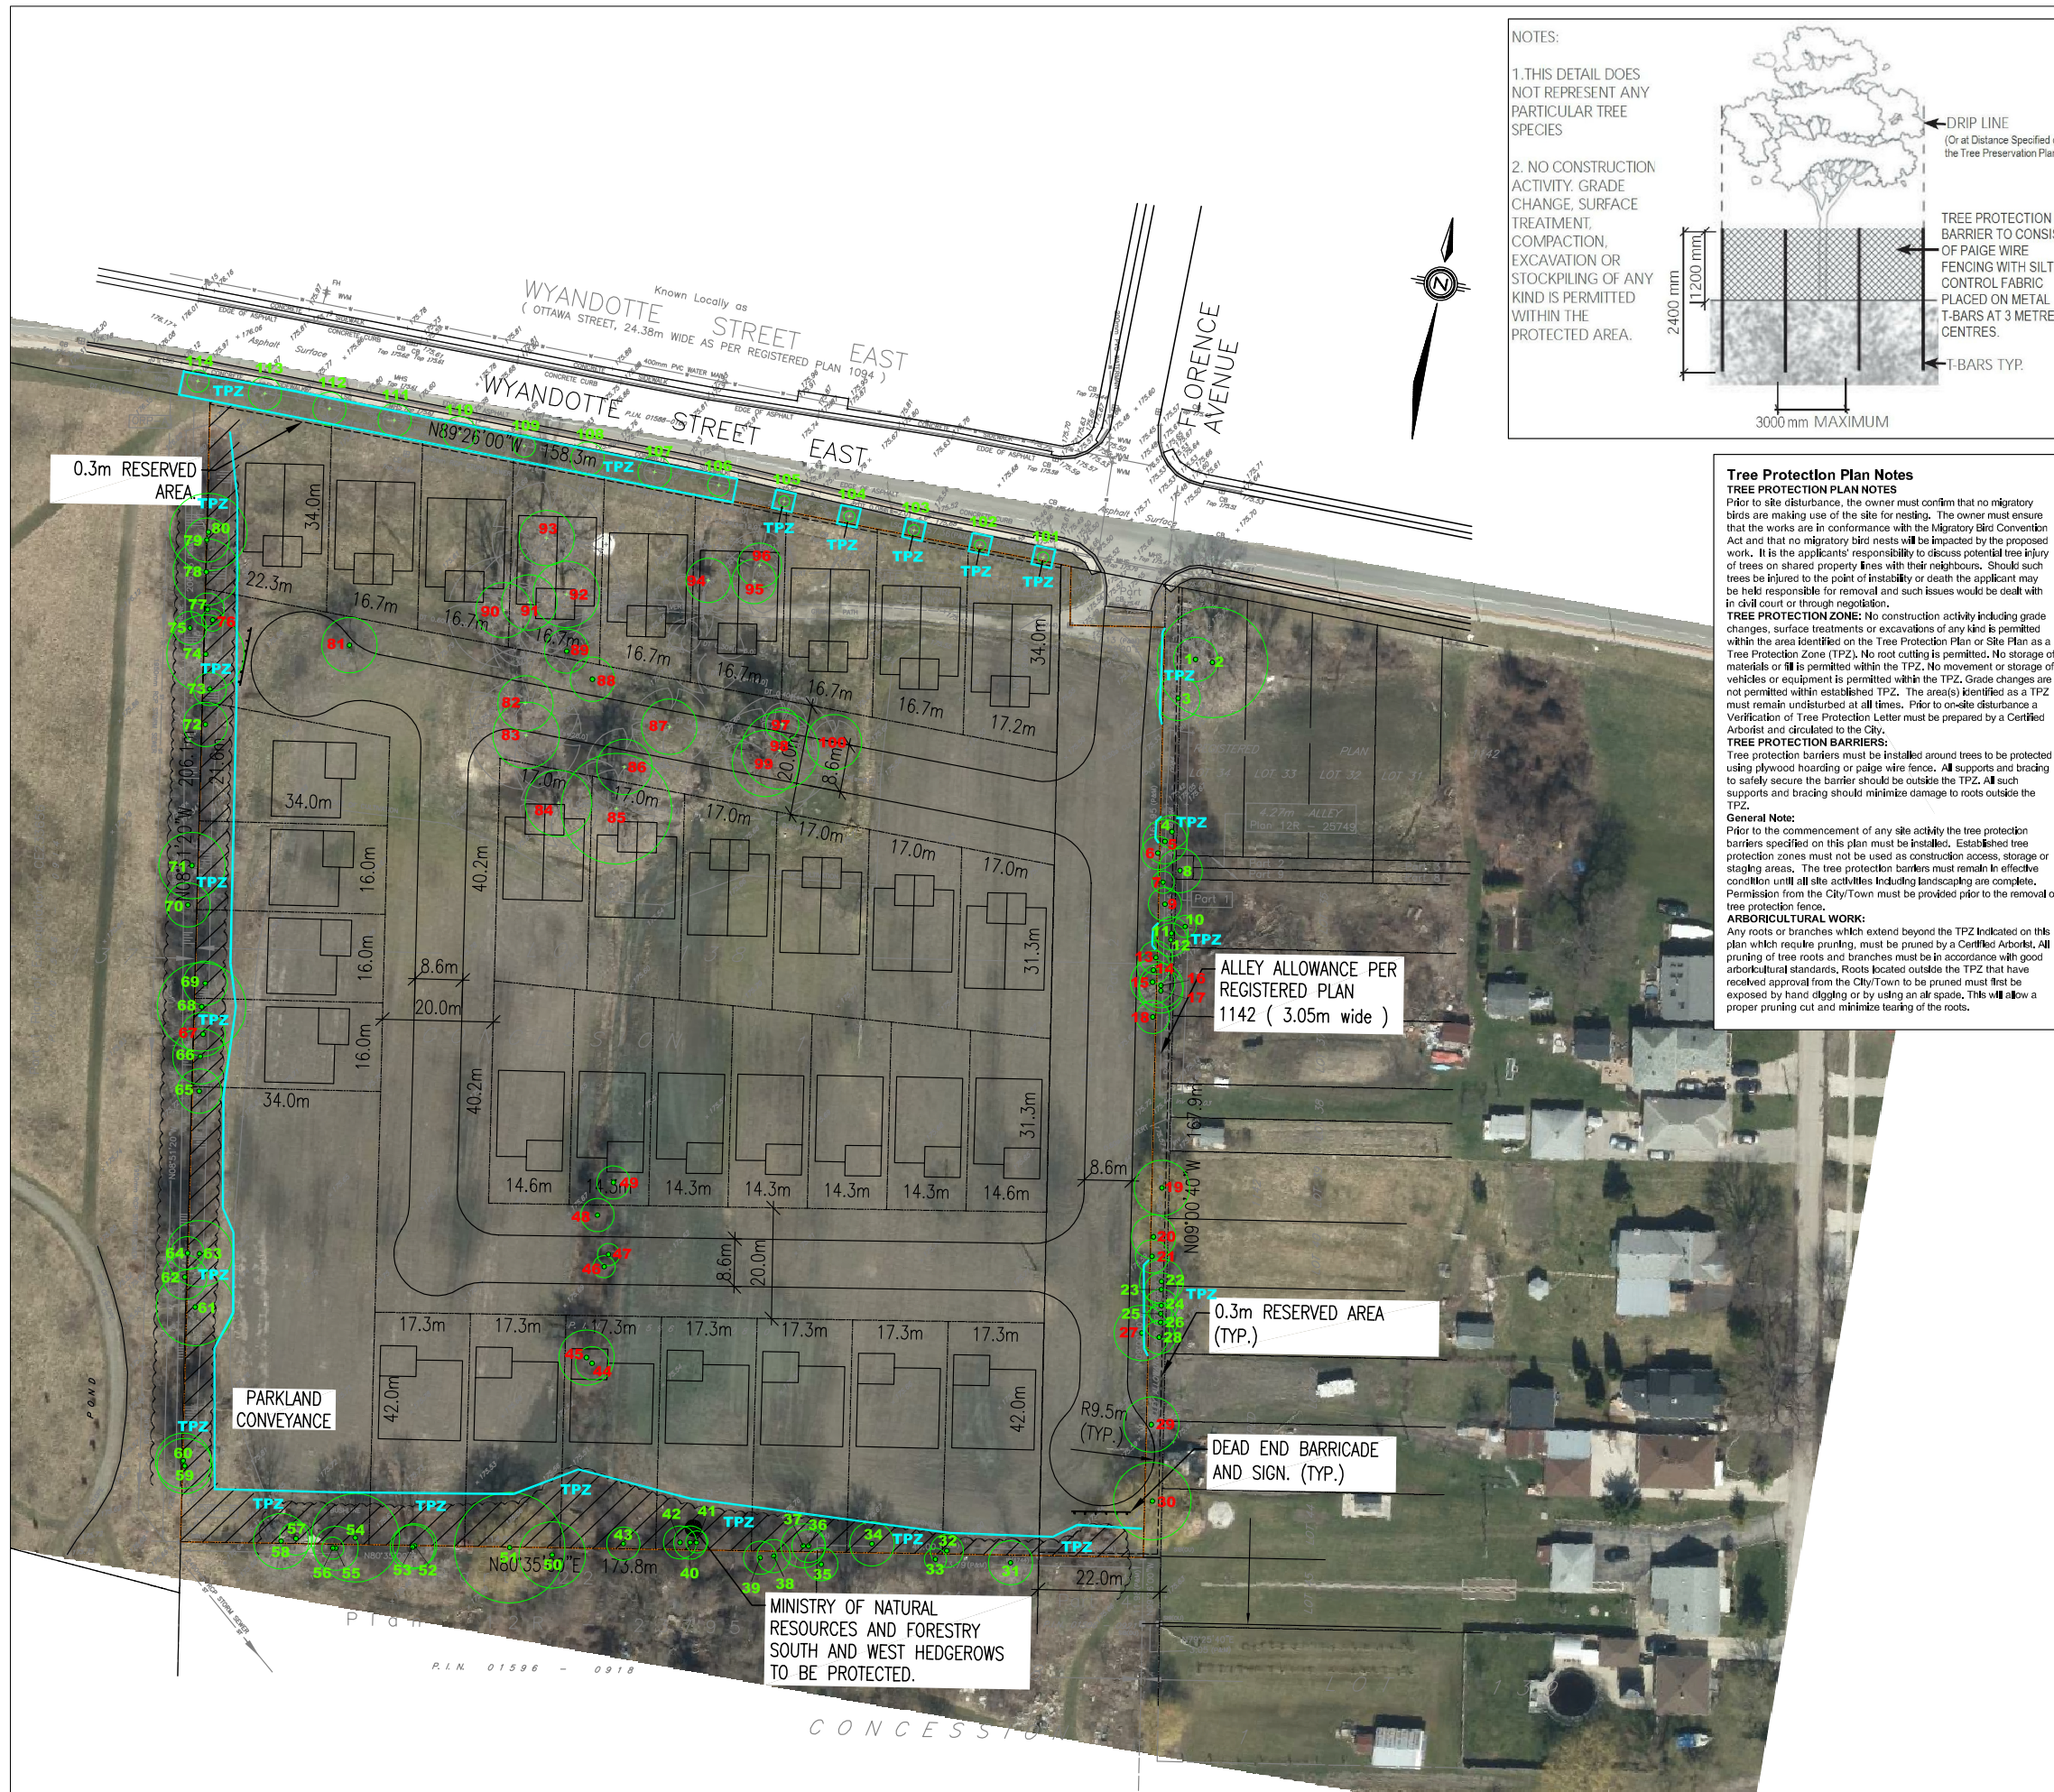
Project #	P129	Figure #	1
Date	25 May 2018		
Scale	1:750

The removal of trees 5-7, 9, 13-21, 27, 29, 30, 44-49 and 81-89 will be required to accommodate the proposed development. These trees will conflict directly with home construction and local road construction.

Trees 67 and 76 do not conflict with the proposed development, however, are exhibiting major defects and must be removed to mitigate the risk they pose to any occupants of the proposed development.

Trees 5, 7, 9, 16, 17, 20, 21, 29 and 30 appear to be situated fully or partially on neighbouring property. Permission from the respective property owner is required prior to the removal of any trees situated fully or partially on neighbouring property.

The preservation of Trees 1-4, 8, 10-12, 22-26, 28, 31-43, 50-66, 68-75, 77-80 and 100-114 will be possible with appropriate tree protection measures, pending a review of detailed grading plans. Tree protection measures will have to be implemented prior to the commencement of earthworks/grading to ensure that no trees identified for preservation are impacted by the proposed development.

Tree protection fence must be installed at the drip line for trees identified for preservation. Refer to Figure 1 for the location of required tree protection fence, the tree protection fence detail and for further tree protection plan notes.
