1027458 ONTARIO INC. Banwell and McHugh Mixed Use Developments

Tree Inventory and Preservation Study

March 2023 – 22-5144 and 22-5266

Tree Inventory and Preservation Study for the Banwell and McHugh Mixed Use Developments

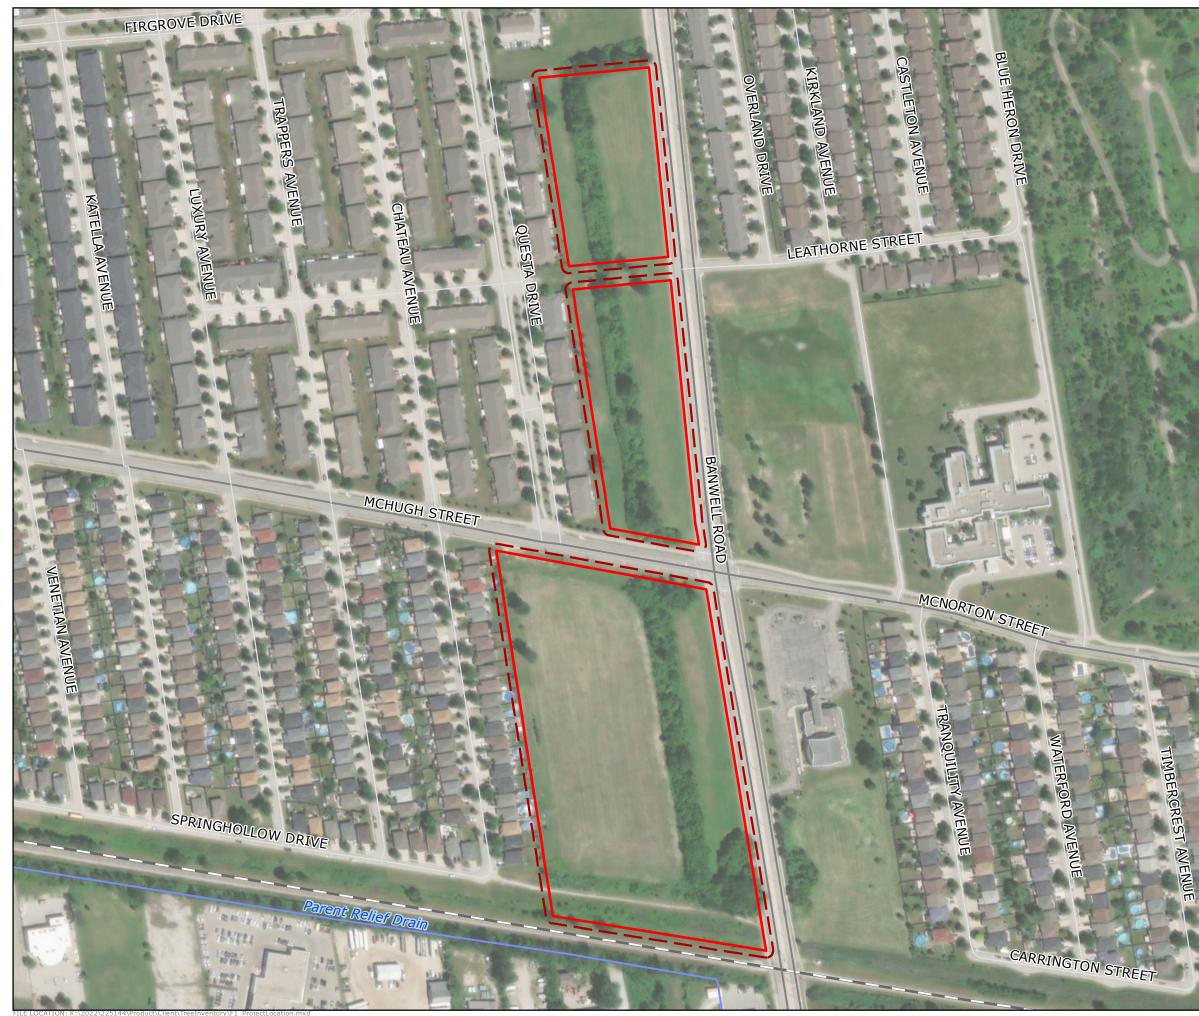
FIGURE 1

The proposed development will be located northwest and southwest of the intersection of McHugh Street and Banwell Road (Appendix A; Figure 1). Dillon's services included documentation of existing trees within the properties that make up the development area in addition to a 6 m buffer onto adjacent lands (the "Project Location"). The TIPS and Tree Inventory figures summarize the tree inventory conducted by Dillon for lands within and adjacent to the Project Location and provide recommendations regarding tree removals and preservation, as well as information related to applicable tree protection policies.

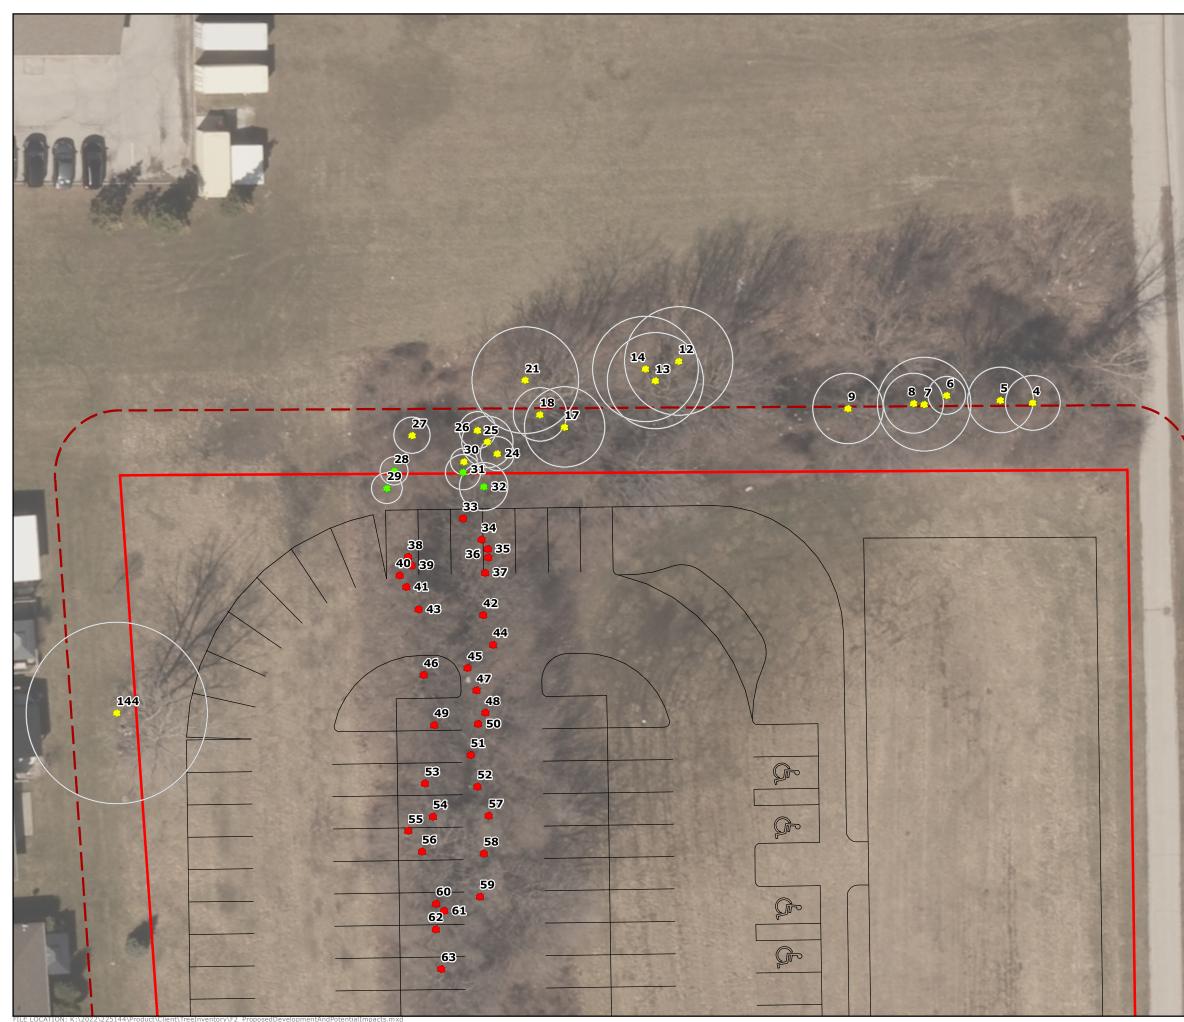
PROPOSED DEVELOPMENT AND POTENTIAL IMPACTS FIGURE 2A

Trees recommended for removal are symbolized in red (client-owned) and orange (not client-owned) on the Tree Inventory figure (Appendix A) and are identified in the tree inventory table (Appendix D). Of the 232 trees identified for removal, 106 trees are in excellent condition, 84 trees are in good condition, 18 trees are in fair condition, 14 trees are in poor condition, and 10 trees are dead.

Client-owned tree removals should be conducted by qualified and ISA-certified arborist following best arboricultural practices. Removal activities should avoid or minimize impacts to adjacent trees to be preserved (as identified below), and timing of removals should consider the project schedule of other construction activities (e.g. conduct removals following the installation of site fencing and/or tree protection fencing).
