**Phase I Environmental Site Assessment**

**Project Name**

Tecumseh Road East,  
Windsor, Ontario

LON-24000090-A0

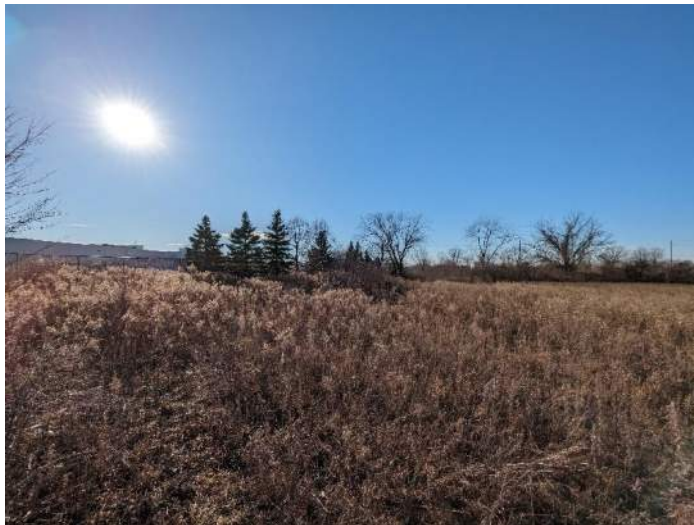
**Photo 1: Facing west from east boundary of Site at the west end of Catherine St.**

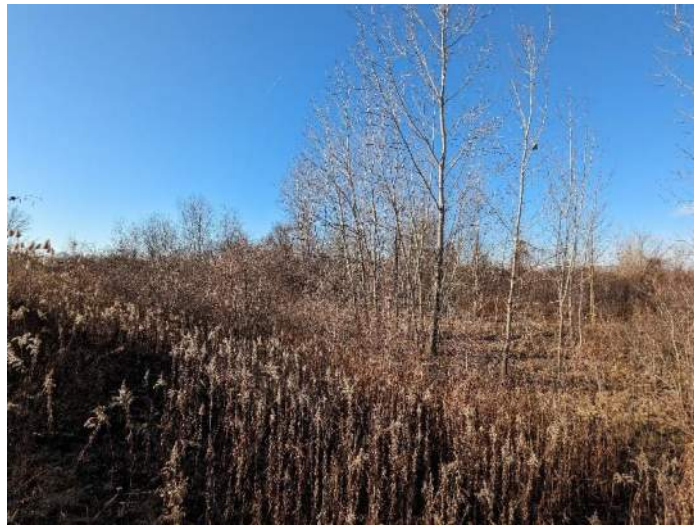
**Photo 2: Facing northwest from the southeast corner of Site, near the northeast corner of "Home Depot".**

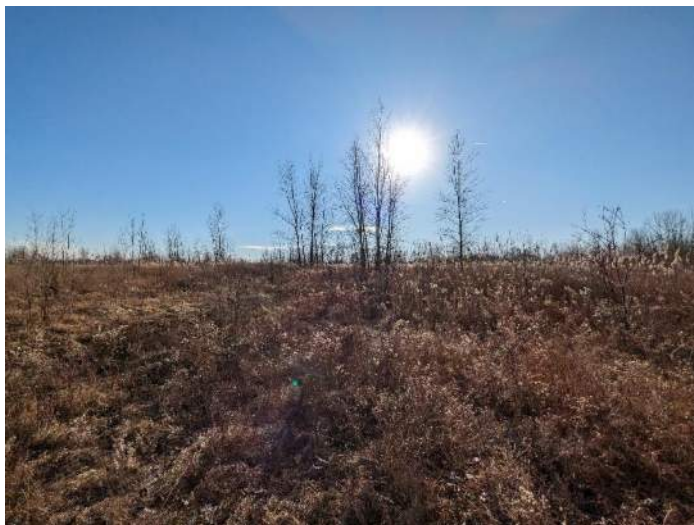
**Photo 3: Facing southwest from the northeast corner of Site.**

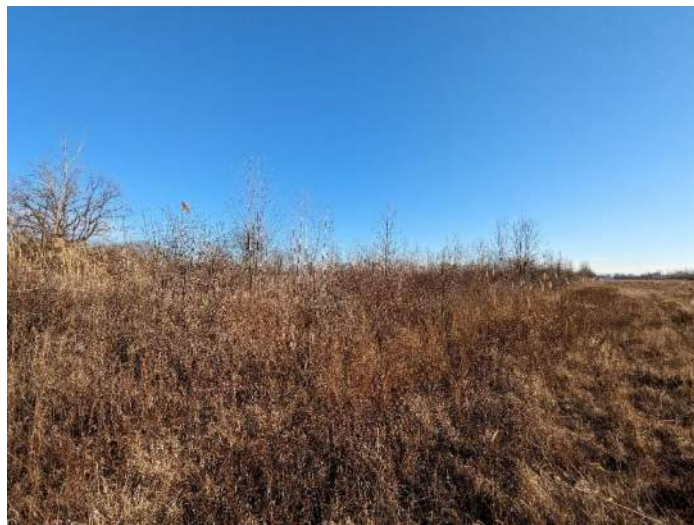
**Photo 4: Facing southeast from the northwest corner of Site.**

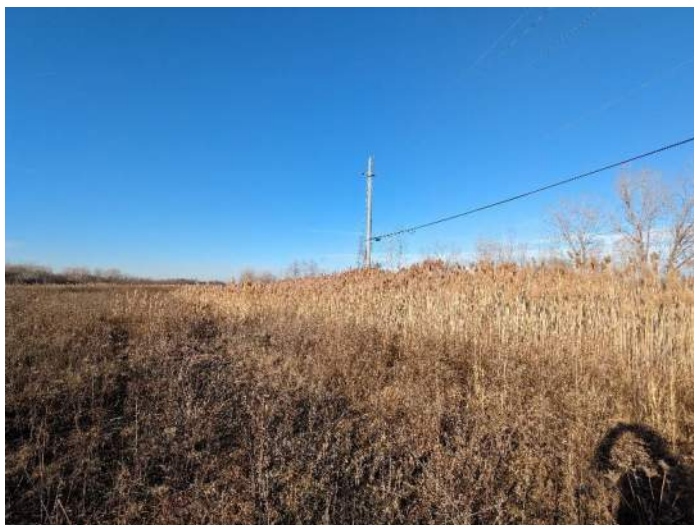
**Photo 5: Facing northeast from southwest corner of Site.**

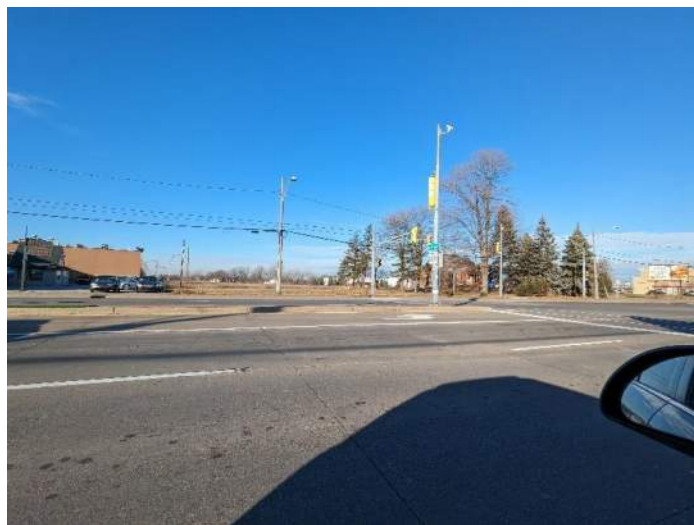
**Photo 6: Facing north from the south boundary of Site at the Rose-Ville Garden Dr & Tecumseh Rd E intsec.**

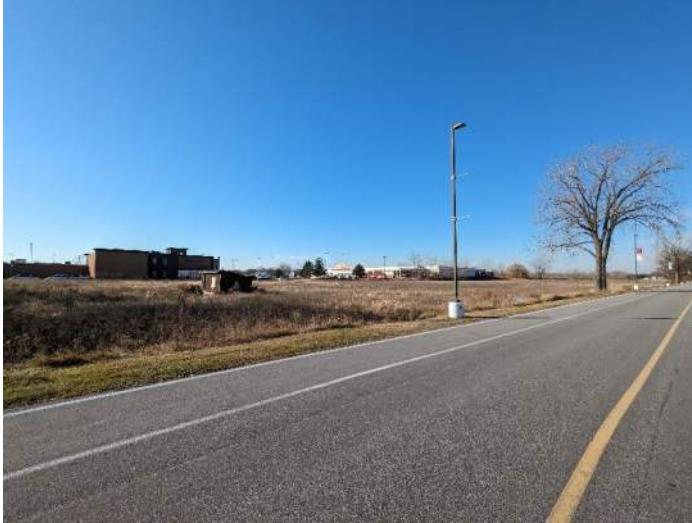
**Photo 7: South adjacent "Home Depot".**

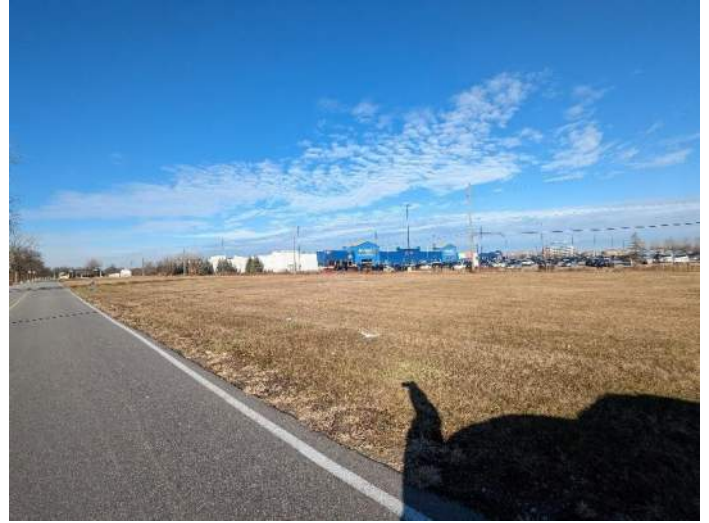
**Photo 8: South adjacent "Walmart".**

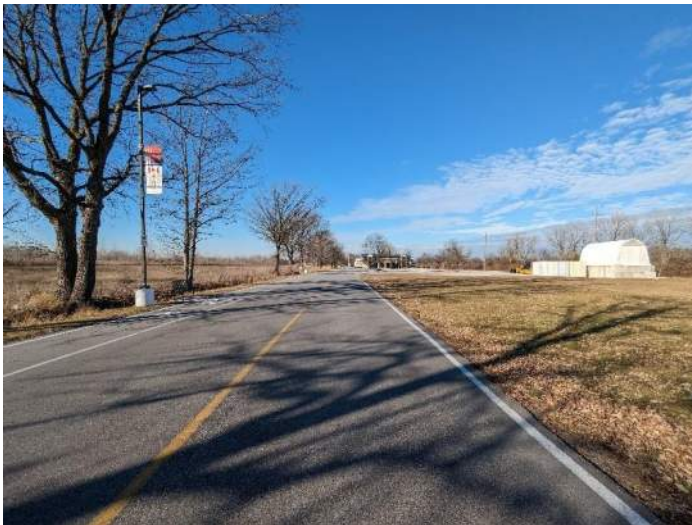
**Photo 9: East adjacent Serbian Centre.**

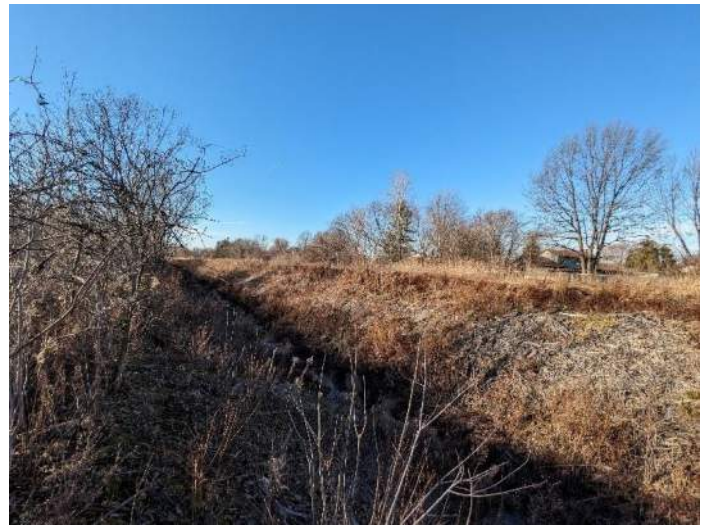
No current water courses or ditches were noted on-Site. Hawkins Drain was observed north adjacent to Site running parallel with the railway.

**Photo 10: North adjacent railway and drainage ditch.**

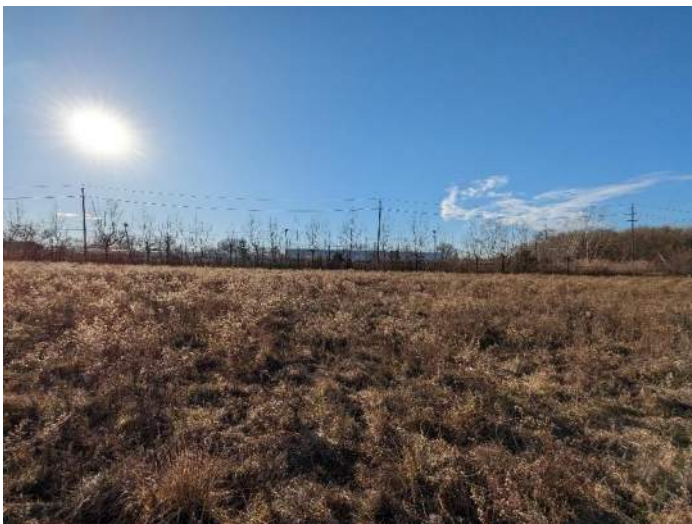
**Photo 11: West adjacent vacant lot and train yard.**

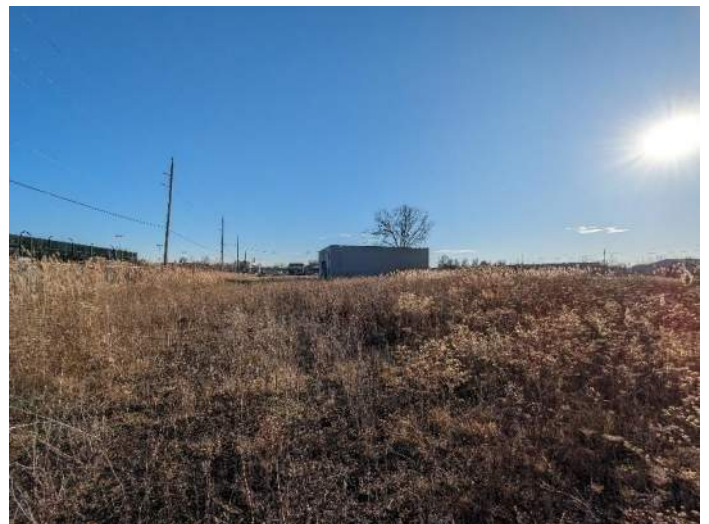
**Photo 12: South adjacent vacant commercial building.**

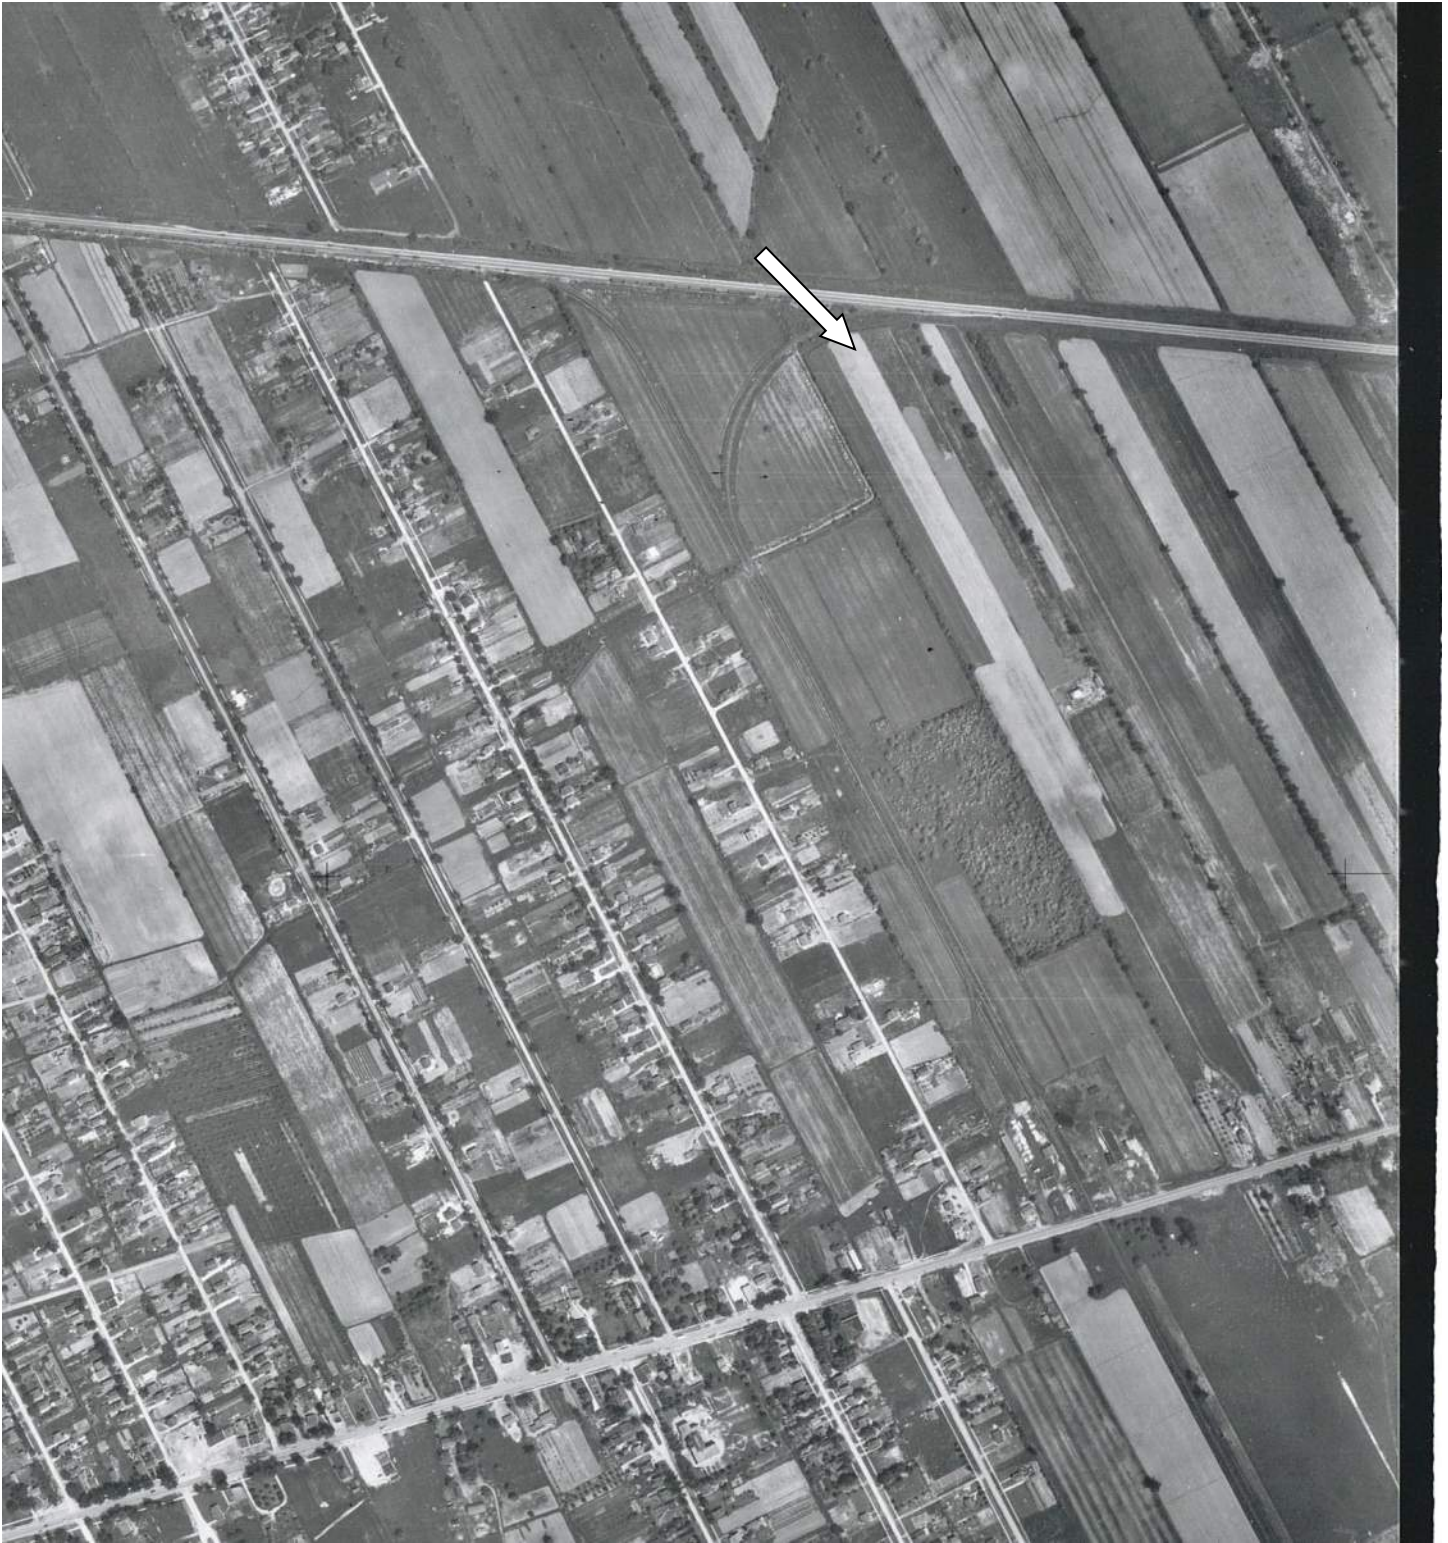
1950 Aerial Photograph (Arrow Indicates Site)

Aerial Photograph	Details
1950	<ul style="list-style-type: none"> <li>• The Site was observed as agricultural/vacant land with two (2) small buildings along the west boundary of Site. Rows of trees were also noted in a north-west orientation.</li> <li>• The surrounding area was shown as primarily agricultural/vacant land with some residential land use.</li> <li>• A railway was observed north adjacent to site with a connected railway siding located west of Site.</li> </ul>

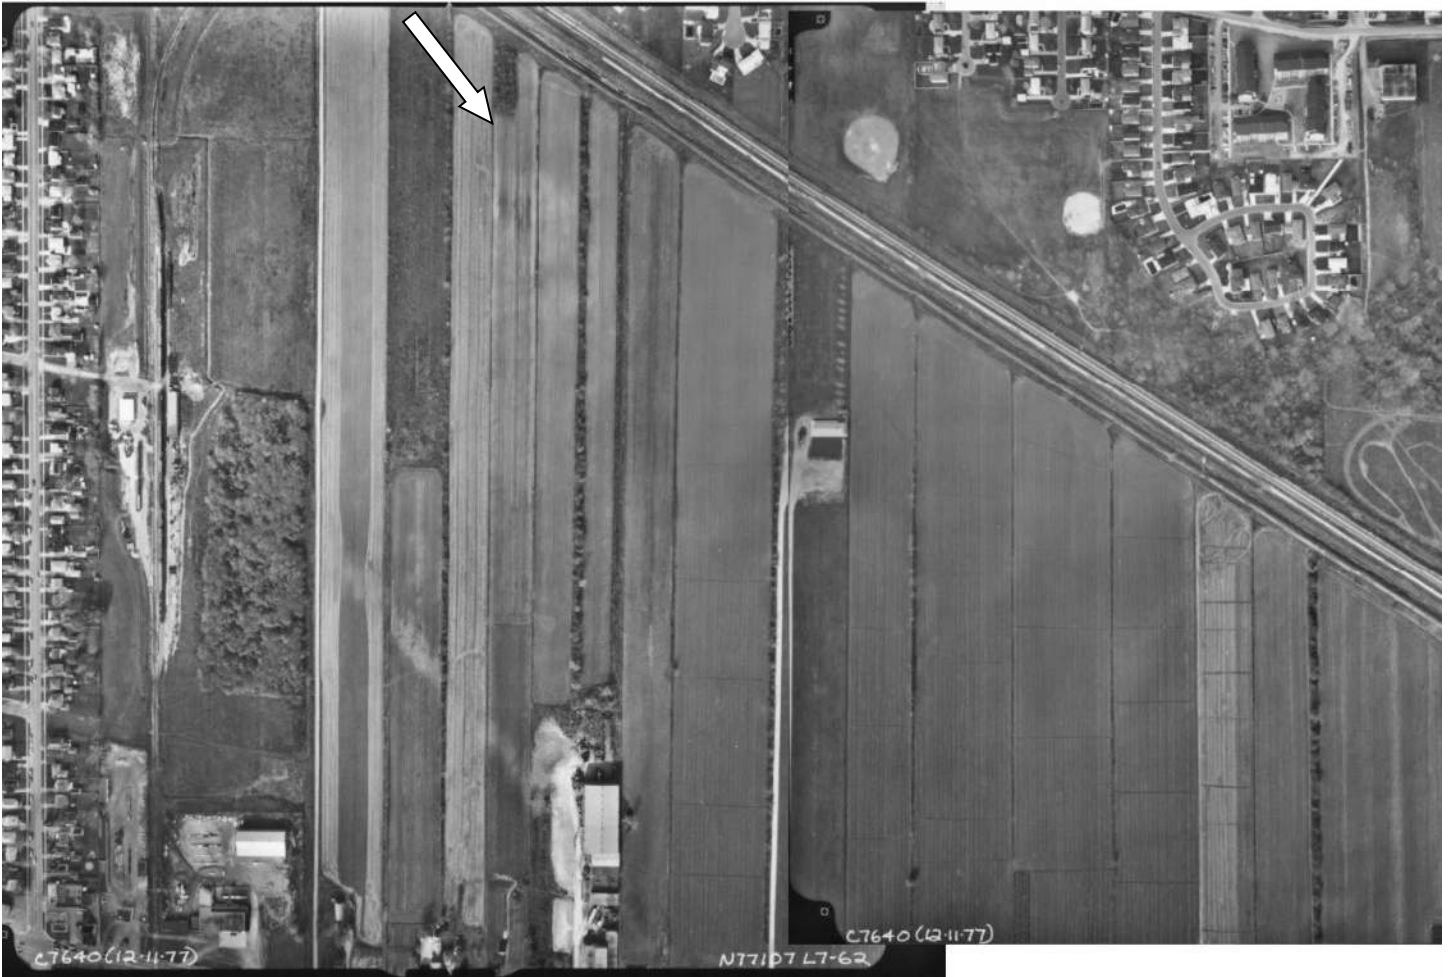
1977 Aerial Photograph

1977	<ul style="list-style-type: none"> <li>• No significant changes were observed on the Site.</li> <li>• A railway storage yard was present along the railway siding present approximately 250 metres to the west of the Site.</li> <li>• A commercial lot facility had been constructed approximately 170 metres to the southwest of Site.</li> </ul>
1987	<ul style="list-style-type: none"> <li>• The portion of Site along the west boundary had been forested.</li> <li>• A large commercial lot (lumber yard) was observed west of Site with outdoor storage and some commercial buildings.</li> <li>• Additional commercial/industrial buildings were observed along Tecumseh Road East.</li> </ul>
1993	<ul style="list-style-type: none"> <li>• No significant changes were observed on the Site.</li> <li>• Additional commercial buildings were observed along Tecumseh Road East.</li> </ul>
2004	<ul style="list-style-type: none"> <li>• Disturbed/stockpiled soil was observed in the central portion of Site.</li> <li>• Catherine Street was observed east adjacent to Site with large commercial buildings observed south and east of Site.</li> </ul>

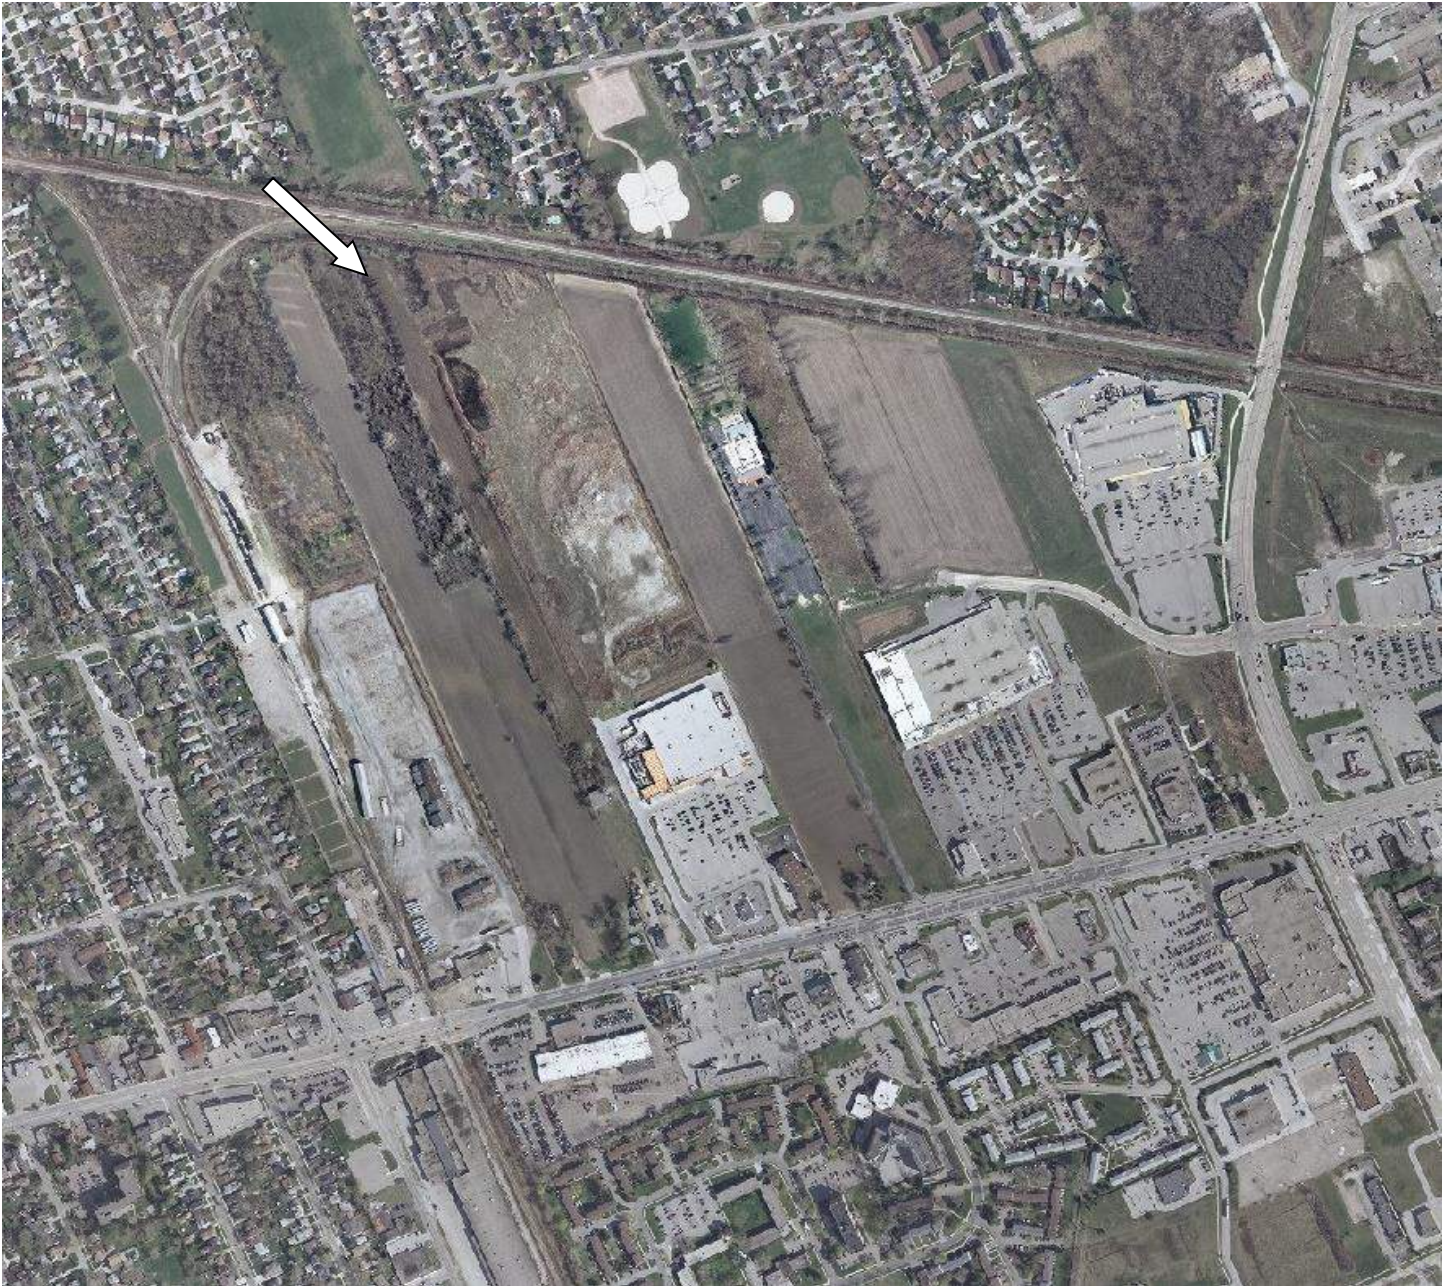
2010 Aerial Photograph

2010	<ul style="list-style-type: none"> <li>• Additional disturbed/stockpiled soil was observed on the central portion of Site with a small pond observed.</li> <li>• A large commercial building was observed south adjacent to Site.</li> </ul>
2023	<ul style="list-style-type: none"> <li>• The Site was observed as vacant.</li> <li>• The storage lot west of Site was now vacant.</li> </ul>
