EAST RIVERSIDE FLOOD RISK ASSESSMENT

Project Background

The City of Windsor retained Landmark Engineers Inc. in the fall of 2018 to undertake a flood risk assessment study for the East Riverside area.

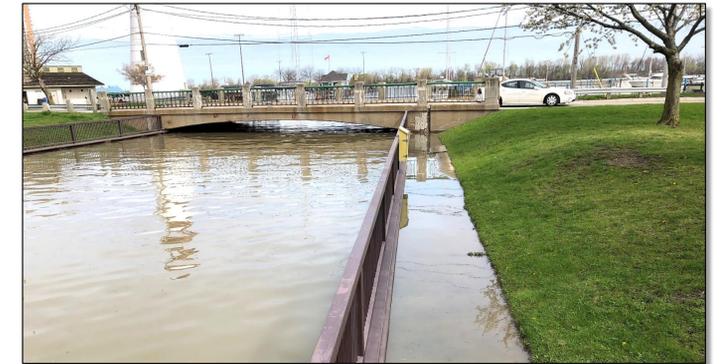
HIGH WATER LEVELS ALONG LITTLE RIVER (LOOKING NORTH)

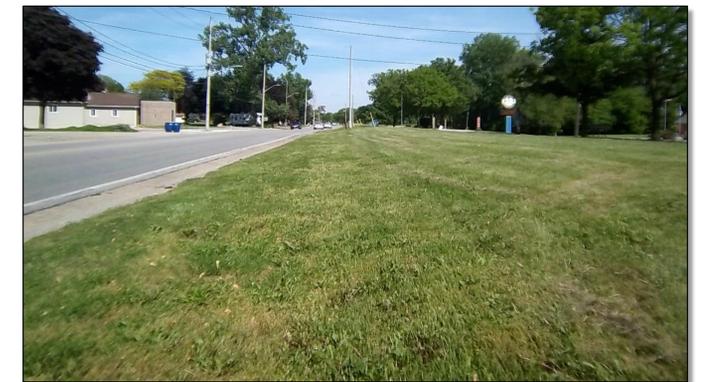
TYPICAL EXISTING EARTH BERM (LOOKING EAST)

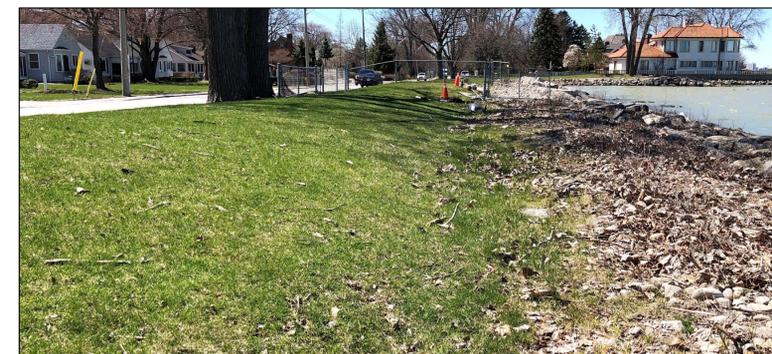
EXISTING EARTH BERM AT ST. ROSE BEACH (LOOKING WEST)

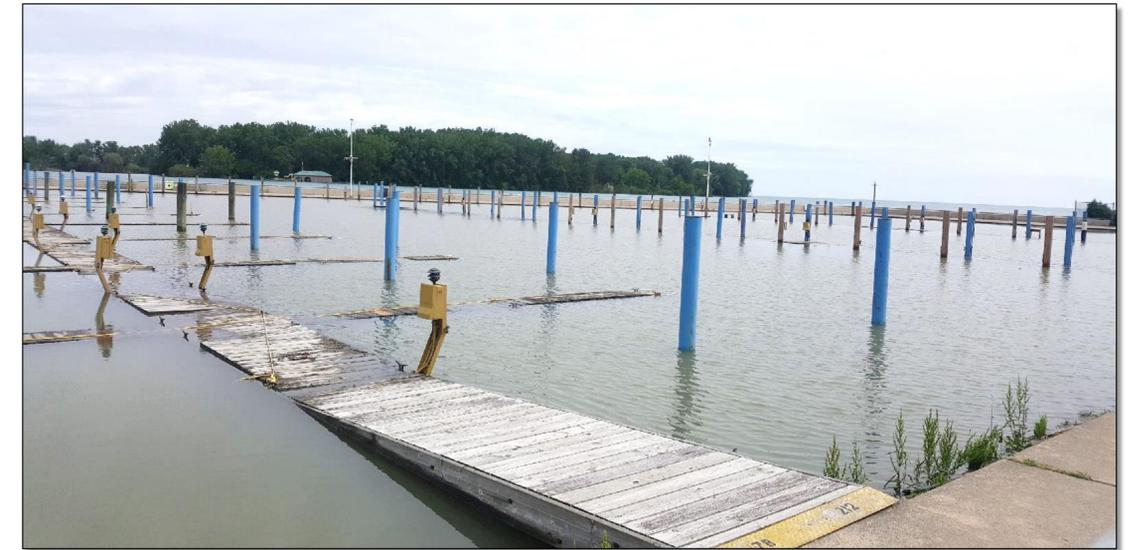
LAKEVIEW MARINA (20 JUNE 2019)

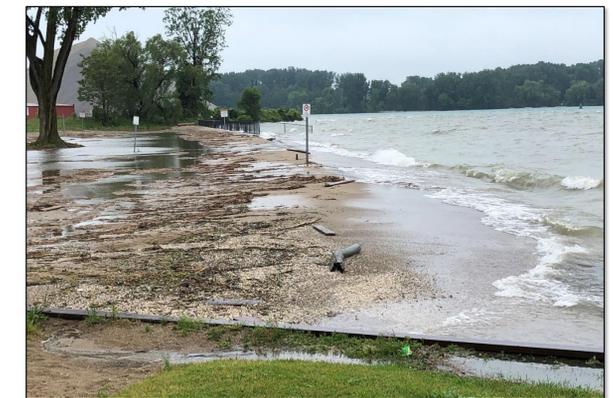
SAND POINT BEACH (16 JUNE 2019)

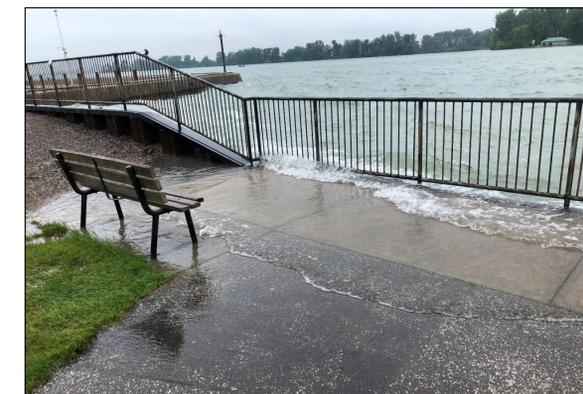
SHANFIELD SHORES PARK (16 JUNE 2019)

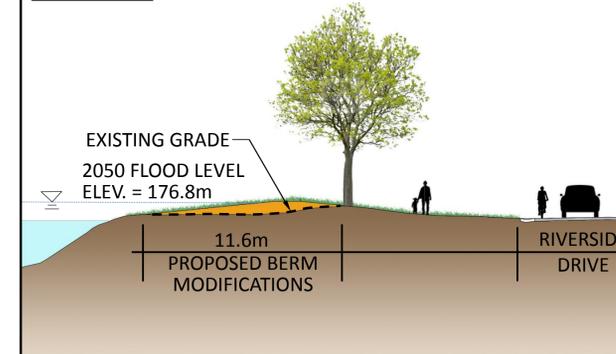
SECTION 1

EXISTING CONDITIONS: Public park with existing earth berm. Elevation of berm lower than 2050 flood elevation.

PROPOSED SOLUTION: Modify existing berm to meet 2050 flood elevation. Realign berm to accommodate existing trees and landscaping where possible.

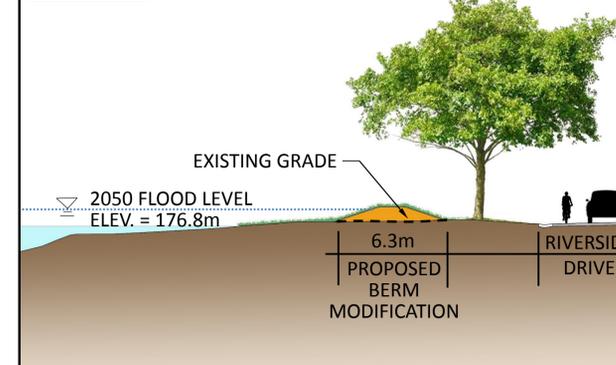
SECTION 3

EXISTING CONDITIONS: Park-like area with elevations below 2050 flood elevation and no discernable berm.

PROPOSED SOLUTION: Construct earth berm to meet 2050 flood elevation. Align berm to preserve existing mature trees and landscaping where possible.

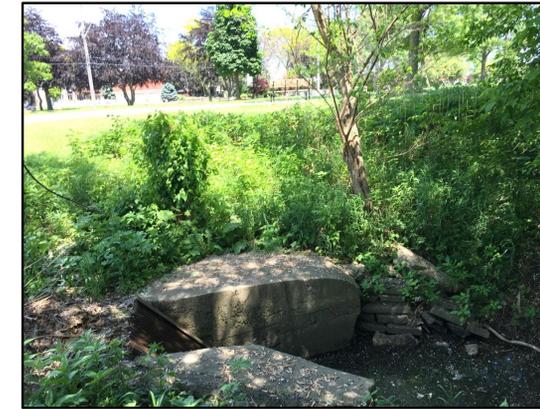
- In the event of high water levels on Lake St. Clair, flooding of Riverside Drive may occur.
- In the event that Riverside Drive is flooded, the storm sewers along the roadway have the potential to convey flood waters inland.
- Flood waters have the potential to enter the catch basins and flow through the sewers under the protective berm and cause inland flooding.
- There are 3 different existing storm sewer configurations where this may occur:
 1. Storm sewers that receive flows from the local storm sewers along Riverside Drive and convey this inland to pumping stations.
 2. Storm sewers collecting surface runoff from inland locations that convey this flow to the storm sewer along Riverside Drive.
 3. Catch basins on the south side of the berm that are directly connected to storm sewers along Riverside Drive.

CATCH BASIN AT SPORTSMAN CLUB,
SOUTH SIDE OF EARTH BERM

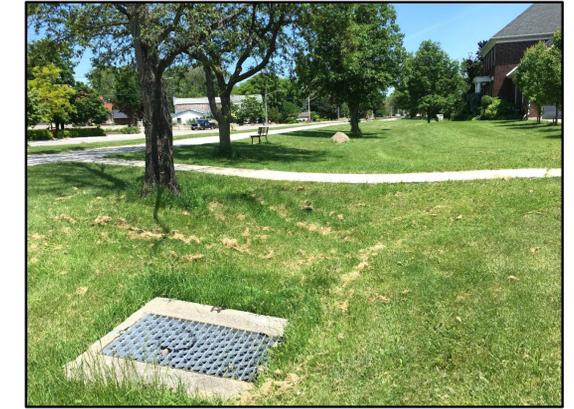
CATCH BASIN WEST OF JARVIS AVE.,
SOUTH SIDE OF EARTH BERM

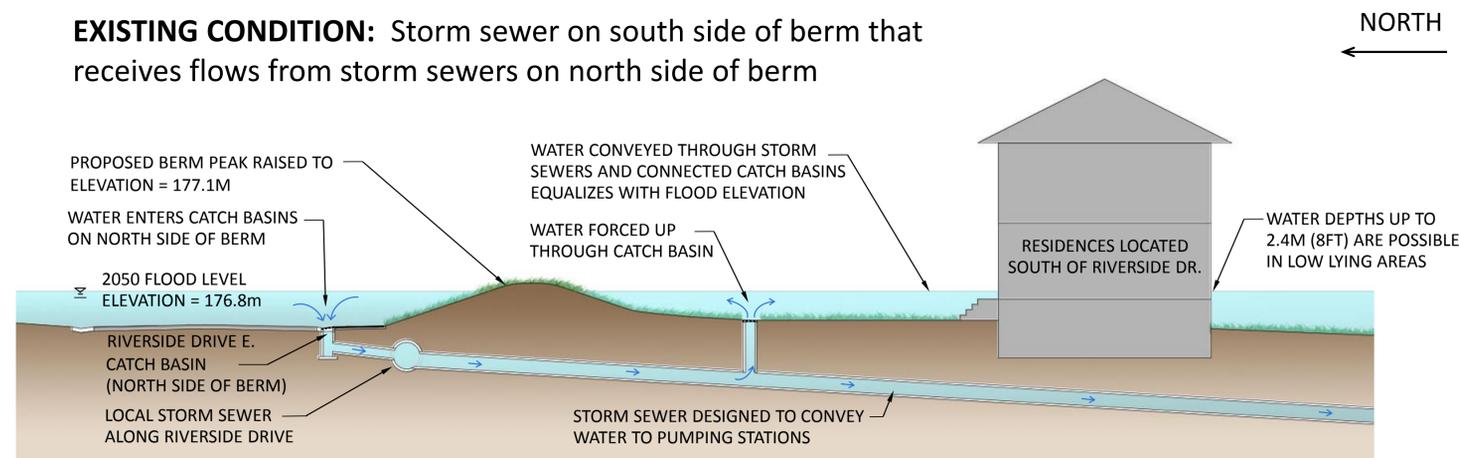
CONFIGURATION 1:

EXISTING CONDITION: Storm sewer on south side of berm that receives flows from storm sewers on north side of berm

- During a high water event, catch basins along Riverside Drive may fill with water and surcharge the storm sewers.
- The water on the south side of the berm has the potential to equalize with the lake water level.
- Inland water levels may reach a depth of 2.4m (8ft) in some areas.
- Potential to cause basement and even first floor flooding in low lying areas.

POTENTIAL SOLUTION: Install sluice gate inline with storm sewer to prevent flow of water to inland areas during flood conditions

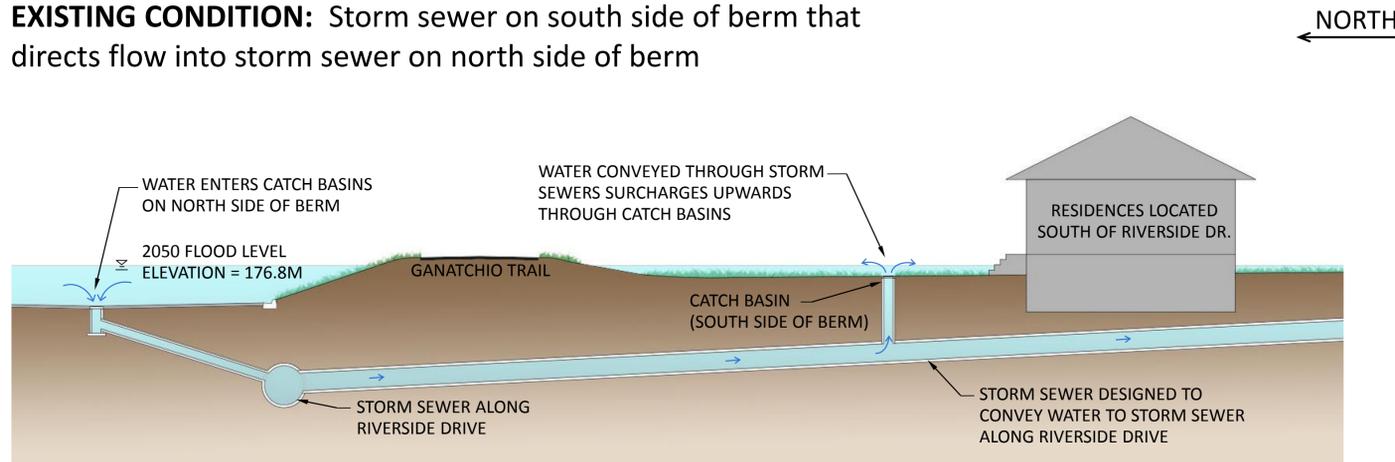
CONFIGURATION 2:

EXISTING CONDITION: Storm sewer on south side of berm that directs flow into storm sewer on north side of berm

- During high water events, water enters storm sewers through catch basins along Riverside Drive and in adjacent parking lots.
- Water is forced upwards through connected sewers and exits through catch basins on south side of berm.
- Water on south side of berm has the potential to equalize with lake water level.

POTENTIAL SOLUTION: Install backflow prevention device (duckbill) inline with storm sewer on south side of berm

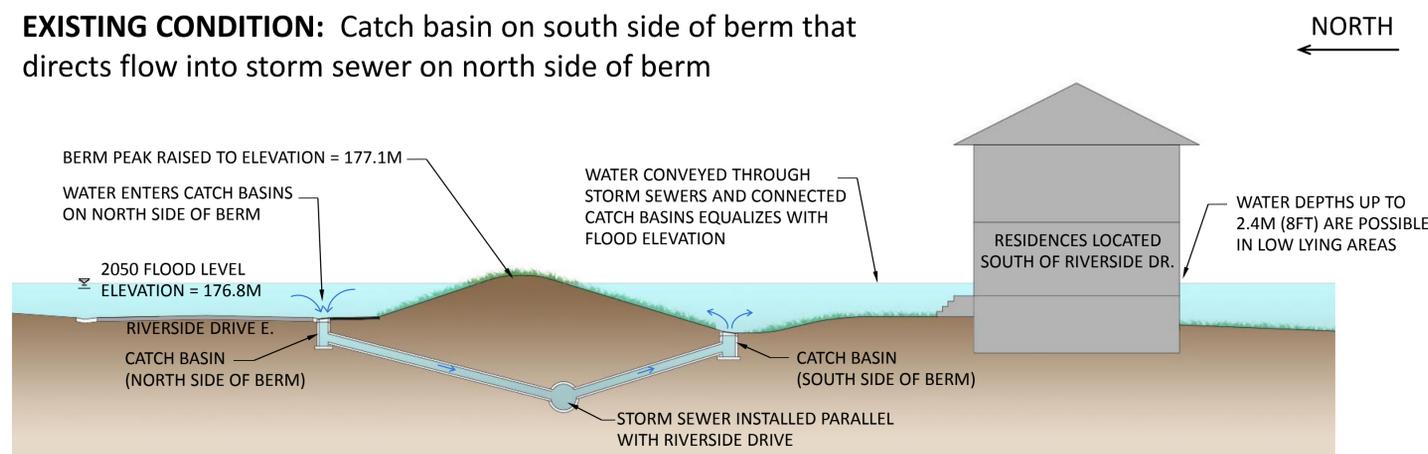
CONFIGURATION 3:

EXISTING CONDITION: Catch basin on south side of berm that directs flow into storm sewer on north side of berm

- During high water events, water enters sewers through catch basins adjacent to Riverside Drive.
- Water flows through cross-connected catch basins on south side of berm and floods neighbourhoods.
- Water on south side of berm has the potential to equalize with lake water level.

POTENTIAL SOLUTION: Modify inlet of catch basin with backflow prevention device (duckbill)
