LAKEFRONT HEIGHTS INC.
**Official Plan and Zoning By-Law
Amendments**

Natural Features Inventory & Preservation Study

Natural Features Inventory & Preservation Study for the property known as Lakefront Heights

Our file: 21-2104

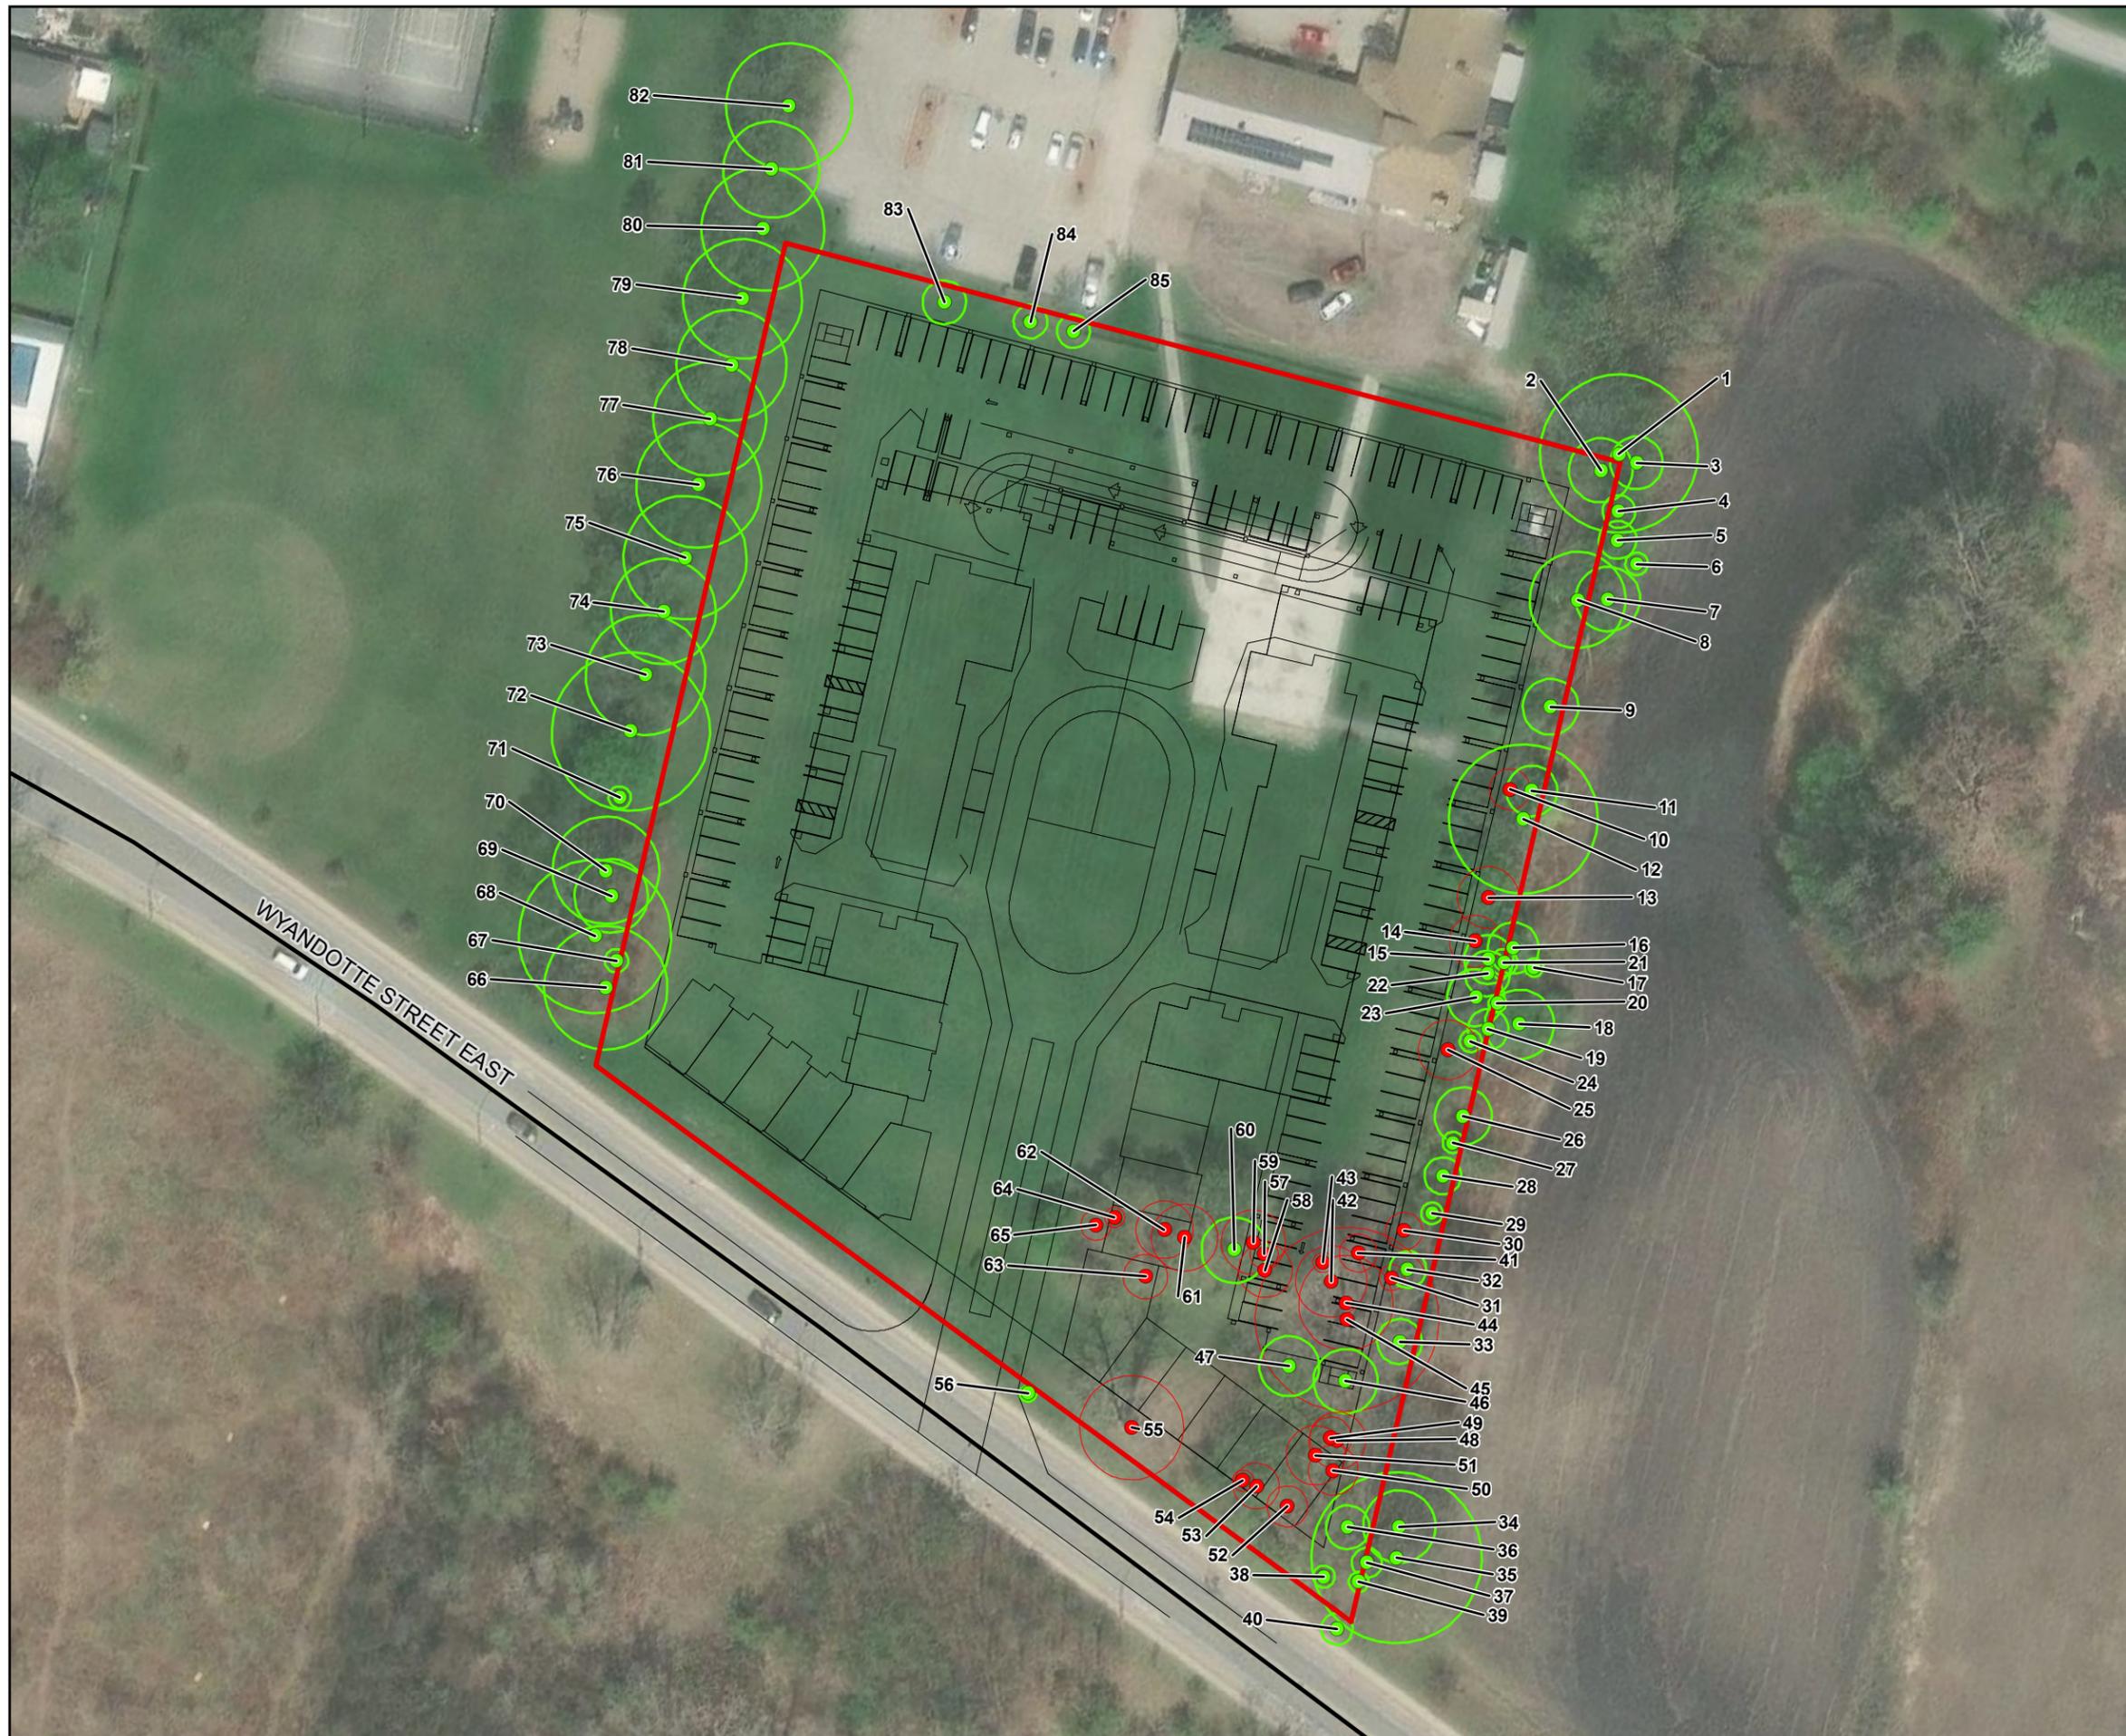
PROPOSED DEVELOPMENT AND POTENTIAL IMPACTS FIGURE 2

Trees recommended for removal are symbolized in red on the Tree Inventory figures (Appendix A; Figure 2) and are identified in the tree inventory table (Appendix C). Of the 27 trees identified for removal, 24 are in good condition, 2 are in poor condition, and 1 is dead.

Tree removals should be conducted by qualified and International Society of Arboriculture (ISA)-certified arborist following best arboricultural practices. Removal activities should avoid or minimize impacts to adjacent trees to be preserved (as identified below), and timing of removals should consider the project schedule of other construction activities (e.g., conduct removals following the installation of site fencing and/or tree protection fencing).

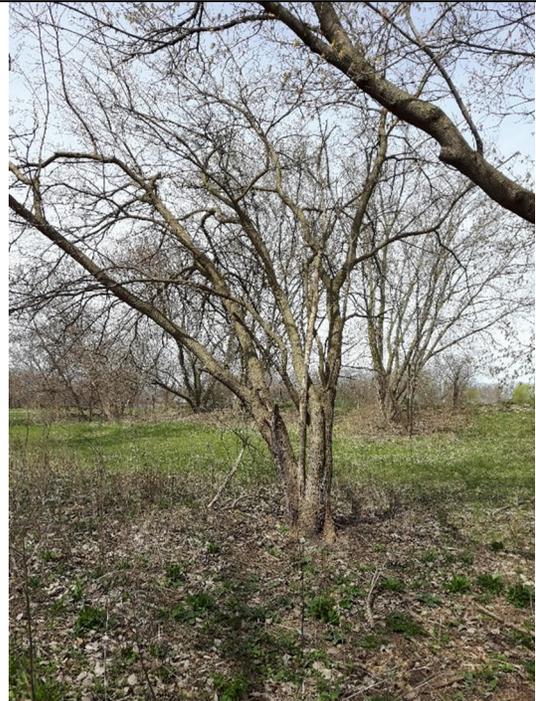
Tree 47: White Mulberry

47	<i>Morus alba</i>	White Mulberry	34.5, 31.4	4.14	Poor	One stem is split	Retain	Not within construction footprint
48	<i>Acer negundo</i>	Manitoba Maple	32.7, 26.5, 12.6	3.92	Good		Remove	Within construction footprint
49	<i>Acer negundo</i>	Manitoba Maple	24	2.88	Good		Remove	Within construction footprint
50	<i>Acer negundo</i>	Manitoba Maple	28.6, 24.0	3.43	Good		Remove	Within construction footprint
51	<i>Acer negundo</i>	Manitoba Maple	34.0, 18.4	4.08	Good		Remove	Within construction footprint
52	<i>Acer negundo</i>	Manitoba Maple	23.5, 18.6	2.82	Good		Remove	Within construction footprint
53	<i>Acer negundo</i>	Manitoba Maple	26.4, 21.1, 16.2, 15.2	3.17	Good		Remove	Within construction footprint
54	<i>Acer negundo</i>	Manitoba Maple	12.1, 10.3	1.45	Good		Remove	Within construction footprint
55	<i>Populus deltoides ssp. Deltoides</i>	Eastern Cottonwood	59.9, 59.5	7.19	Good		Remove	Within construction footprint
