TREE INVENTORY & PRESERVATION STUDY

2121 Riverside Drive West, City of Windsor

July 2, 2024

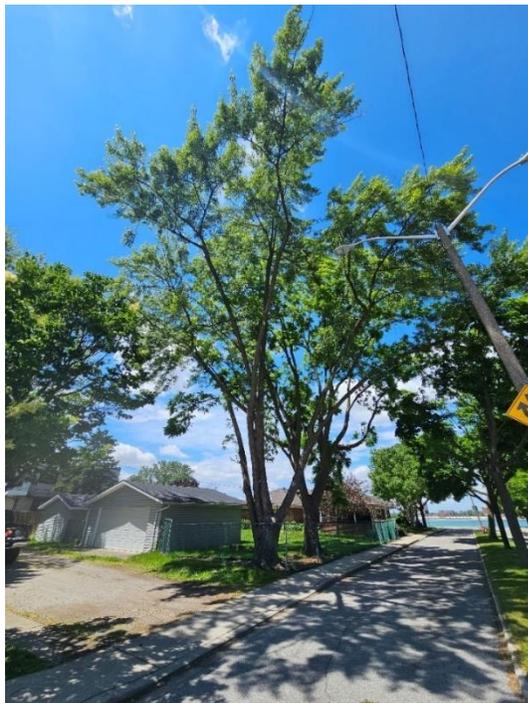
FIGURE 1: PHOTO OF 82-65 CM DBH SILVER MAPLE

TABLE 1: 82-35 CM DBH SILVER MAPLE ATTRIBUTES

Species of Tree: Silver Maple, <i>Acer saccharinum</i>		Size: 82 cm & 35 cm DBH (co-dominate stem)	Location: South west corner of property
Canopy Vitality: Good	Structure: Good	Ownership: Private	
Other Comments: Minor amount of deadwood in canopy; probable root damage from sidewalk installation; some surface roots			
Impact of Development on this tree: This tree is already showing signs of stress as portions of its canopy is showing signs of decline. The impact of construction in and around this tree will cause further decline as this tree is already in the mature stage of its life span.			
Possible Infrastructure Modifications: Modifications to the site plan in order to retain this tree is not recommended as this tree is entering the late stages of its life span and any gains in tree preservation will likely not be realized post construction.			
Preservation or Removal of Tree Recommended: Removal

Best Management Practices to mitigate impact of development upon trees: NA			
Provisions for tree replacement for trees that were to be retained but that were not successfully preserved: This is a privately owned tree and compensation to the City for replacement trees is generally not a past practice. However, consideration for the funding of future tree planting for either on site or within the neighbourhood can be discussed.			
Details of maintenance program post development: Not applicable.

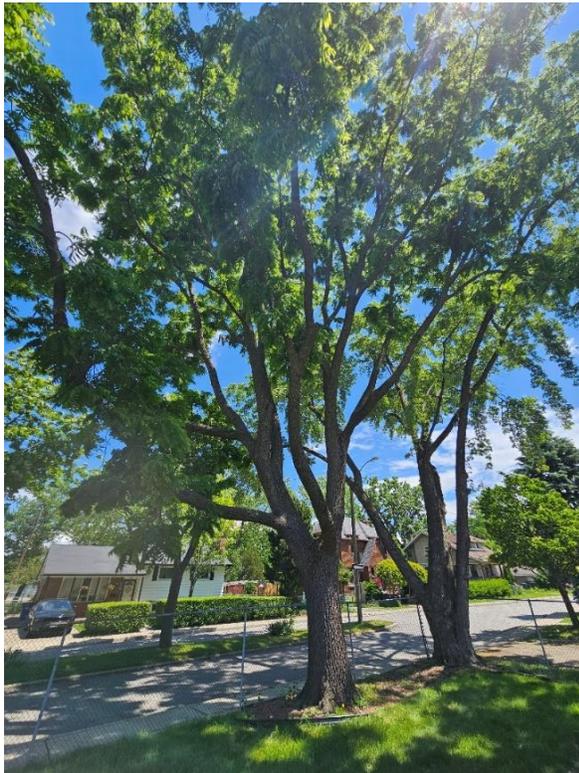
FIGURE 2: PHOTO OF 71 CM DBH BLACK WALNUT

TABLE 2: 71 CM DBH BLACK WALNUT ATTRIBUTES

Species of Tree: Black Walnut, <i>Juglans nigra</i>		Size: 71 cm DBH	Location: South west corner
Canopy Vitality: Good	Structure: Good		Ownership: Private
Other Comments: Minor deadwood; location is causing the adjacent sidewalk to heave upwards; probable root damage from sidewalk installation			
Impact of Development on this tree: Black Walnut are sensitive trees and do not tolerate construction activities and damages (Coder, 2021). The development of this site in and around this tree will lead to its demise.			
Possible Infrastructure Modifications: Modifications to the site plan in order to retain this tree is not recommended as these trees are not tolerant to construction activities.			
Preservation or Removal of Tree Recommended: Removal			
Best Management Practices to mitigate impact of development upon trees: NA			
Provisions for tree replacement for trees that were to be retained but that were not successfully preserved: This is a privately owned tree and compensation to the City for replacement trees is generally not a past practice. However, consideration for the funding of future tree planting for either on site or within the neighbourhood can be discussed.

Details of maintenance program post development: NA

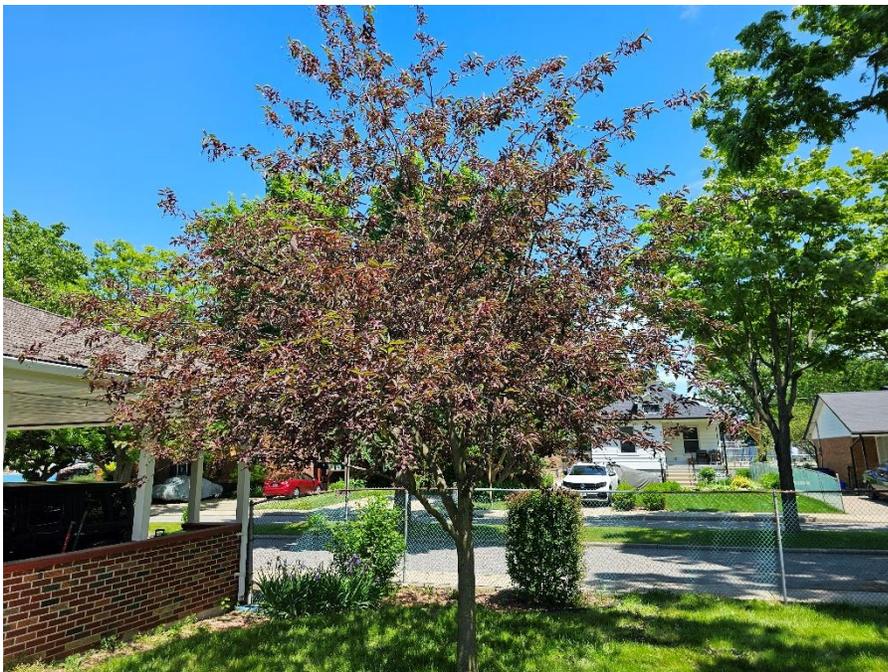
FIGURE 3: PHOTO OF 16 CM DBH CHOKE CHERRY

TABLE 3: 16 CM DBH CHOKE CHERRY ATTRIBUTES

Species of Tree: Choke Cherry, <i>Prunus virginiana</i>		Size: 16 cm DBH	Location: South of carport
Canopy Vitality: Fair	Structure: Fair		Ownership: Private
Other Comments: Medium infestation of the disease known as ‘Black Knot of Cherry’; noticeable crown thinning			
Impact of Development on this tree: This tree is unfortunately located in the footprint of the proposed building and will have to be removed			
Possible Infrastructure Modifications: Not applicable			
Preservation or Removal of Tree Recommended: Removal			
Best Management Practices to mitigate impact of development upon trees: NA			
Provisions for tree replacement for trees that were to be retained but that were not successfully preserved: This is a privately owned tree and compensation to the City for replacement trees is generally not a past practice. However, consideration for the funding of future tree planting for either on site or within the neighbourhood can be discussed.

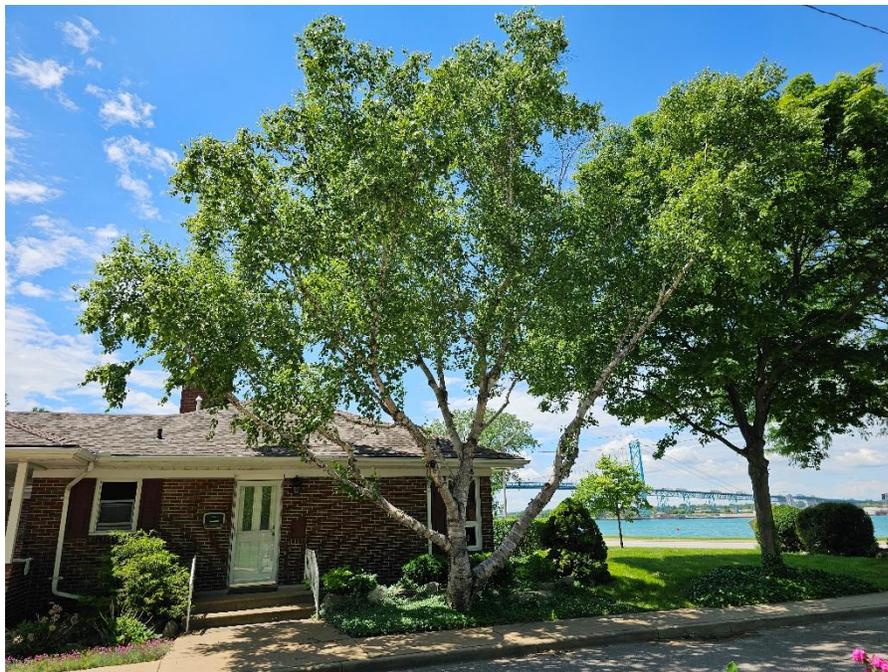
FIGURE 4: PHOTO OF 26-40 CM DBH PAPER BIRCH

TABLE 4: 26-40 CM DBH PAPER BIRCH ATTRIBUTES

Species of Tree: Paper Birch, <i>Betula papyrifera</i>		Size: 26-40 cm DBH	Location: North East corner of house
Canopy Vitality: Fair	Structure: Fair	Ownership: Private	
Other Comments: Signs of crown dieback, possibly from the Bronze Birch Borer			
Impact of Development on this tree: This tree is unfortunately located in the footprint of the proposed building and will have to be removed			
Possible Infrastructure Modifications: Not applicable			
Preservation or Removal of Tree Recommended: Removal			
Best Management Practices to mitigate impact of development upon trees: Not applicable.			
Provisions for tree replacement for trees that were to be retained but that were not successfully preserved: This is a privately owned tree and compensation to the City for replacement trees is generally not a past practice. However, consideration for the funding of future tree planting for either on site or within the neighbourhood can be discussed.

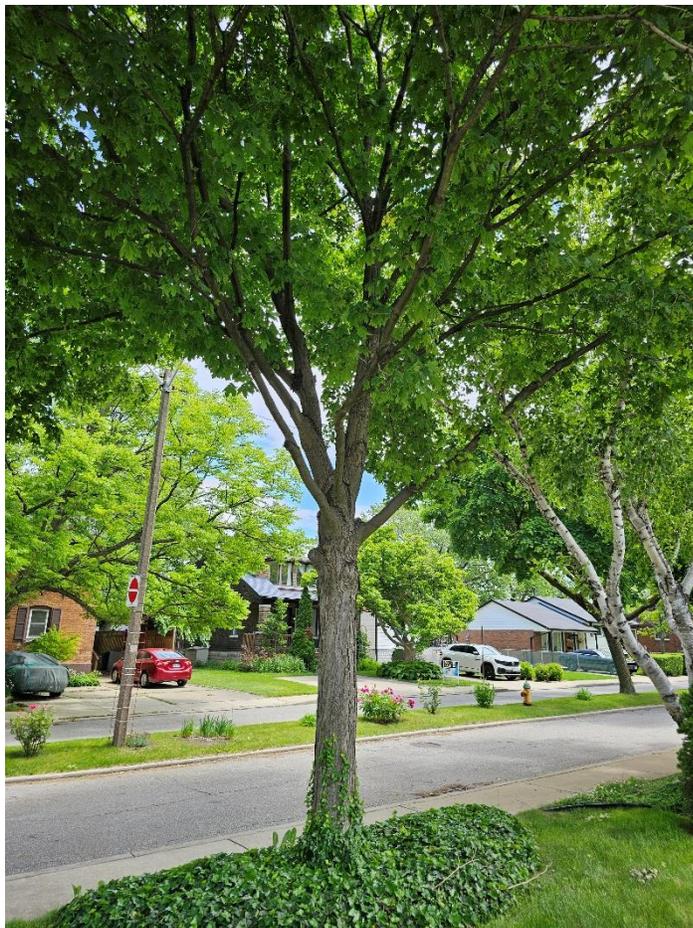
FIGURE 5: PHOTO OF 37 CM DBH SUGAR MAPLE

TABLE 5: 37 CM DBH SUGAR MAPLE ATTRIBUTES

Species of Tree: Sugar Maple, <i>Acer saccharum</i>		Size: 37 cm DBH	Location: North east corner of house
Canopy Vitality: Good	Structure: Good		Ownership: Private
Other Comments: Healthy vibrant tree			
Impact of Development on this tree: This tree is unfortunately located in the footprint of the proposed building and will have to be removed			
Possible Infrastructure Modifications: Not applicable.			
Preservation or Removal of Tree Recommended: Removal			
Best Management Practices to mitigate impact of development upon trees: Not applicable.			
Provisions for tree replacement for trees that were to be retained but that were not successfully preserved: This is a privately owned tree and compensation to the City for replacement trees is generally not a past practice. However, consideration for the funding of future tree planting for on either site or within the neighbourhood can be discussed.

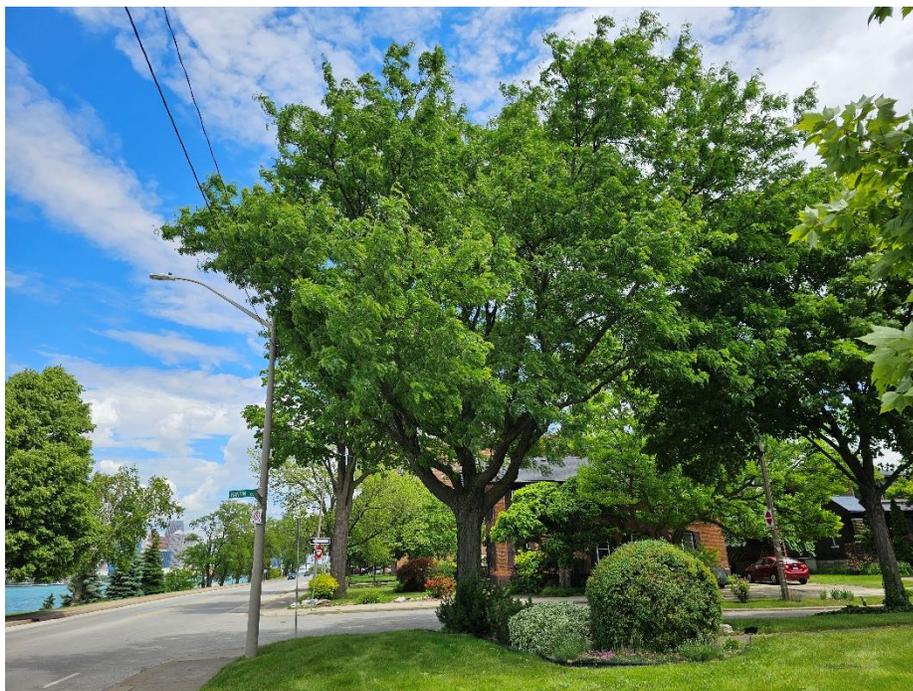
FIGURE 6: PHOTO OF 61 CM DBH HONEYLOCUST

TABLE 6: 61 CM DBH HONEYLOCUST ATTRIBUTES

Species of Tree: Honeylocust, <i>Gleditsia triacanthos</i>		Size: 61 cm DBH	Location: North east corner of property
Canopy Vitality: Good	Structure: Good		Ownership: Private
Other Comments: Minor amount of deadwood present; severe girdling roots			
Impact of Development on this tree: This tree is free and clear of this development and should be retained.			
Possible Infrastructure Modifications: This tree needs to be protected throughout the construction process and tree protection fencing should be installed around the circumference of the canopy.			
Preservation or Removal of Tree Recommended: Preservation			
Best Management Practices to mitigate impact of development upon trees: Identify the tree protection zone and install tree protection fencing around the circumference of the tree’s canopy to protect the root system and from heavy machinery striking the tree.			
Provisions for tree replacement for trees that were to be retained but that were not successfully preserved: This is a privately owned tree and compensation to the City for replacement trees is generally not a past practice. However, consideration for the funding of future tree planting for either on site or within the neighbourhood can be considered in lieu.

Details of maintenance program post development: Decorative shredded mulch to be applied post development to help the tree retain moisture, keep machinery away from striking the bark, and to provide organic material to the soil. The tree should than be monitored for its vitality and watered weekly during times of droughty conditions in the summer and for the first 3 years post construction.

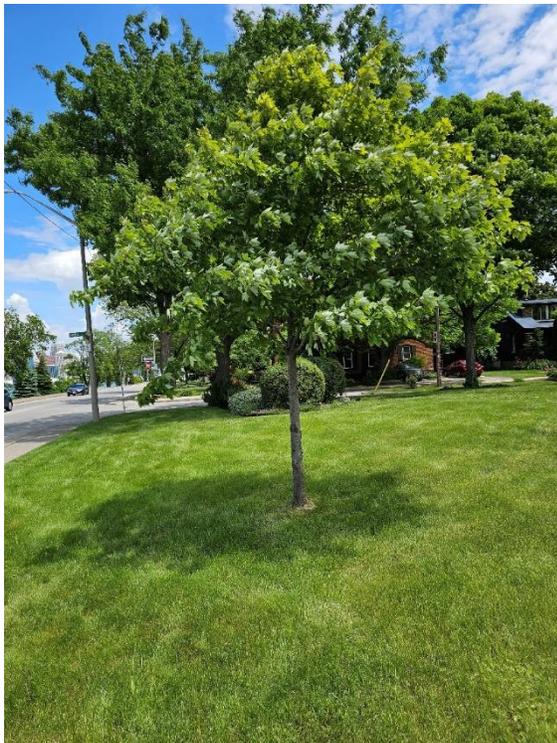
FIGURE 7: PHOTO OF 10 CM DBH RED MAPLE

TABLE 7: 10 CM DBH RED MAPLE ATTRIBUTES

Species of Tree: Red Maple, <i>Acer rubrum</i>		Size: 10 cm DBH	Location: North west corner of property
Canopy Vitality: Good	Structure: Good		Ownership: Private
Other Comments: Newer planting			
Impact of Development on this tree: This tree is free and clear of this development and should be retained.			
Possible Infrastructure Modifications: This tree should be protected throughout the construction process and tree protection fencing should be installed around the circumference of the canopy.			
Preservation or Removal of Tree Recommended: Preservation			
Best Management Practices to mitigate impact of development upon trees: Identify the tree protection zone and install tree protection fencing around the circumference of the tree’s canopy to protect the root system and from heavy machinery striking the tree and compacting the soil.			
Provisions for tree replacement for trees that were to be retained but that were not successfully preserved: This is a privately owned tree and compensation to the City for replacement trees is generally not a past practice. However, consideration for the funding of future tree planting for either on site or within the neighbourhood can be discussed.

Details of maintenance program post development: Decorative shredded mulch to be applied post development to help the tree retain moisture, keep machinery away from striking the bark, and to provide organic material to the soil. The tree should than be monitored for its vitality and watered weekly during times of droughty conditions in the summer and for the first 3 years post construction.

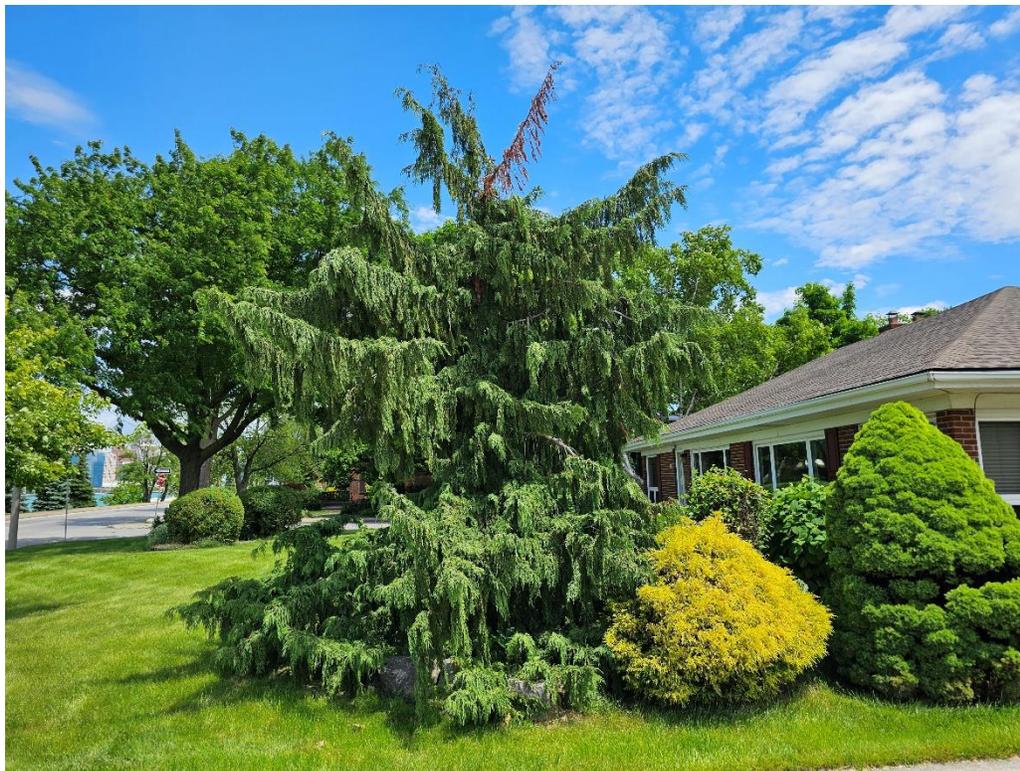
FIGURE 8: PHOTO OF 23 CM DBH NOOTKA CYPRESS

TABLE 8: 23 CM DBH NOOTKA CYPRESS ATTRIBUTES

Species of Tree: Nootka Cypress, <i>Chamaecyparis nootkatensis</i>		Size: 23 cm DBH	Location: North west of current house
Canopy Vitality: Good	Structure: Good		Ownership: Private
Other Comments: Fine specimen			
Impact of Development on this tree: This tree is unfortunately located in the footprint of the proposed building and will have to be removed			
Possible Infrastructure Modifications: Not applicable			
Preservation or Removal of Tree Recommended: Removal			
Best Management Practices to mitigate impact of development upon trees: Not applicable			
Provisions for tree replacement for trees that were to be retained but that were not successfully preserved: This is a privately owned tree and compensation to the City for replacement trees is generally not a past practice. However, consideration for the funding of future tree planting for either on site or within the neighbourhood can be discussed.

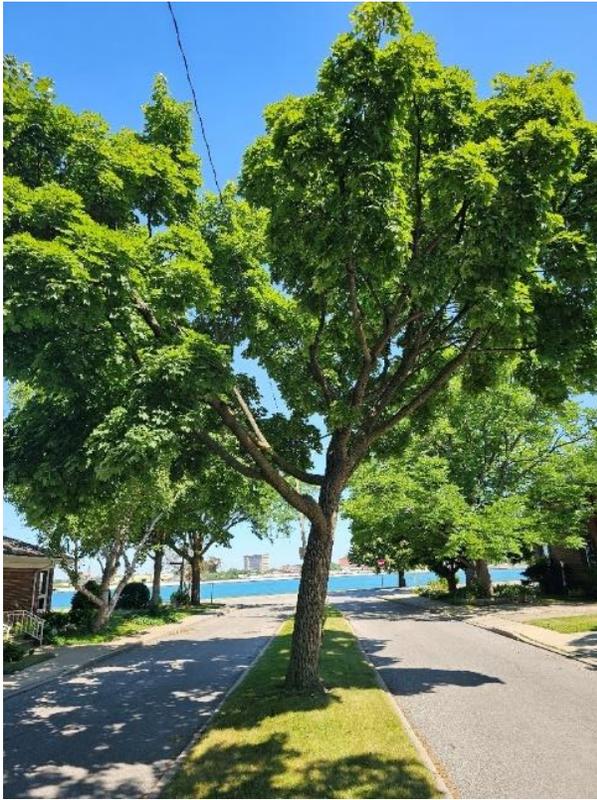
FIGURE 9: PHOTO OF 23 CM DBH NORWAY MAPLE

TABLE 9: 48 CM DBH NORWAY MAPLE ATTRIBUTES

Species of Tree: Norway Maple, <i>Acer platanoides</i>		Size: 48 cm DBH	Location: Across from 126 Rankin in Centre Median
Canopy Vitality: Good	Structure: Good		Ownership: Municipal
Other Comments: Has a girdling root, has a 'V' shape appearance from pruning back of street light wire			
Impact of Development on this tree: This tree is free and clear of this development and should be retained and protected.			
Possible Infrastructure Modifications: This tree should be protected throughout the construction process. Tree protection fencing should be installed around all three (3) trees growing on the centre median as one large tree protection zone. This will keep all heavy machinery and building supplies from being staged around the trees and over their rooting systems.			
Preservation or Removal of Tree Recommended: Preservation			
Best Management Practices to mitigate impact of development upon trees: Identify the tree protection zone and install tree protection fencing around this tree and the other two (2) trees near by.

Provisions for tree replacement for trees that were to be retained but that were not successfully preserved: If these trees are properly protected through the creation of a tree protection zone, then the likelihood of this tree succumbing to construction activities would be very low. If these measures are in place and the trees still do succumb, a tree assessment should be conducted to see if their death was associated with this development in any way or whether they died due to some other abiotic/biotic factor.			
Details of maintenance program post development: Decorative shredded mulch to be applied post development to help the tree retain moisture, keep machinery away from striking the bark, and to provide organic material to the soil. The tree should than be monitored for its vitality and watered weekly during times of droughty conditions during the summer for the first 3 years post construction.

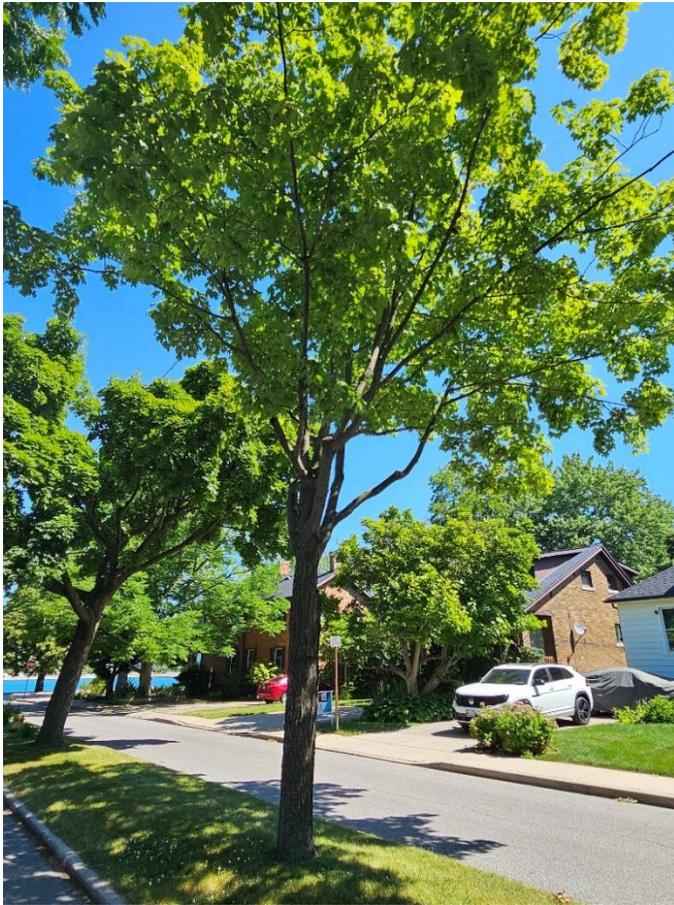
FIGURE 10: PHOTO OF 31 CM DBH RED MAPLE

TABLE 10: 31 CM DBH RED MAPLE ATTRIBUTES

Species of Tree: Red Maple, <i>Acer rubrum</i>		Size: 31 cm DBH	Location: Across from 136 Rankin in Centre Median
Canopy Vitality: Good	Structure: Good		Ownership: Municipal
Other Comments: This is the middle tree of three (3) trees located on the centre median			
Impact of Development on this tree: This tree is free and clear of this development and should be retained and protected.			
Possible Infrastructure Modifications: This tree should be protected throughout the construction process. Tree protection fencing should be installed around all three (3) trees growing on the centre median as one large tree protection zone. This will keep all heavy machinery and building supplies from being staged around the trees and over their rooting systems.			
Preservation or Removal of Tree Recommended: Preservation			
Best Management Practices to mitigate impact of development upon trees: Identify the tree protection zone and install tree protection fencing around this tree and the other two (2) trees near by.

Provisions for tree replacement for trees that were to be retained but that were not successfully preserved: If these trees are properly protected through the creation of a tree protection zone, then the likelihood of this tree succumbing to construction activities would be very low. If these measures are in place and the trees still do succumb, a tree assessment should be conducted to see if their death was associated to this development in any way or whether they died to some other abiotic/biotic factor.			
Details of maintenance program post development: Decorative shredded mulch to be applied post development to help the tree retain moisture, keep machinery away from striking the bark, and to provide organic material to the soil. The tree should than be monitored for its vitality and watered weekly during times of droughty conditions during the summer for the first 3 years post construction.

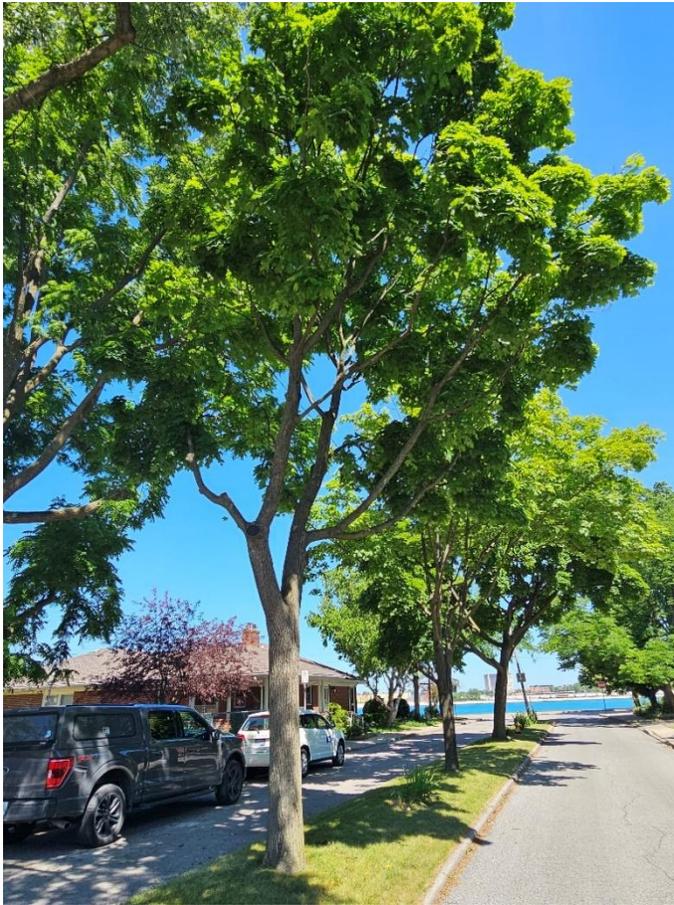
FIGURE 11: PHOTO OF 23 CM DBH NORWAY MAPLE

TABLE 11: 37 CM DBH NORWAY MAPLE ATTRIBUTES

Species of Tree: Norway Maple, <i>Acer platanoides</i>		Size: 37 cm DBH	Location: Across from 140 Rankin in Centre Median
Canopy Vitality: Good	Structure: Good		Ownership: Municipal
Other Comments: The southern Norway Maple in the centre island			
Impact of Development on this tree: This tree is free and clear of this development and should be retained and protected.			
Possible Infrastructure Modifications: This tree should be protected throughout the construction process. Tree protection fencing should be installed around all three (3) trees growing on the centre median as one large tree protection zone. This will keep all heavy machinery and building supplies from being staged around the trees and over their rooting systems.			
Preservation or Removal of Tree Recommended: Preservation			
Best Management Practices to mitigate impact of development upon trees: Identify the tree protection zone and install tree protection fencing around this tree and the other two (2) trees near by.

Provisions for tree replacement for trees that were to be retained but that were not successfully preserved: If these trees are properly protected through the creation of a tree protection zone, then the likelihood of this tree succumbing to construction activities would be very low. If these measures are in place and the trees still do succumb, a tree assessment should be conducted to see if their death was associated to this development in any way or whether they died to some other abiotic/biotic factor.			
Details of maintenance program post development: Decorative shredded mulch to be applied post development to help the tree retain moisture, keep machinery away from striking the bark, and to provide organic material to the soil. The tree should than be monitored for its vitality and watered weekly during times of droughty conditions during the summer for the first 3 years post construction.
