# Grand Marais Drain Channel Improvements Class Environmental Assessment Dougall Avenue to West of Huron Church Road

## PROJECT FILE

Job Number: 11-007  
June 2012

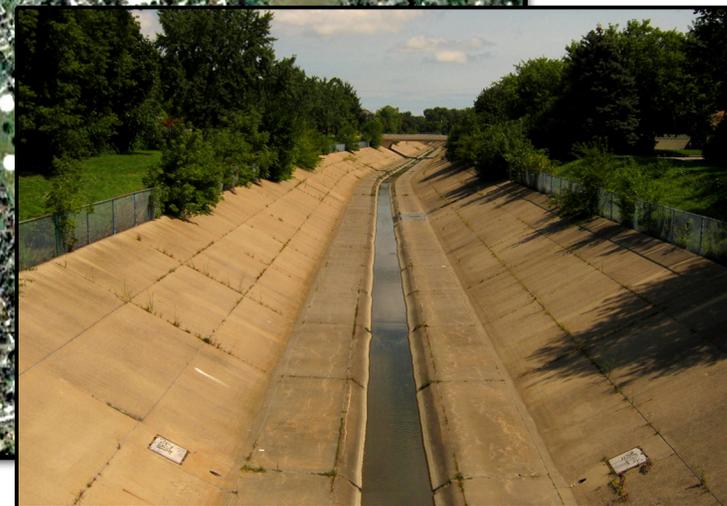
EXISTING CHANNEL SECTION (TYPICAL)

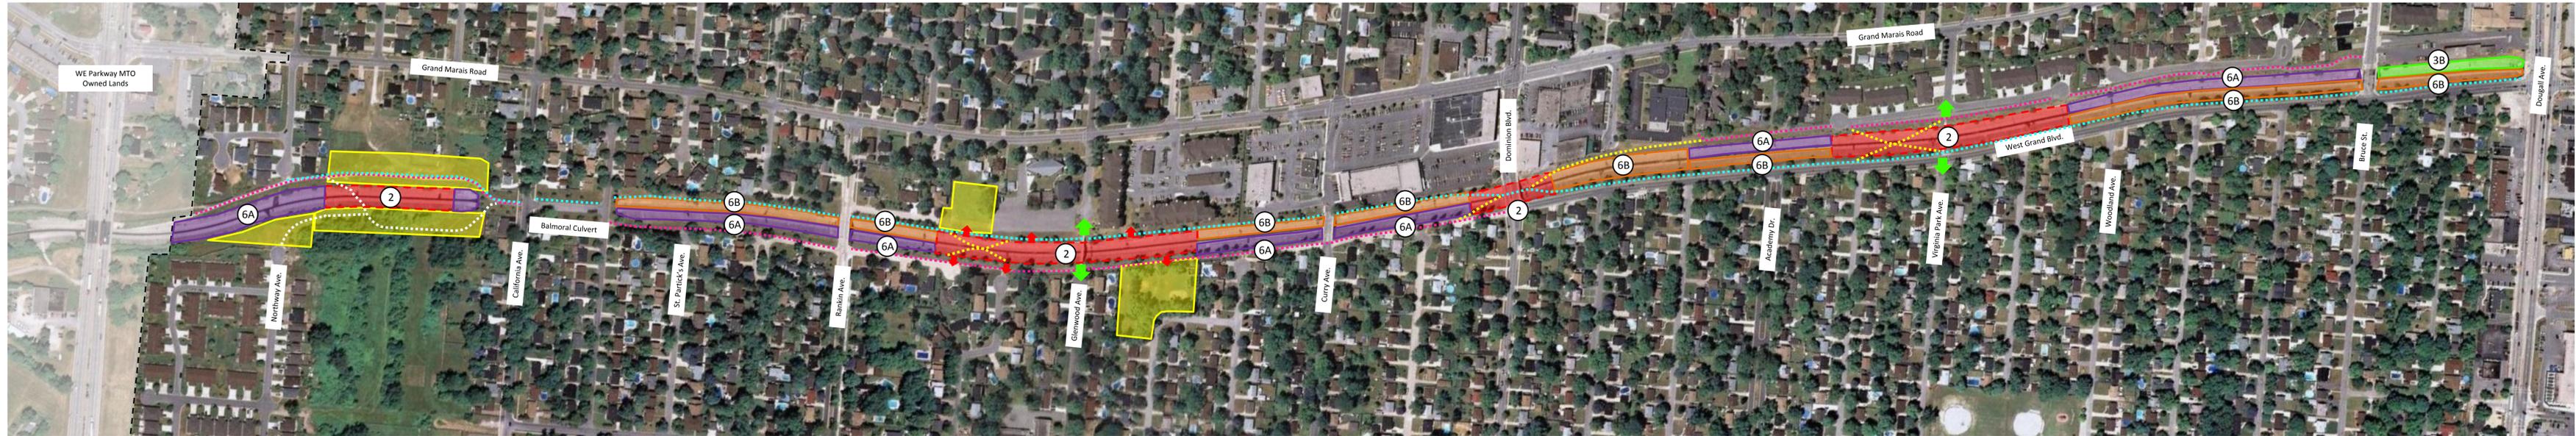
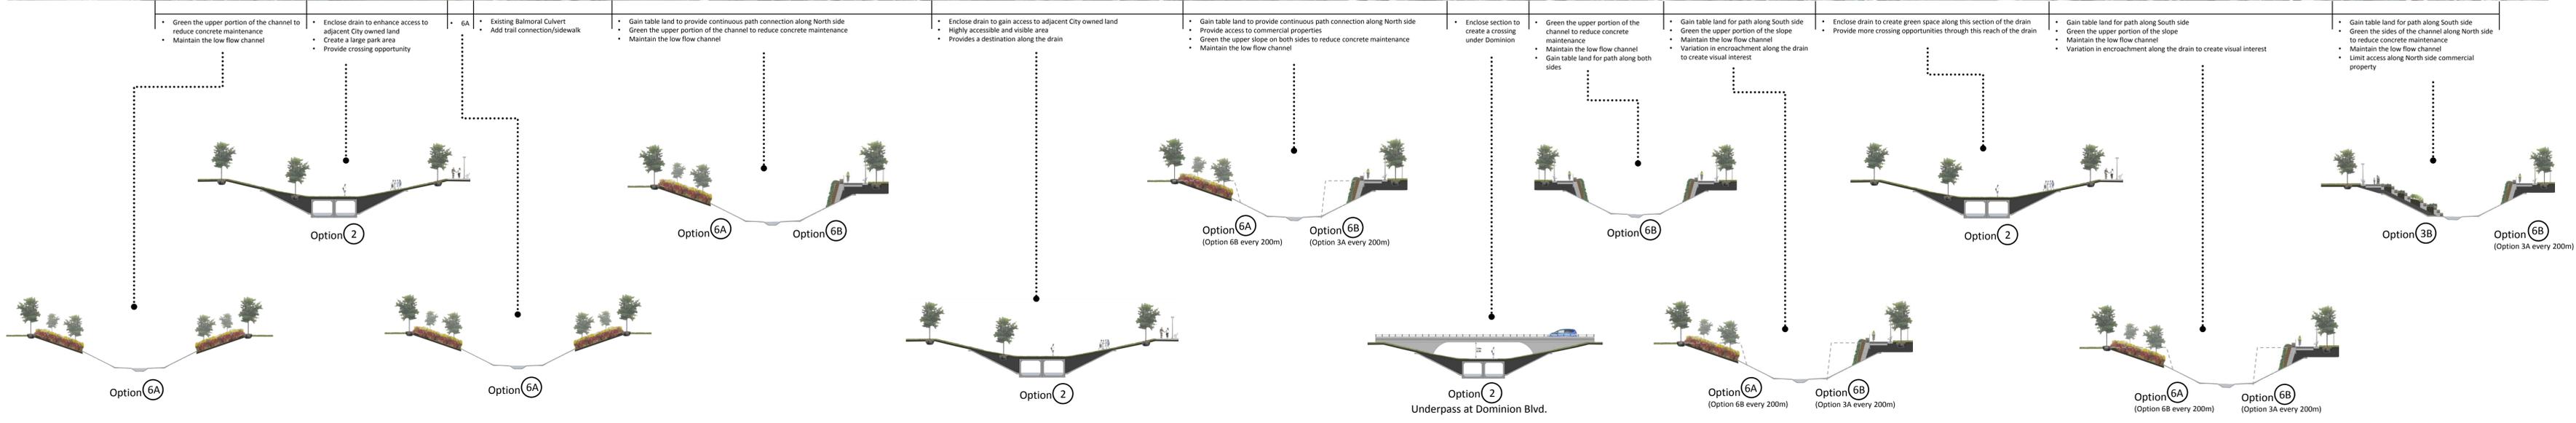
Preferred Solution

- Green the upper portion of the channel to reduce concrete maintenance
- Maintain the low flow channel
- Enclose drain to enhance access to adjacent City owned land

- Create a large park area
- Provide crossing opportunity
- 6A
- Existing Balmoral Culvert
- Add trail connection/sidewalk
- Gain table land to provide continuous path connection along North side

- Variation in encroachment along the drain to create visual interest
- Gain table land for path along South side
- Green the sides of the channel along North side to reduce concrete maintenance

- Maintain the low flow channel
- Limit access along North side commercial property

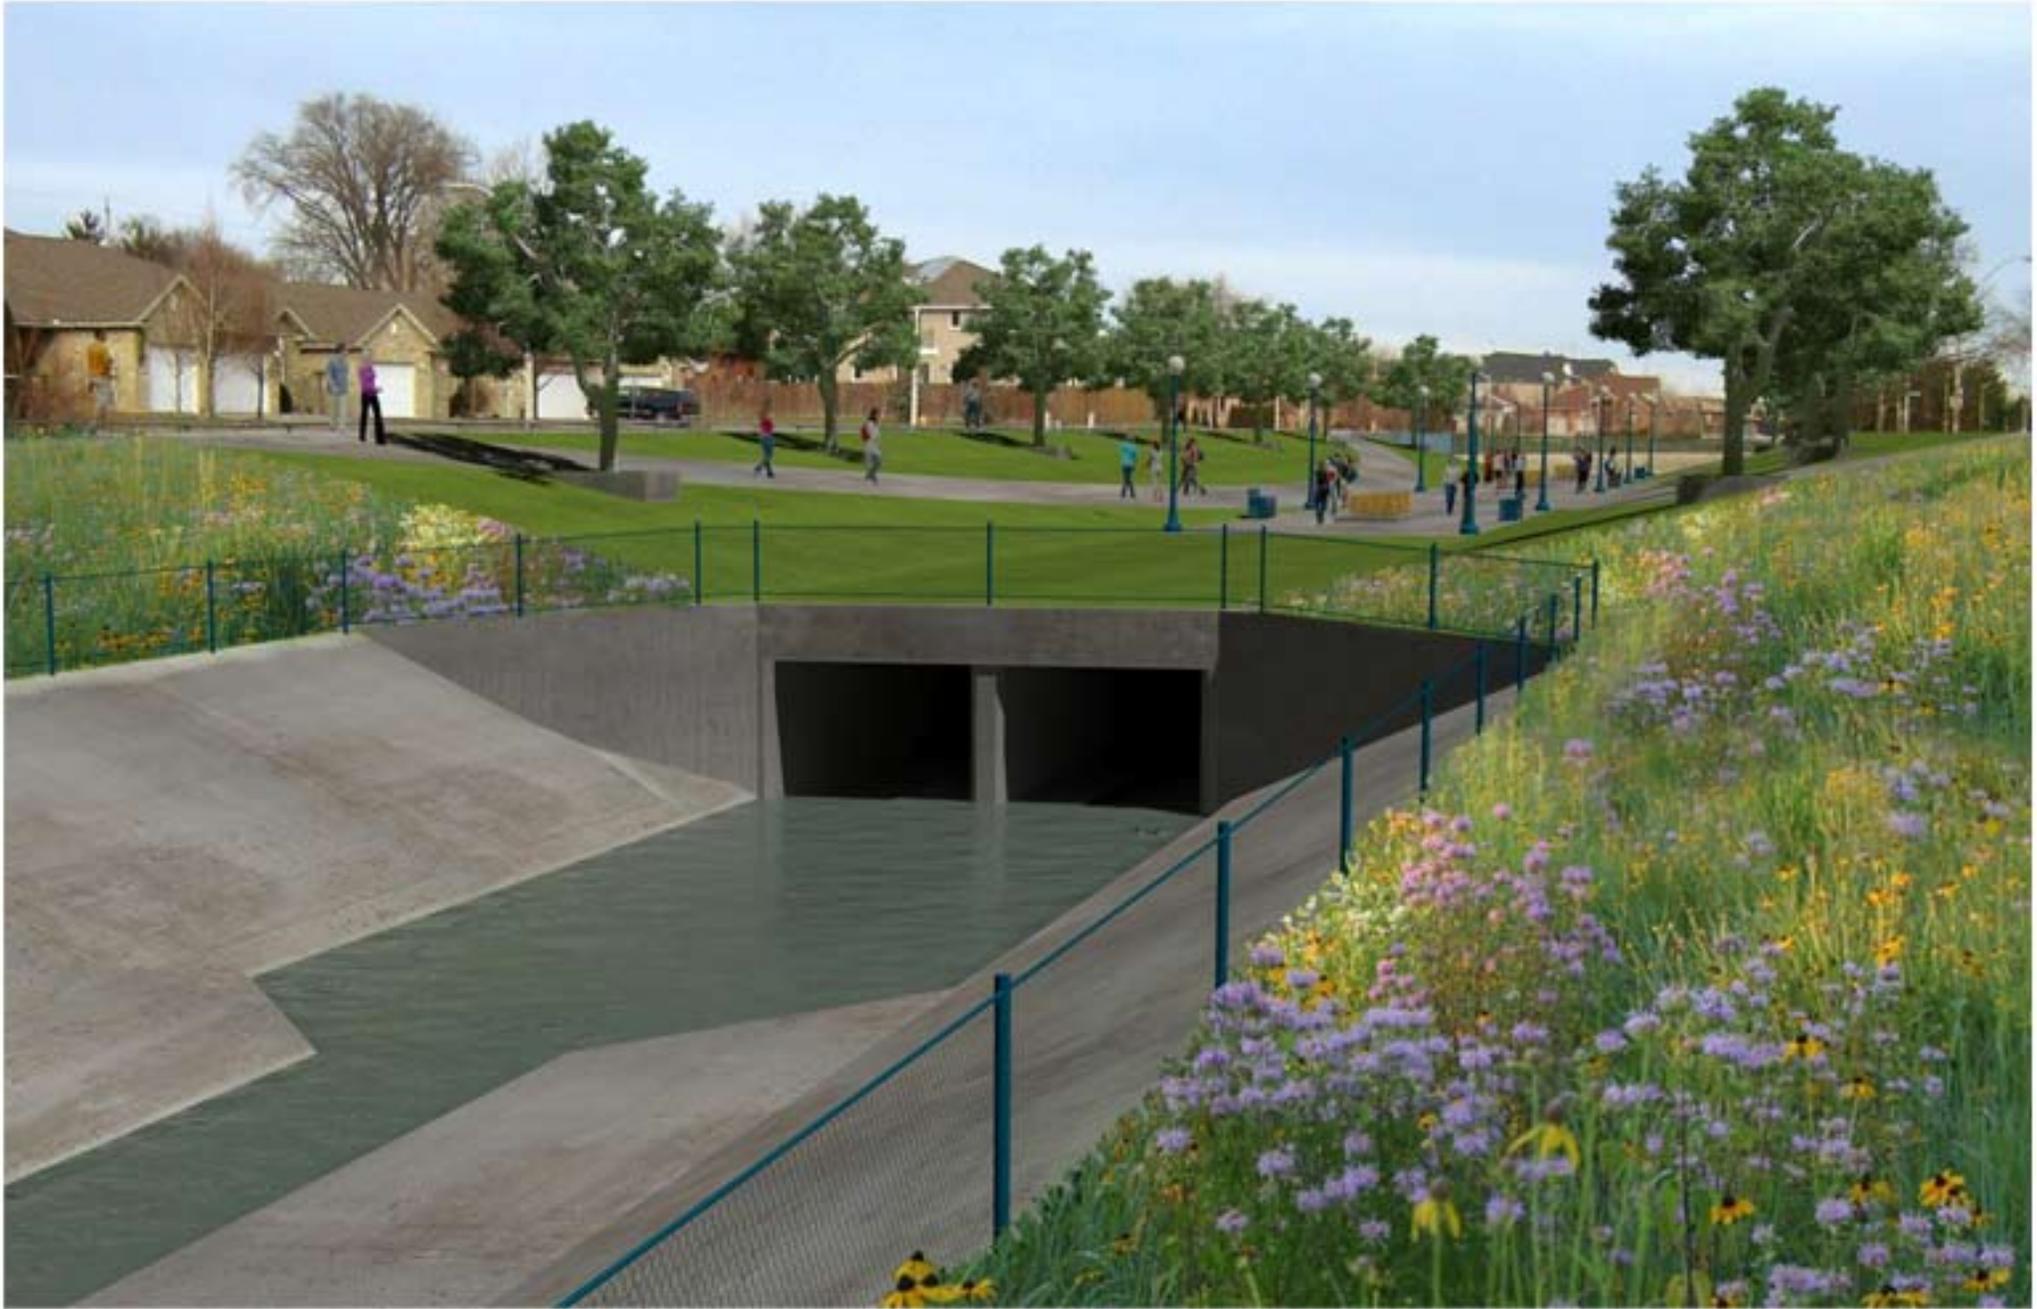
Conceptual Rendering - Option 2A - Channel Enclosure

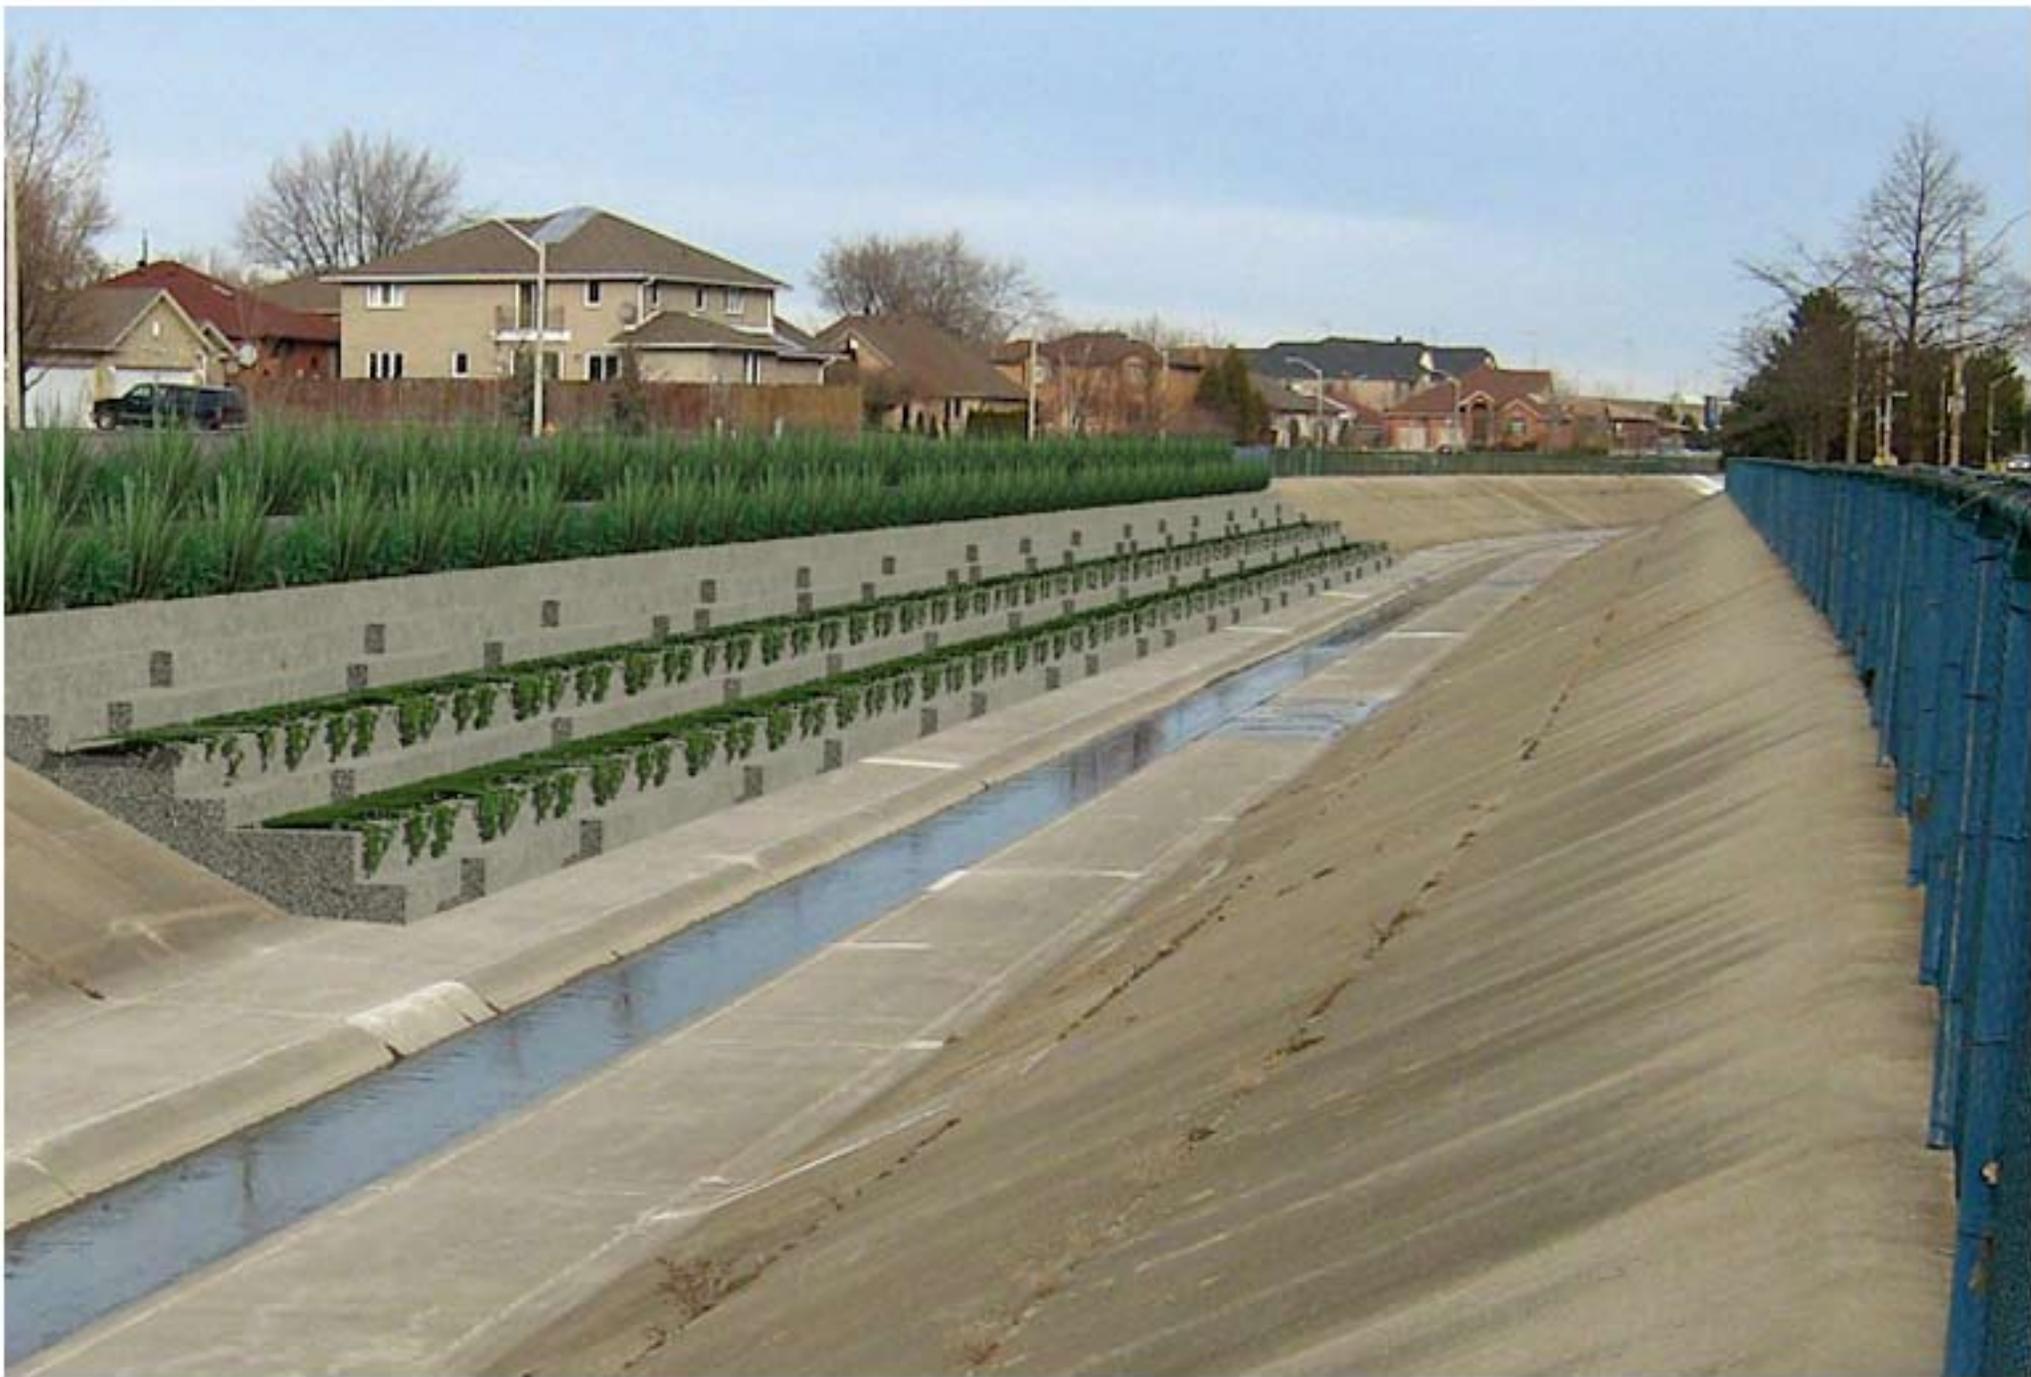
Conceptual Rendering - Option 3B - Channel Offset Stone Wall

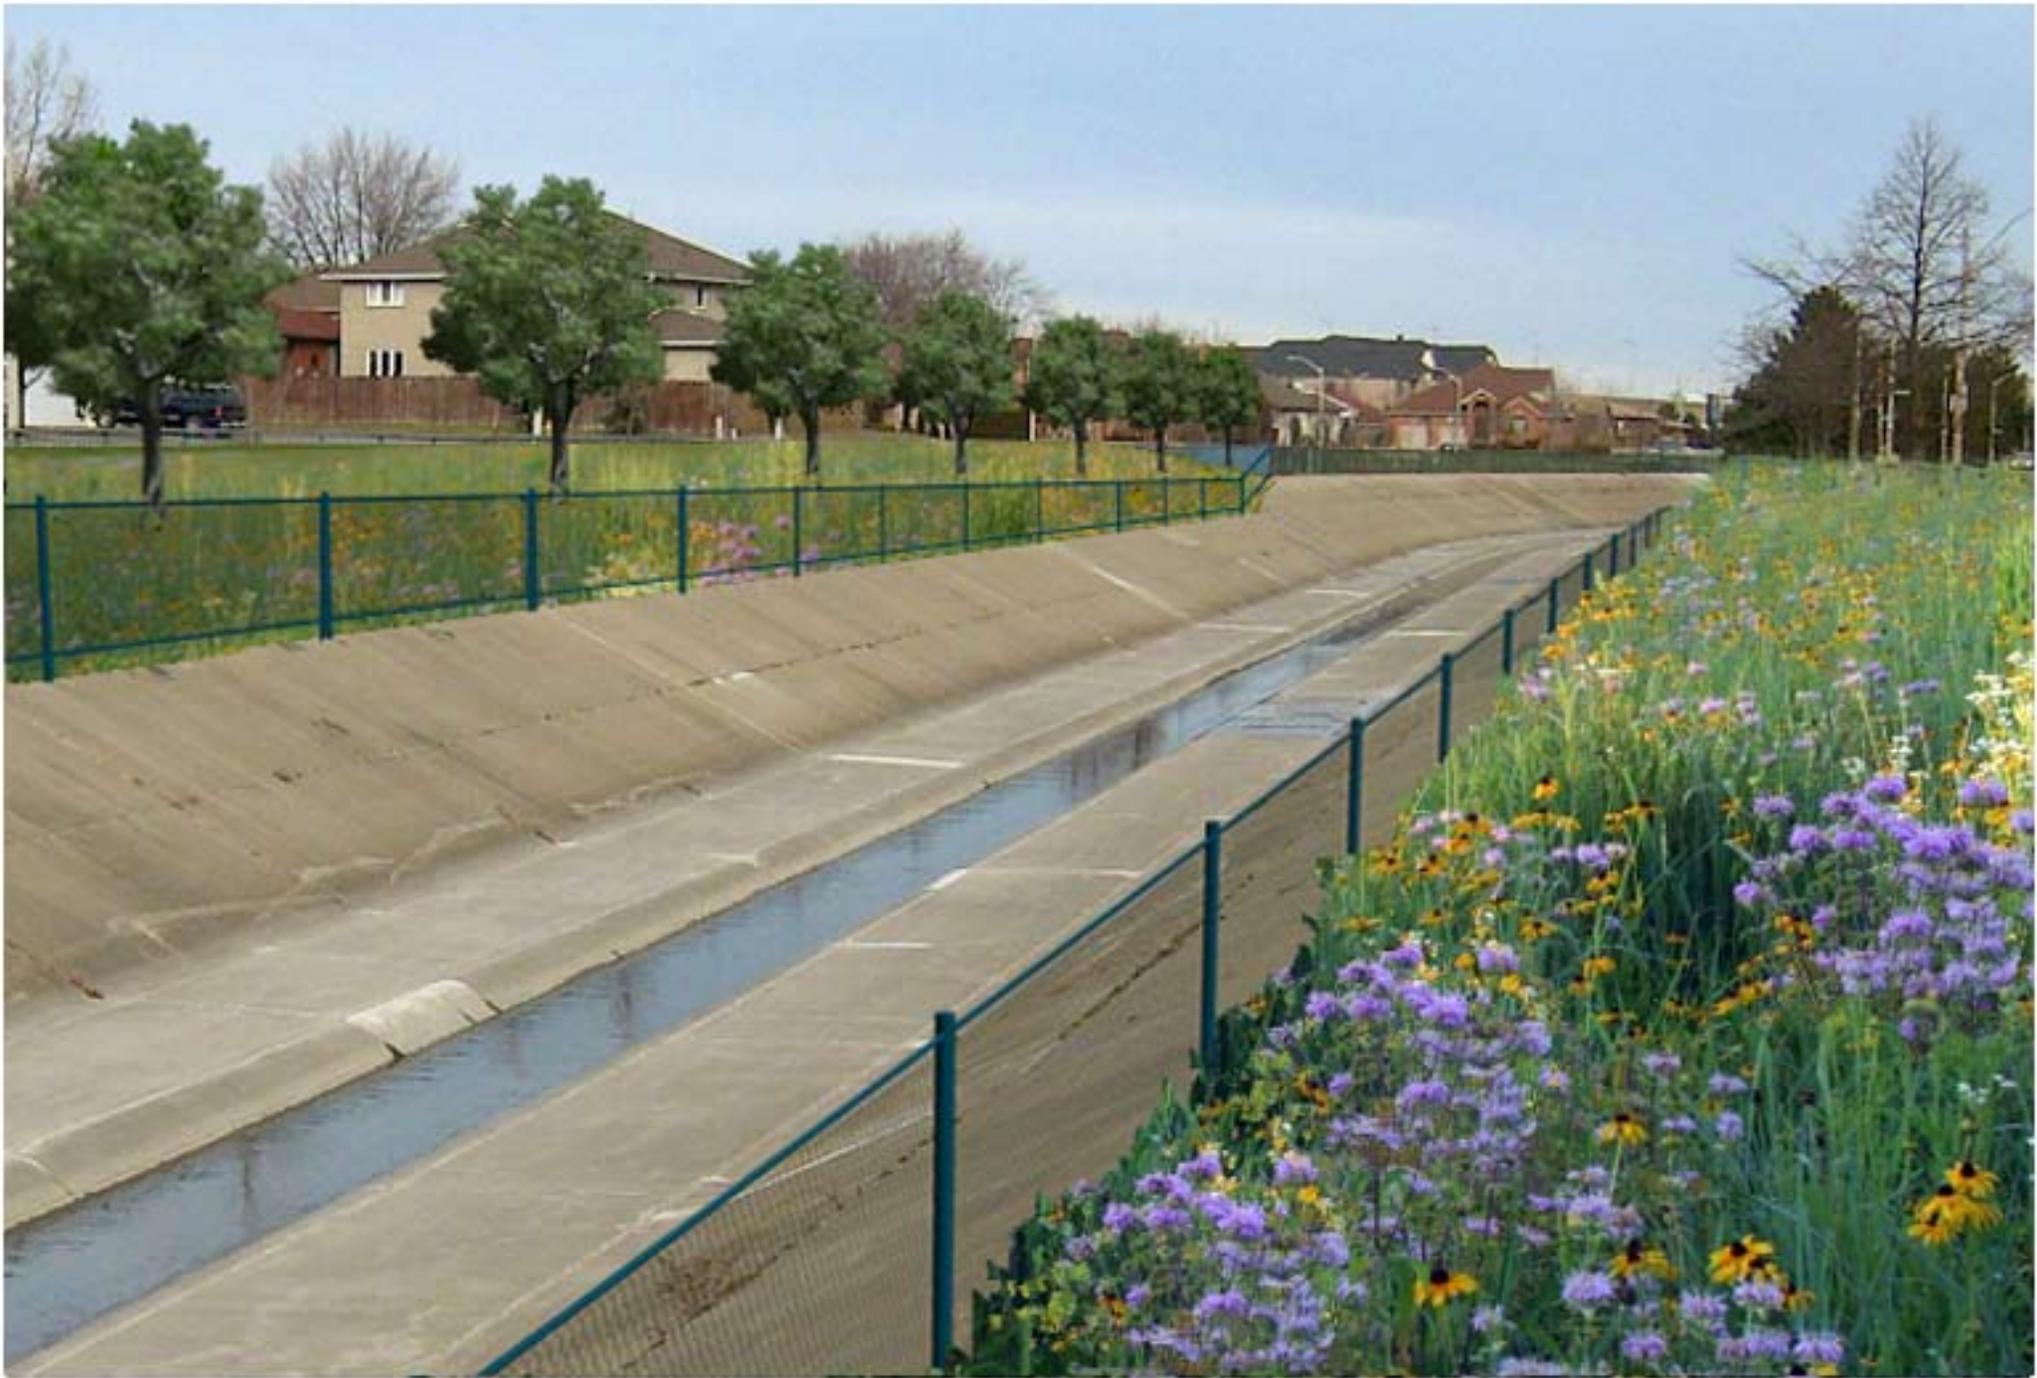
Conceptual Rendering - Option 6A - Green Upper Slope (both sides)

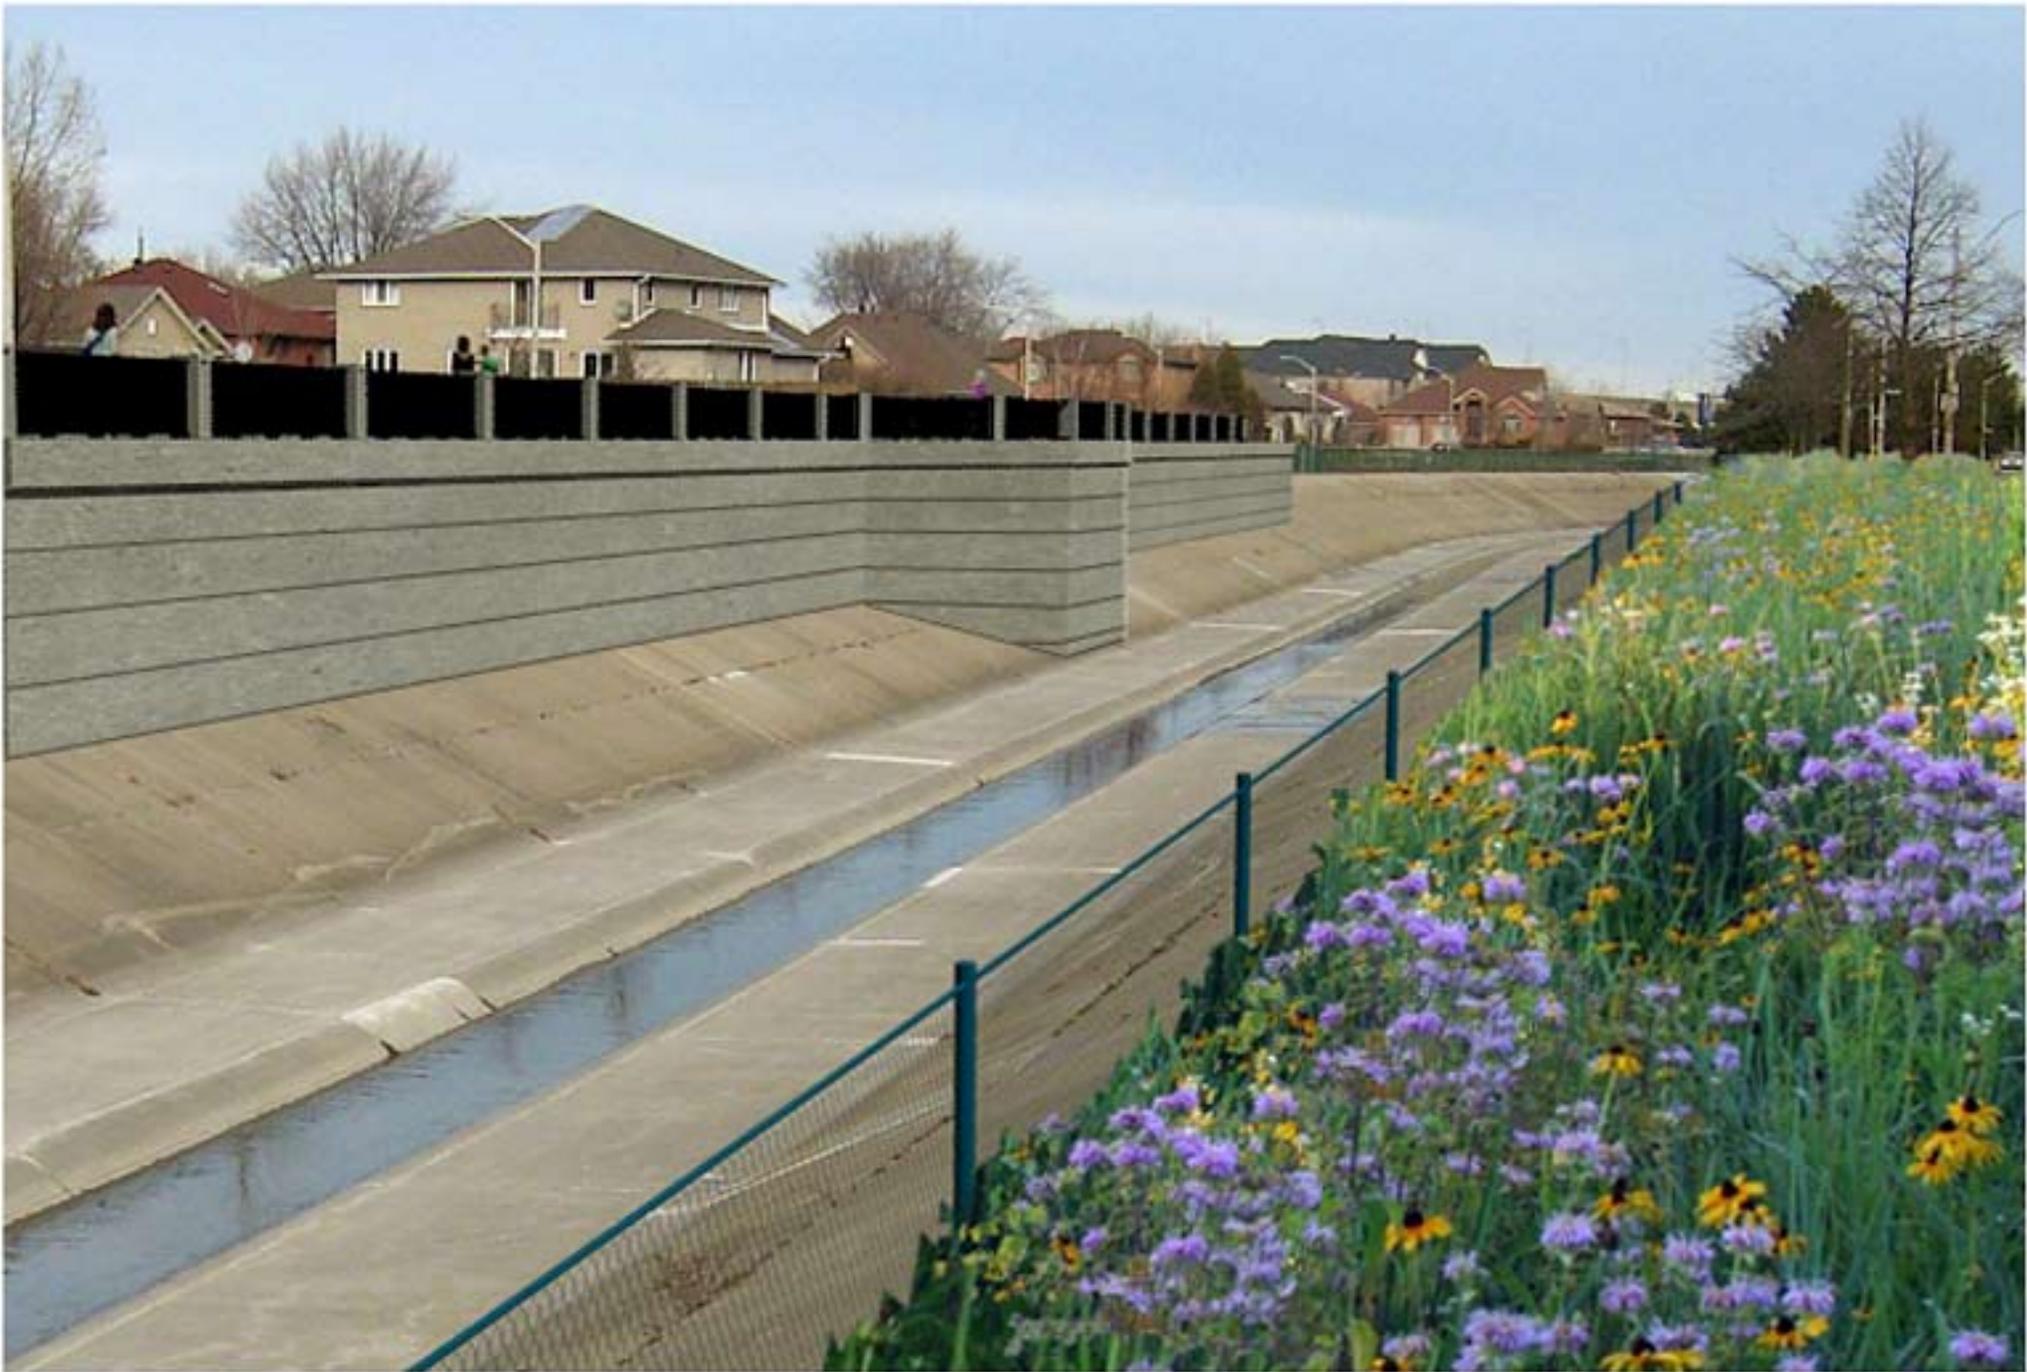
Conceptual Rendering - Option 6B - Channel Offset One Panel with  
Option 3A @ 200m - Channel Offset Three Panels

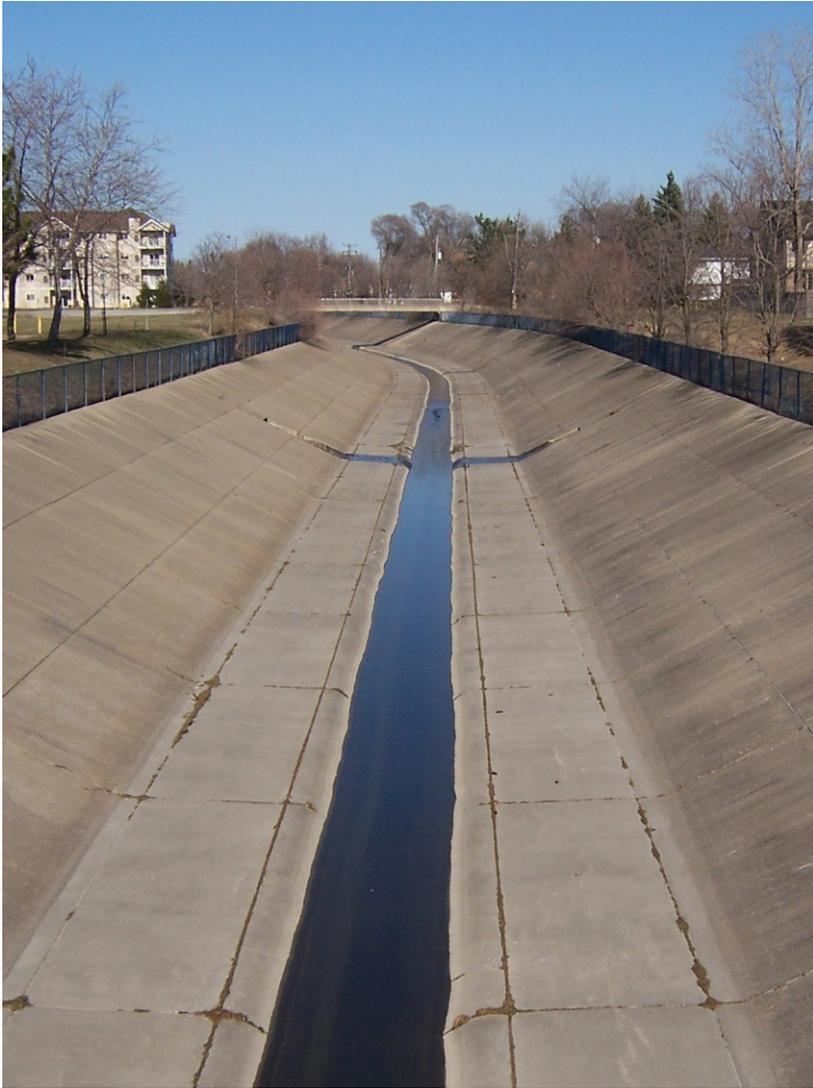
Typical Cross-Section of the Grand Marais Drain

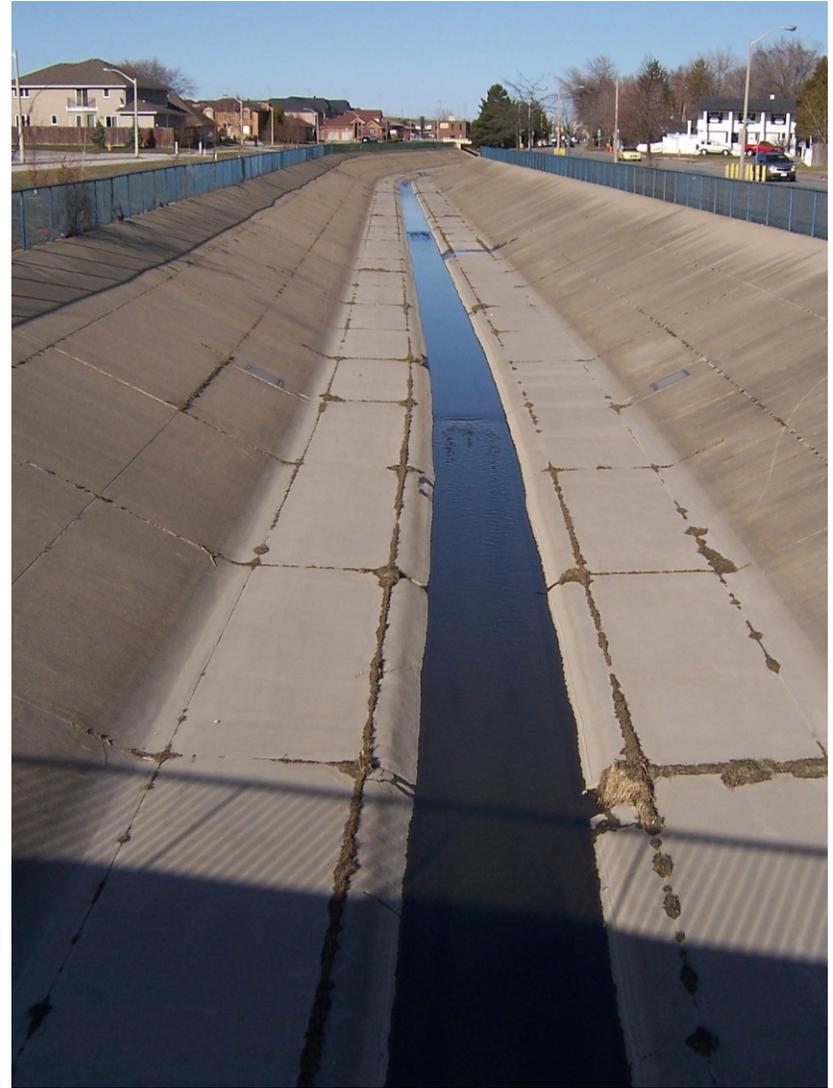
Typical Cross-Section of the Grand Marais Drain
