**ENVIRONMENTAL ASSESSMENT - 6TH CONCESSION/
NORTH TALBOT ROAD, CITY OF WINDSOR, ESSEX
COUNTY, ONTARIO**

Archaeological Stage 1: Background Study

**Final Report
Original**

P359-0009-2013
5th February 2014

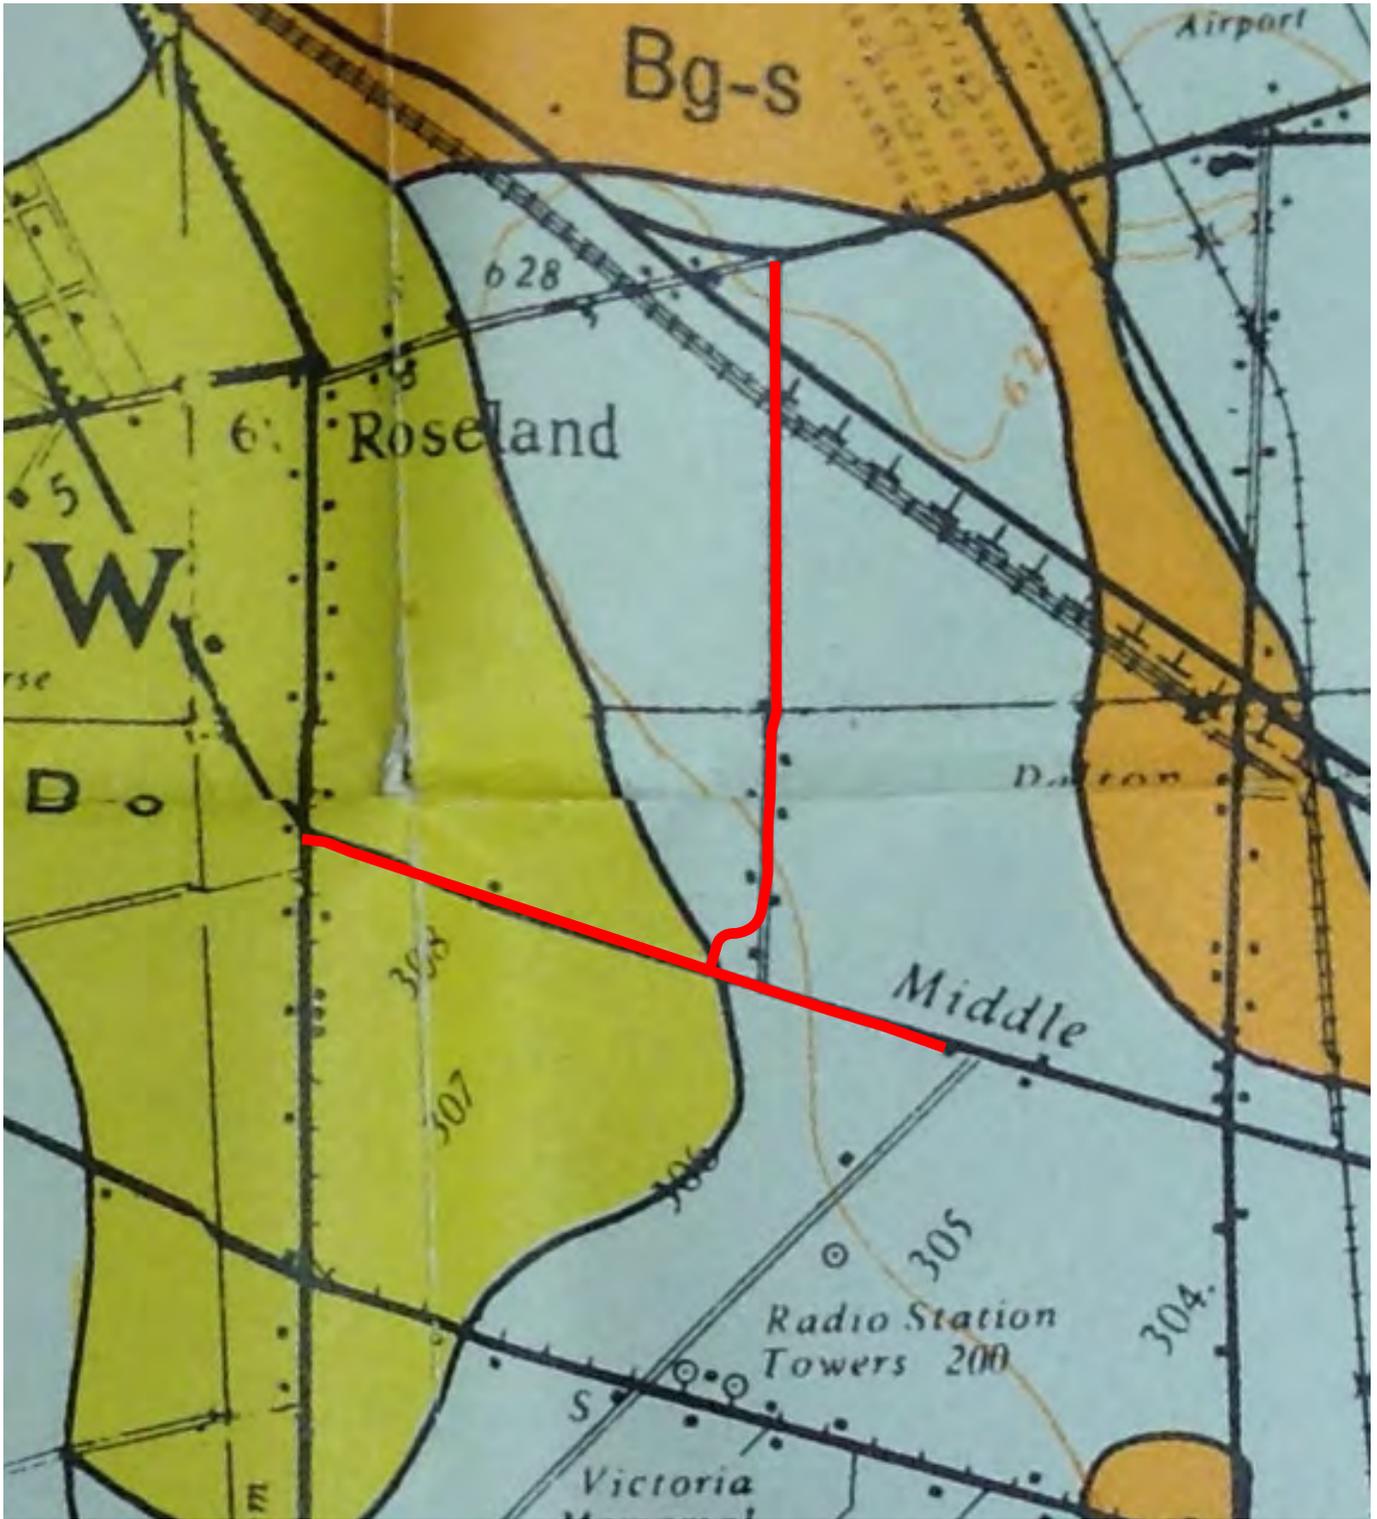
Figure 4: Soil Map of Study Area, 1947

- Approximate Archaeological Study Area
- Bcl: Brookston Clay Loam
- Bg-s: Burford Loam Shallow Phase
- Bs: Brookston Clay Sand Spot Phase (sandy loam)

The Study Area is in a naturally level to almost level region of the Essex Clay Plain and consists of two varieties of the Brookston Clay soil series: Brookston clay loam and Brookston clay sand spot phase. Brookston clay loam is a “dark clay loam over mottled blue-grey gritty clay and clay loam”, with few stone inclusions, and is almost level with poor natural drainage (Richards *et al.* 1949: soil map). Its sand spot phase is found in “mixed areas of shallow sand knolls less than three feet over clay intermixed with Brookston clay and clay loam” on “almost level” terrain with poor natural drainage (*ibid*). The west half of the North Talbot Road corridor is composed of the sand spot phase, while the remainder of the North Talbot Road corridor and the 6th Concession Road corridor is of Brookston Clay (see **Figure 4**).

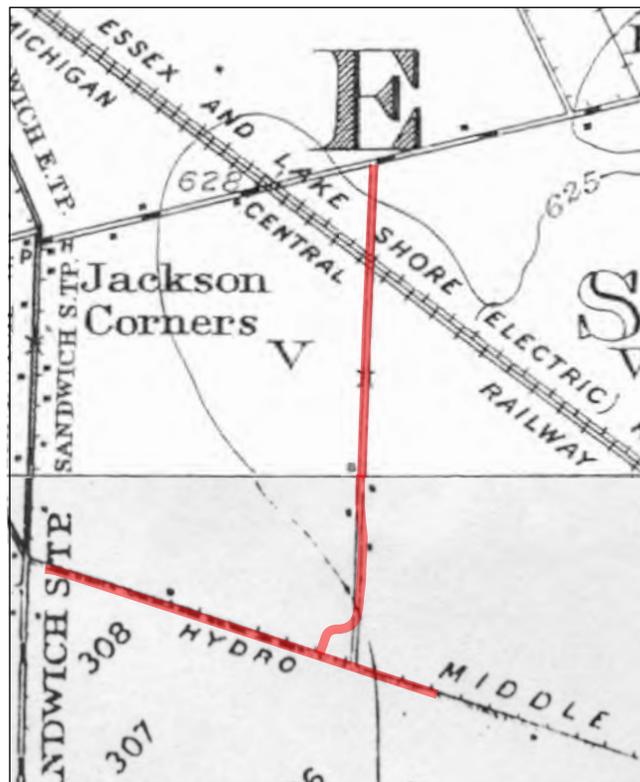
Figure 5: Historic Atlas of Essex & Kent Counties, 1880-1881
 Portion of East and West Sandwich Townships

Archaeological Study Area (approximate)

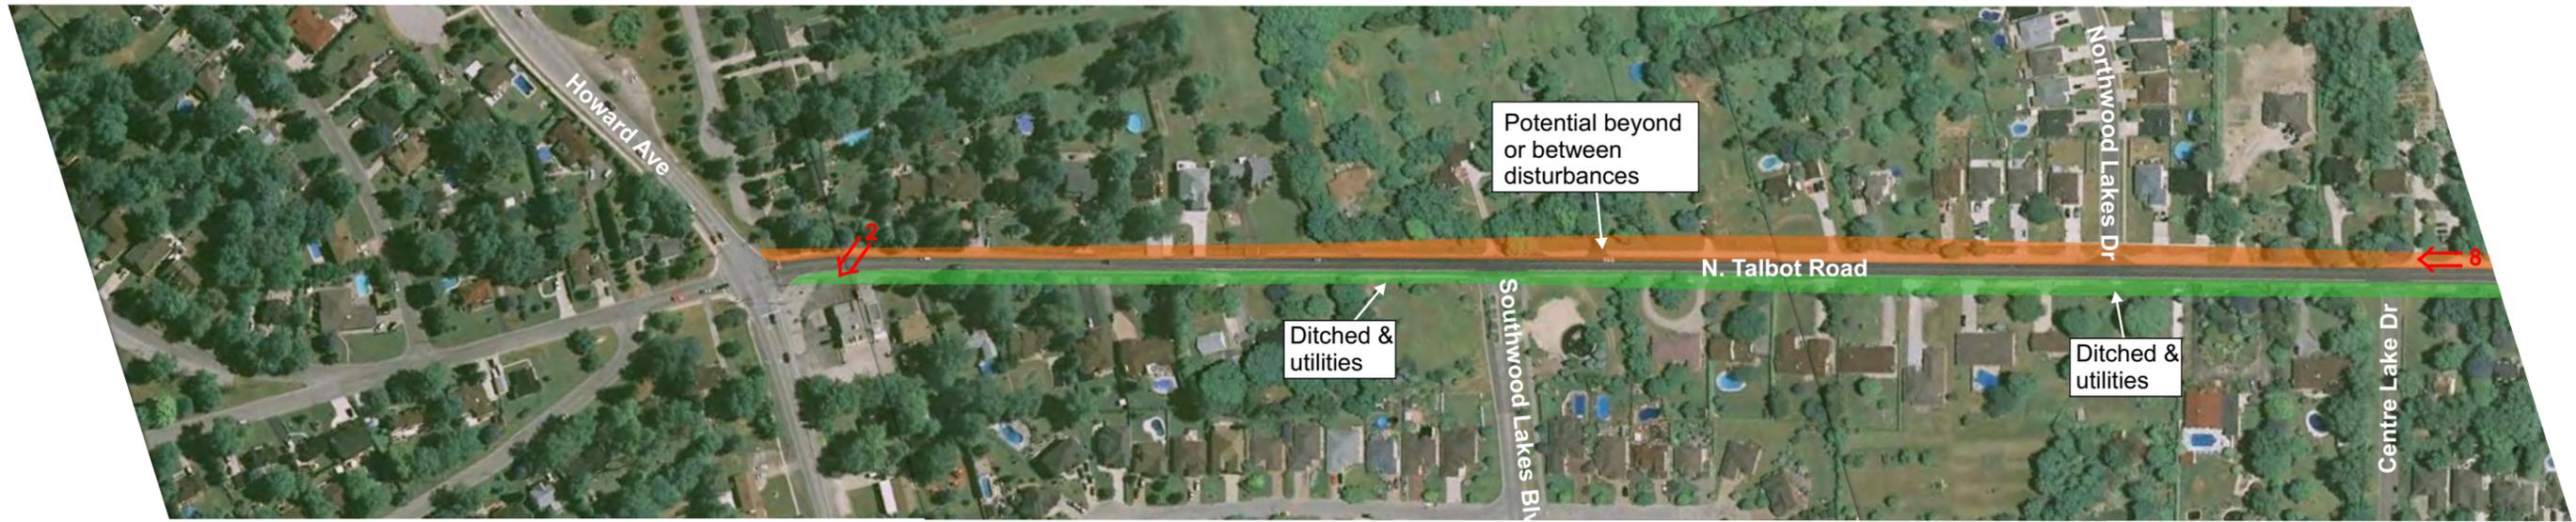
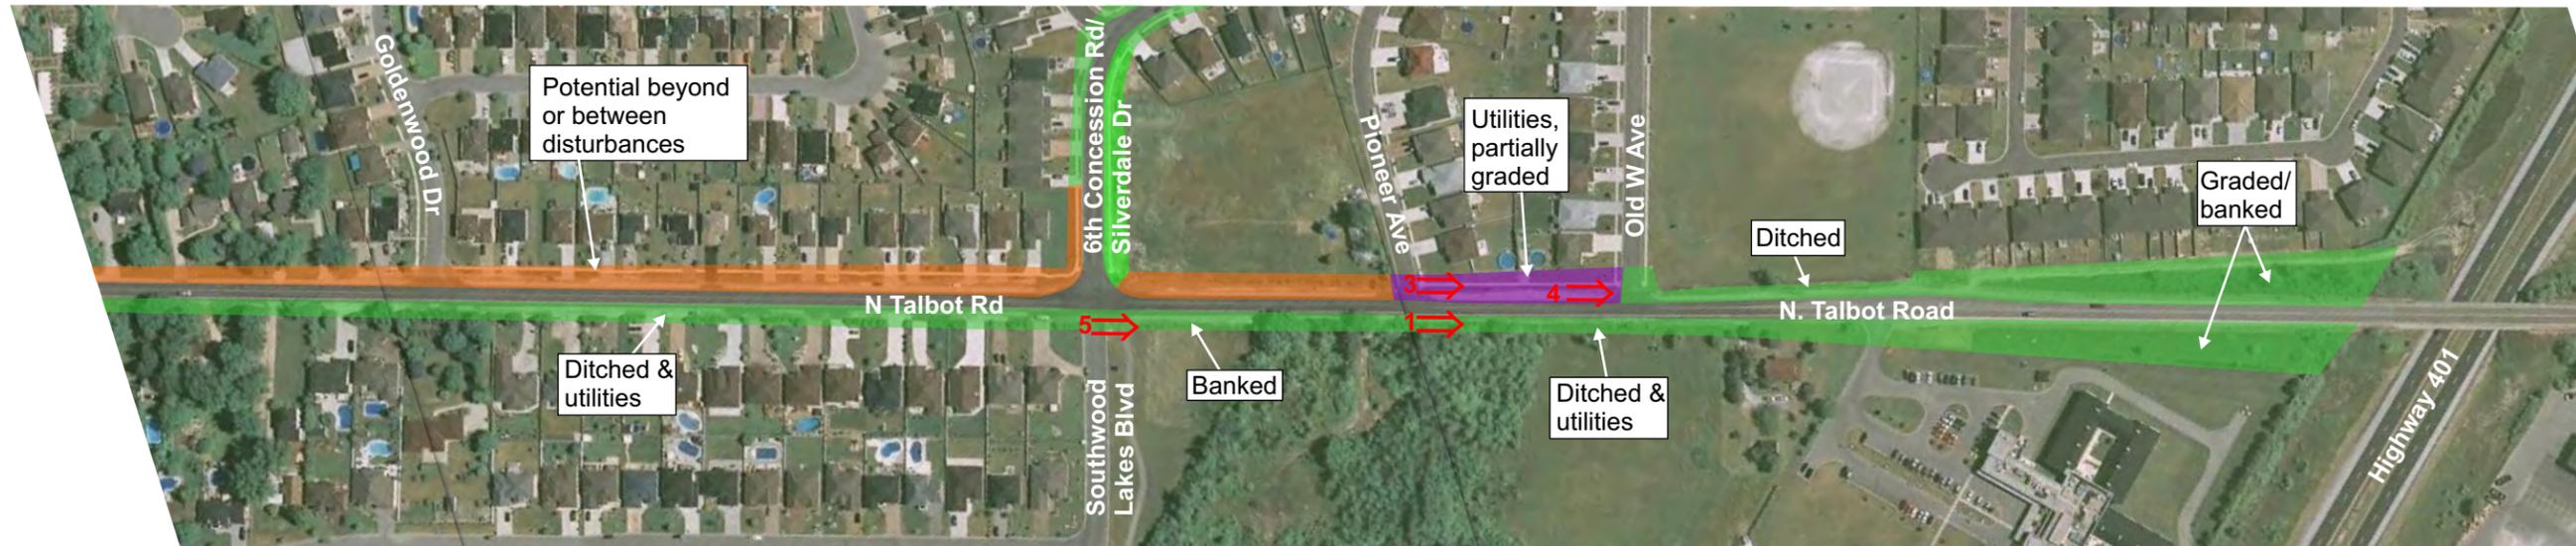
Figure 7: Stage 1 Potential Results - North Talbot Road

- Low Potential
- High Potential, Stage 2 Recommended (5M interval shovel testing)
- High Potential, Stage 2 Recommended (judgemental shovel testing)

Note: Width of the marked corridor is an approximation of the ROW for demonstration purposes only; all potential pertains to within the ROW beyond the current road footprint.

- 1) That Stage 2: Assessment be conducted on the sections of the archaeological Study Area which may retain high potential as depicted on *Figures 7* and *8*, with the understanding that potential may be reduced during the assessment due to high levels of modern disturbance;
- 2) That the locations within the Study Area deemed to be of low potential (also on *Figures 7* and *8*) require no further archaeological work.

Section of Study Area	Potential Rating	Comments
North Talbot Road, Northern ROW – Note ROW is wider on the north side than the south side		
Howard Ave to 6 th Concession Rd	High Potential	ROW extends past the sidewalk onto the residential lawns with only intermittent ditching; possibility of natural soils beyond or between the utilities, ditching and sidewalk. Stage 2 recommended.
6 th Concession Rd to Pioneer Ave	High Potential	An undeveloped lot (with an early to mid 20 th C house on the corner of Pioneer Ave) borders the Study Area, and due to the ROW width, there is potential beyond the paved shoulder & utilities. Stage 2 recommended.
Pioneer Ave to Old West Ave	High Potential	ROW abuts fenced yards of a newer subdivision and appears to have been graded with utilities, however the level of disturbance cannot be confirmed visually. Stage 2 judgemental shovel testing recommended.
Old West Ave to Highway 401 overpass	Low Potential	ROW is narrower & completely ditched by North Talbot Park; east of the park the grading for the overpass begins, with ditching and banking in the ROW; therefore this section has been extensively disturbed in modern times.

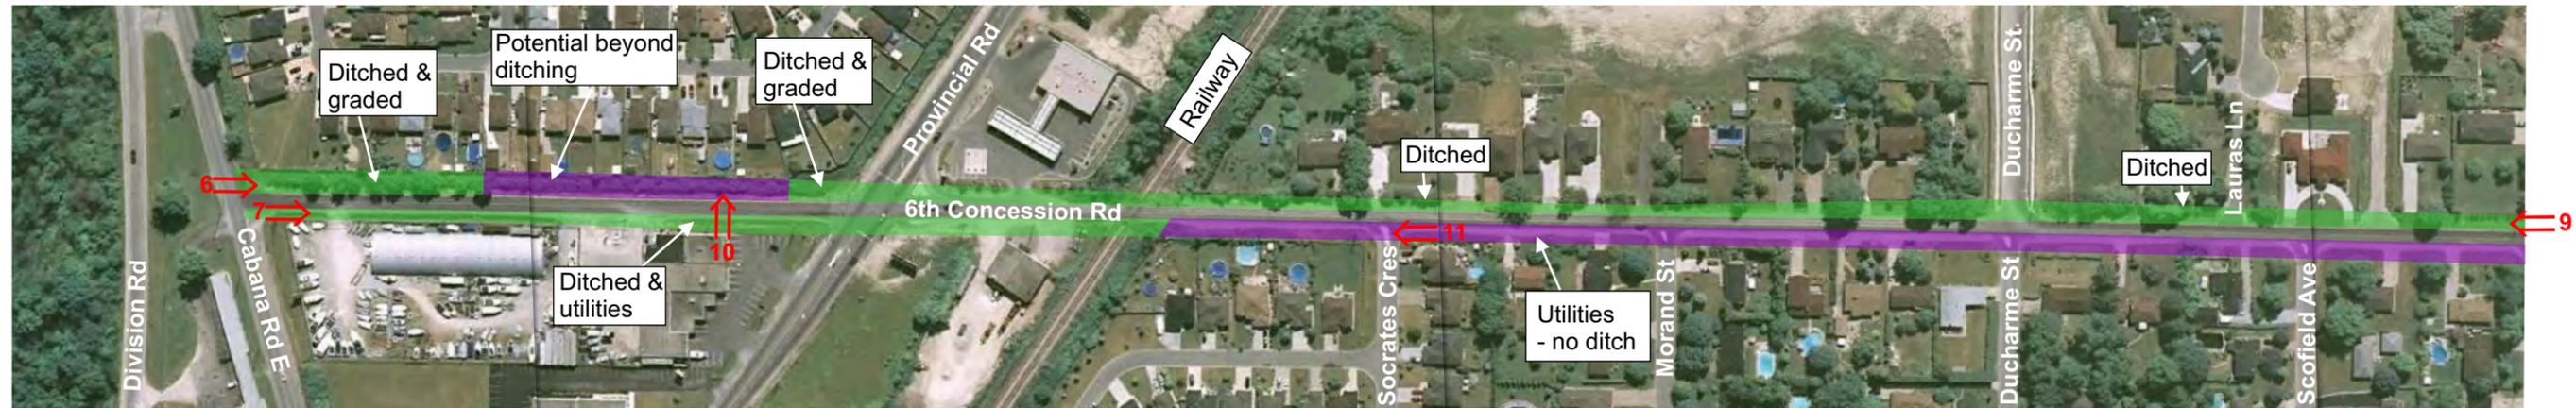
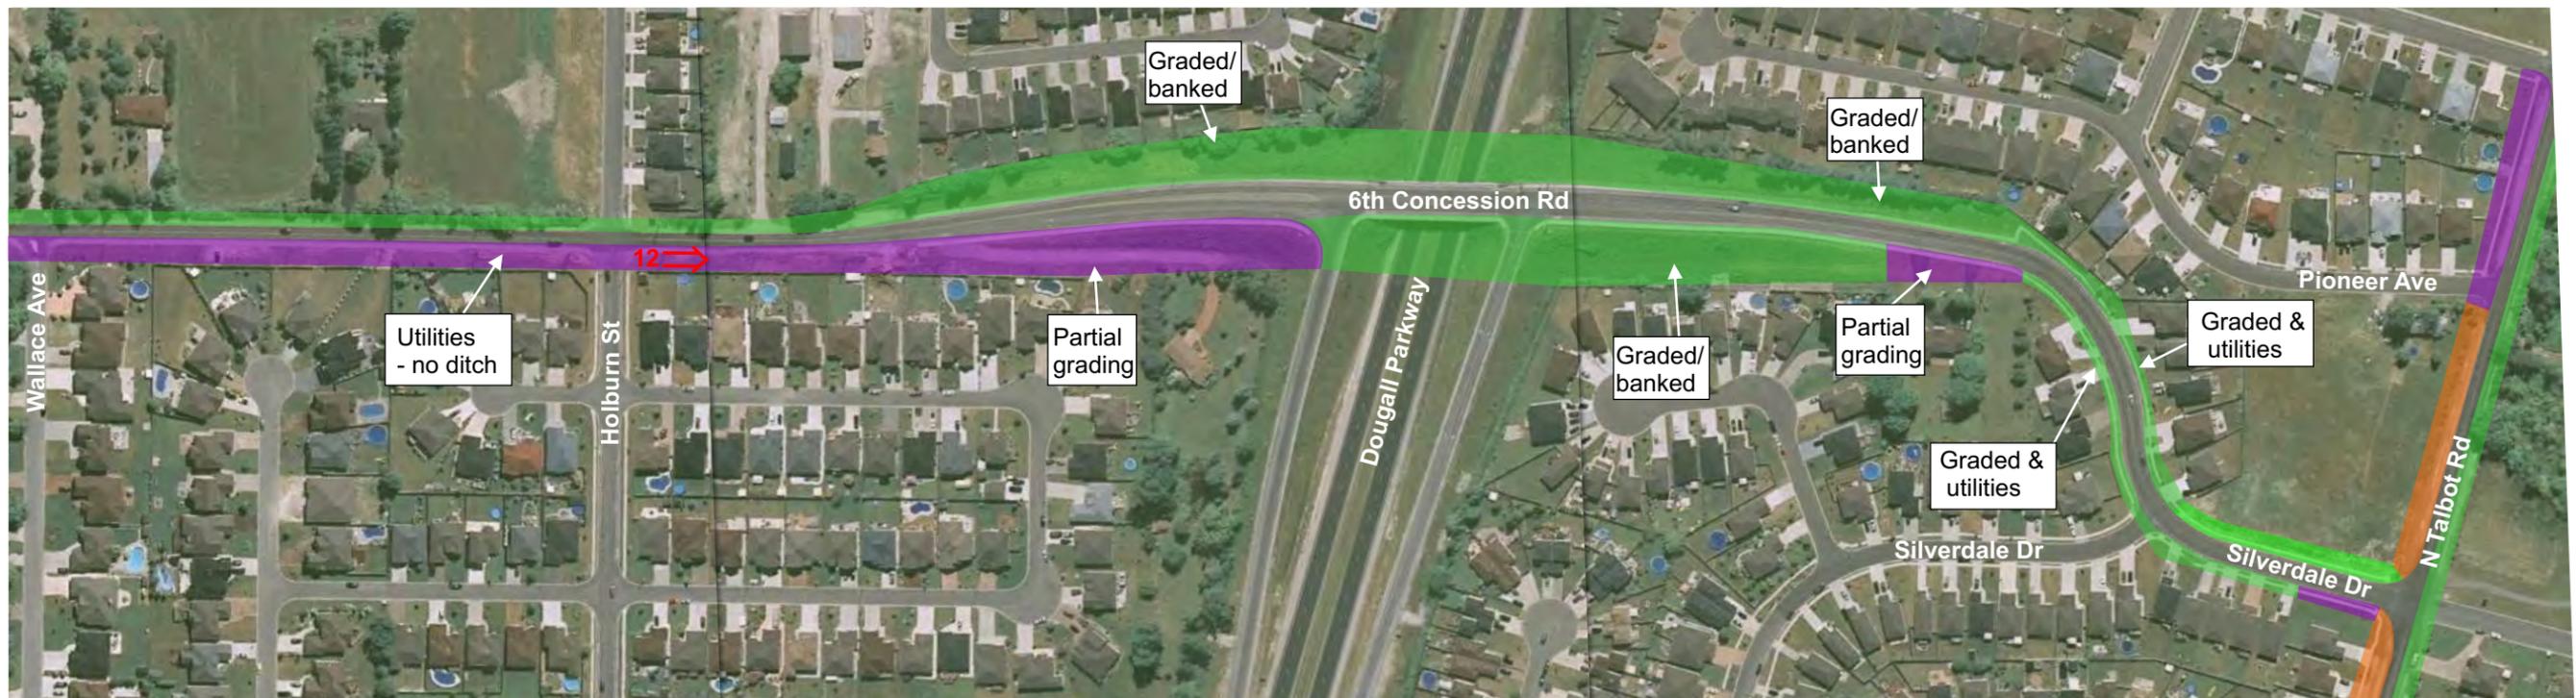
Figure 8: Stage 1 Potential Results - 6th Concession Rd

| | High Potential, Stage 2 Recommended (5M interval shovel testing) | | Low Potential |
| | High Potential, Stage 2 Recommended (judgemental shovel testing) | | Location & Direction of Photographic Plates |

Note: Width of the marked corridor is an approximation of the ROW for demonstration purposes only; all potential pertains to within the ROW beyond the current road footprint.

6th Concession Road, Western ROW		
North Talbot Rd to Dougall Pkwy	High to Low Potential	This section with the new alignment of 6 th Concession Rd, adjacent subdivision, and approach to the Dougall Pkwy overpass, has been extensively disturbed through grading and utilities; however there are two sections at either end of the subdivision, where Stage 2 judgemental shovel testing is recommended to confirm the level of disturbance (see <i>Figure 8</i>).
Dougall Pkwy to the railway line	High Potential	There is no ditching in the western ROW and the ground is generally level from the road to the yards of the adjacent subdivisions; while utilities are present, the level of disturbance from the utilities and any previous grading cannot be confirmed visually, therefore Stage 2 judgemental shovel testing is recommended .
Railway line to Cabana Rd E	Low Potential	The ROW is extensively disturbed by ditching, utilities, and grading for the railway and cross roads.

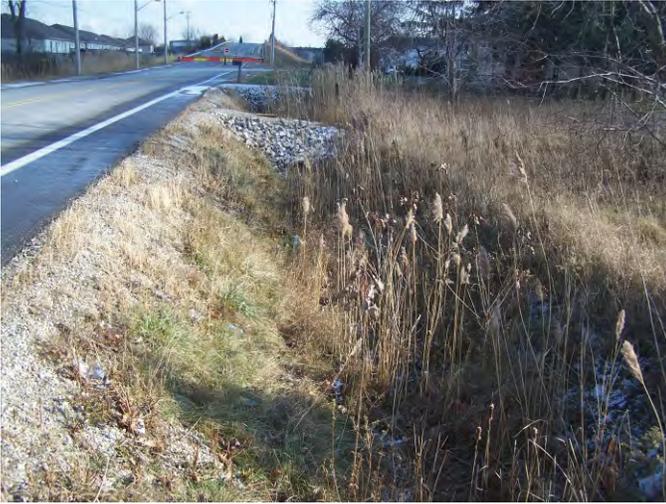
Plate 1: North Talbot Road, southern ROW showing ditch and gas line across from Pioneer Ave.; looking east.

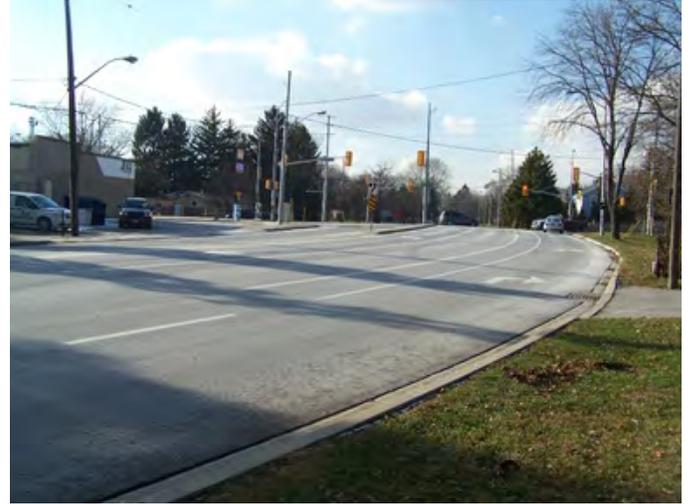
Plate 2: Looking west at the intersection of North Talbot Road and Howard Avenue; commercial business in the south ROW, residential lawns in the north.

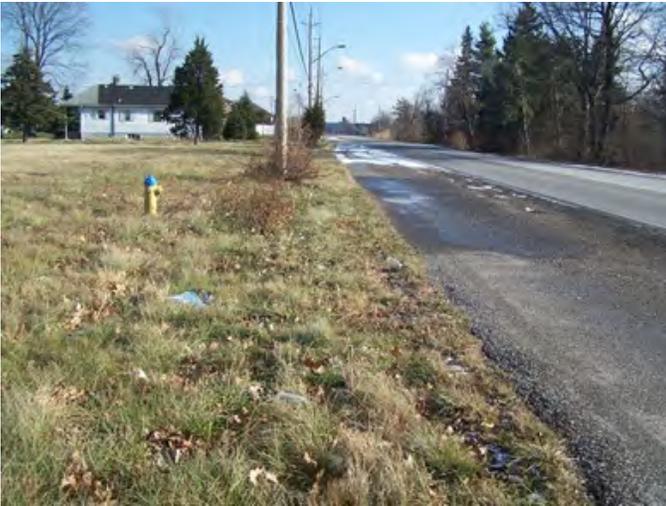
Plate 3: Looking east along North Talbot Road from the current 6th Concession Road intersection, showing the paved shoulder & water main but no ditching.

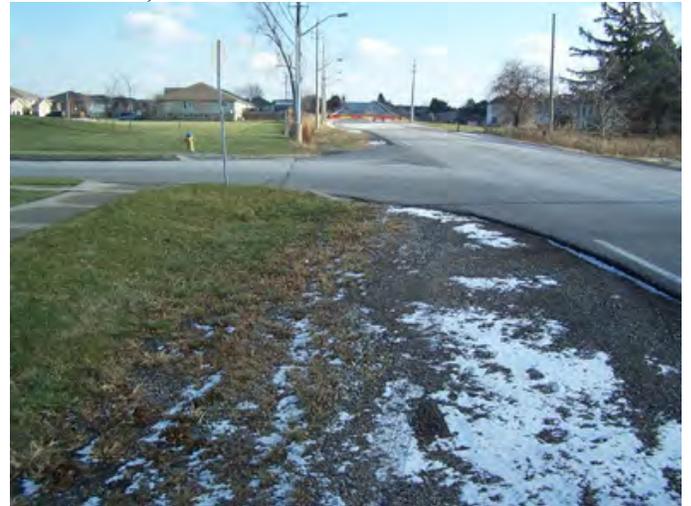
Plate 4: Looking east across Old West Avenue to North Talbot Park in the northern ROW of North Talbot Road.

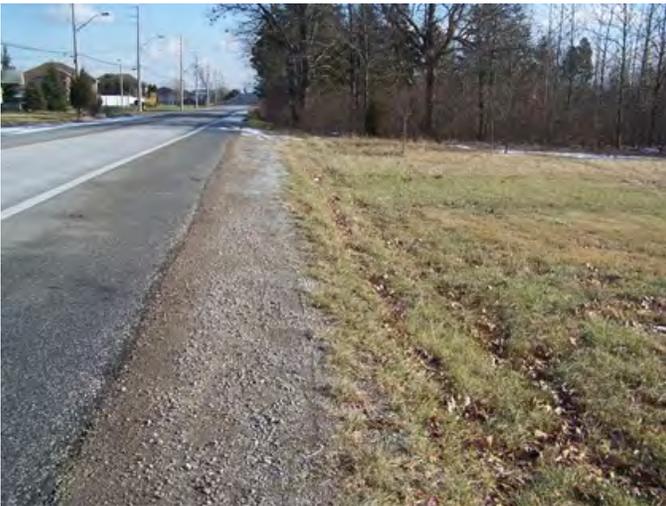
Plate 5: The southern ROW of North Talbot Road at Stoneybrook Park; note the paved and gravel shoulder banked down to the park; looking south.

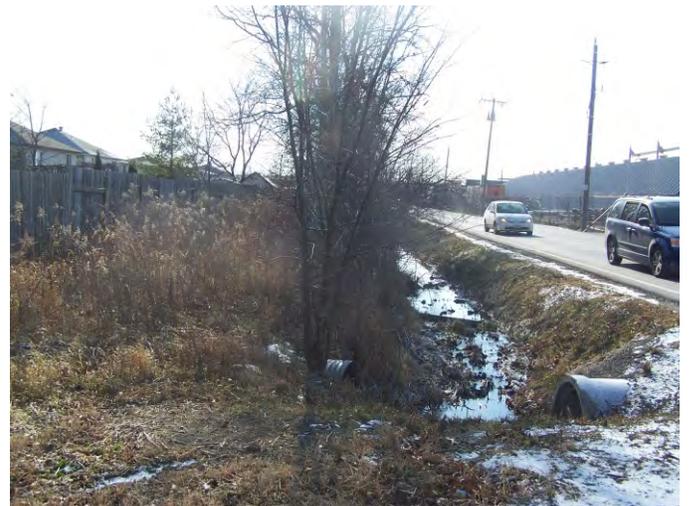
Plate 6: 6th Concession and Cabana Road intersection, showing ditching and residential buildings on east side; looking south.

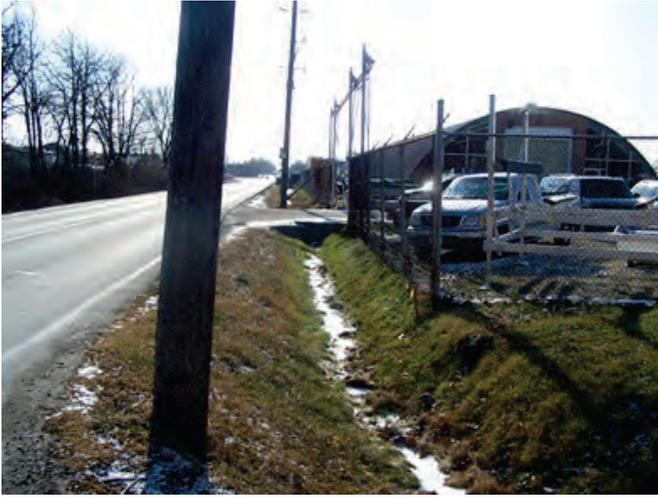
Plate 7: Looking south at the ditching along the 6th Concession Road western ROW from Cabana Road.

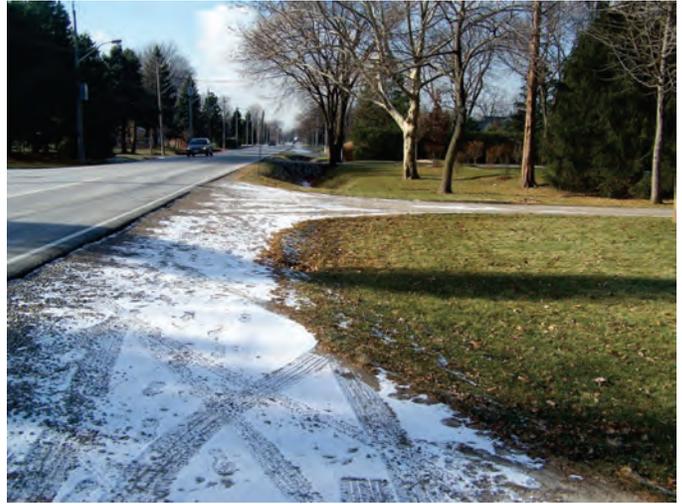
Plate 8: North Talbot Road, northern ROW west of Goldenwood Drive, showing gravel shoulder, & intermittent ditching by residential lawns; facing west.

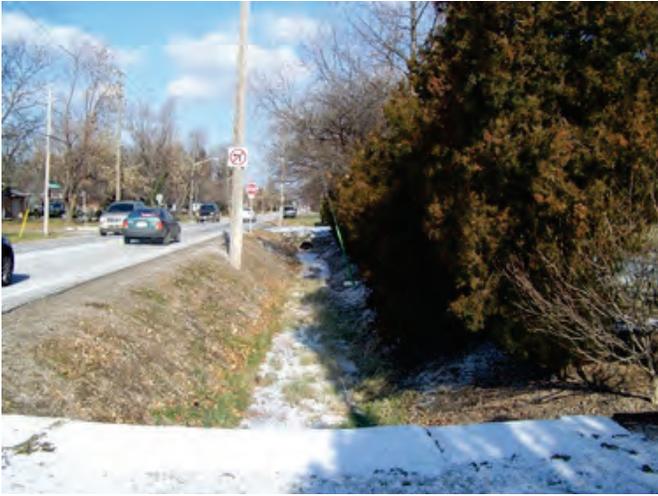
Plate 9: Ditching along 6th Concession Road across from Wallace Avenue; looking north.

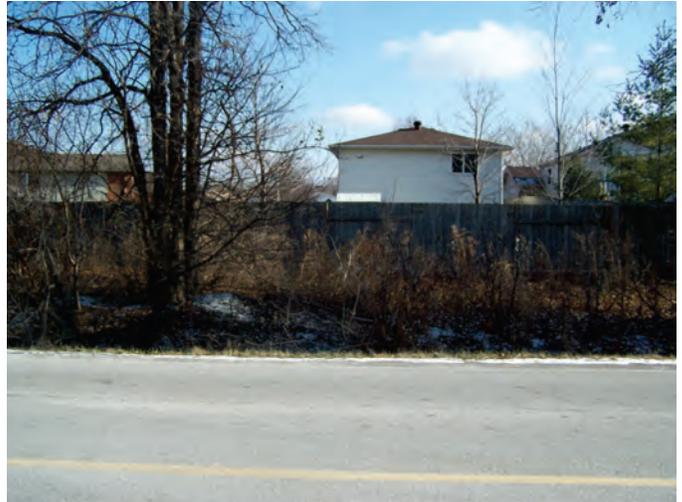
Plate 10: Looking across 6th Concession Road between Cabana Road East and Provincial Road to the eastern ROW and the space between the ditch and the fence.

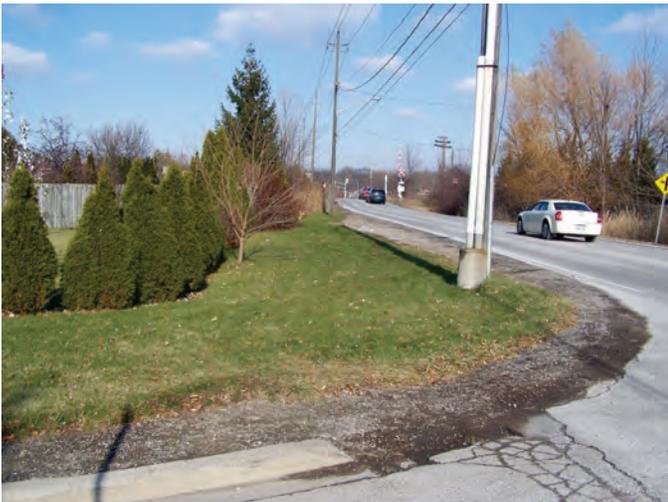
Plate 11: Looking north at the western ROW of 6th Concession Rd from its intersection with Socrates Cres.

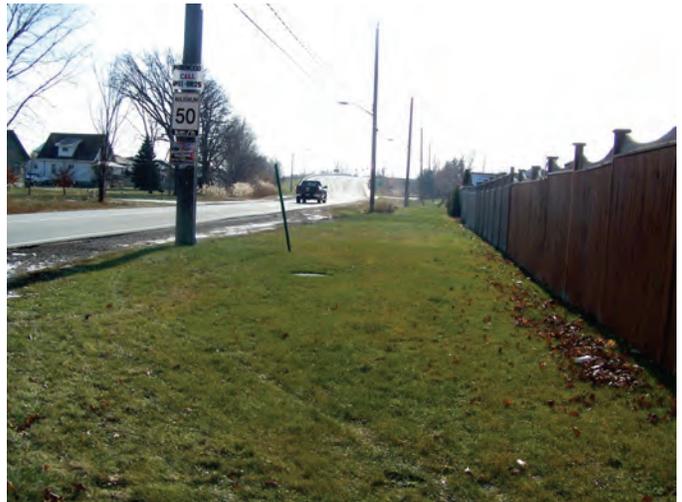
Plate 12: Looking south along the western ROW of 6th Concession Road from Holburn Street to the Dougall Pkwy overpass.
