4170 & 4190 Sixth Concession Road Windsor, ON

Goodban Ecological Consulting Inc. 879 Cabot Trail Milton, ON L9T 3W4

Tree Preservation Plan

Date 16 February 2024 1:400 @ 24x36

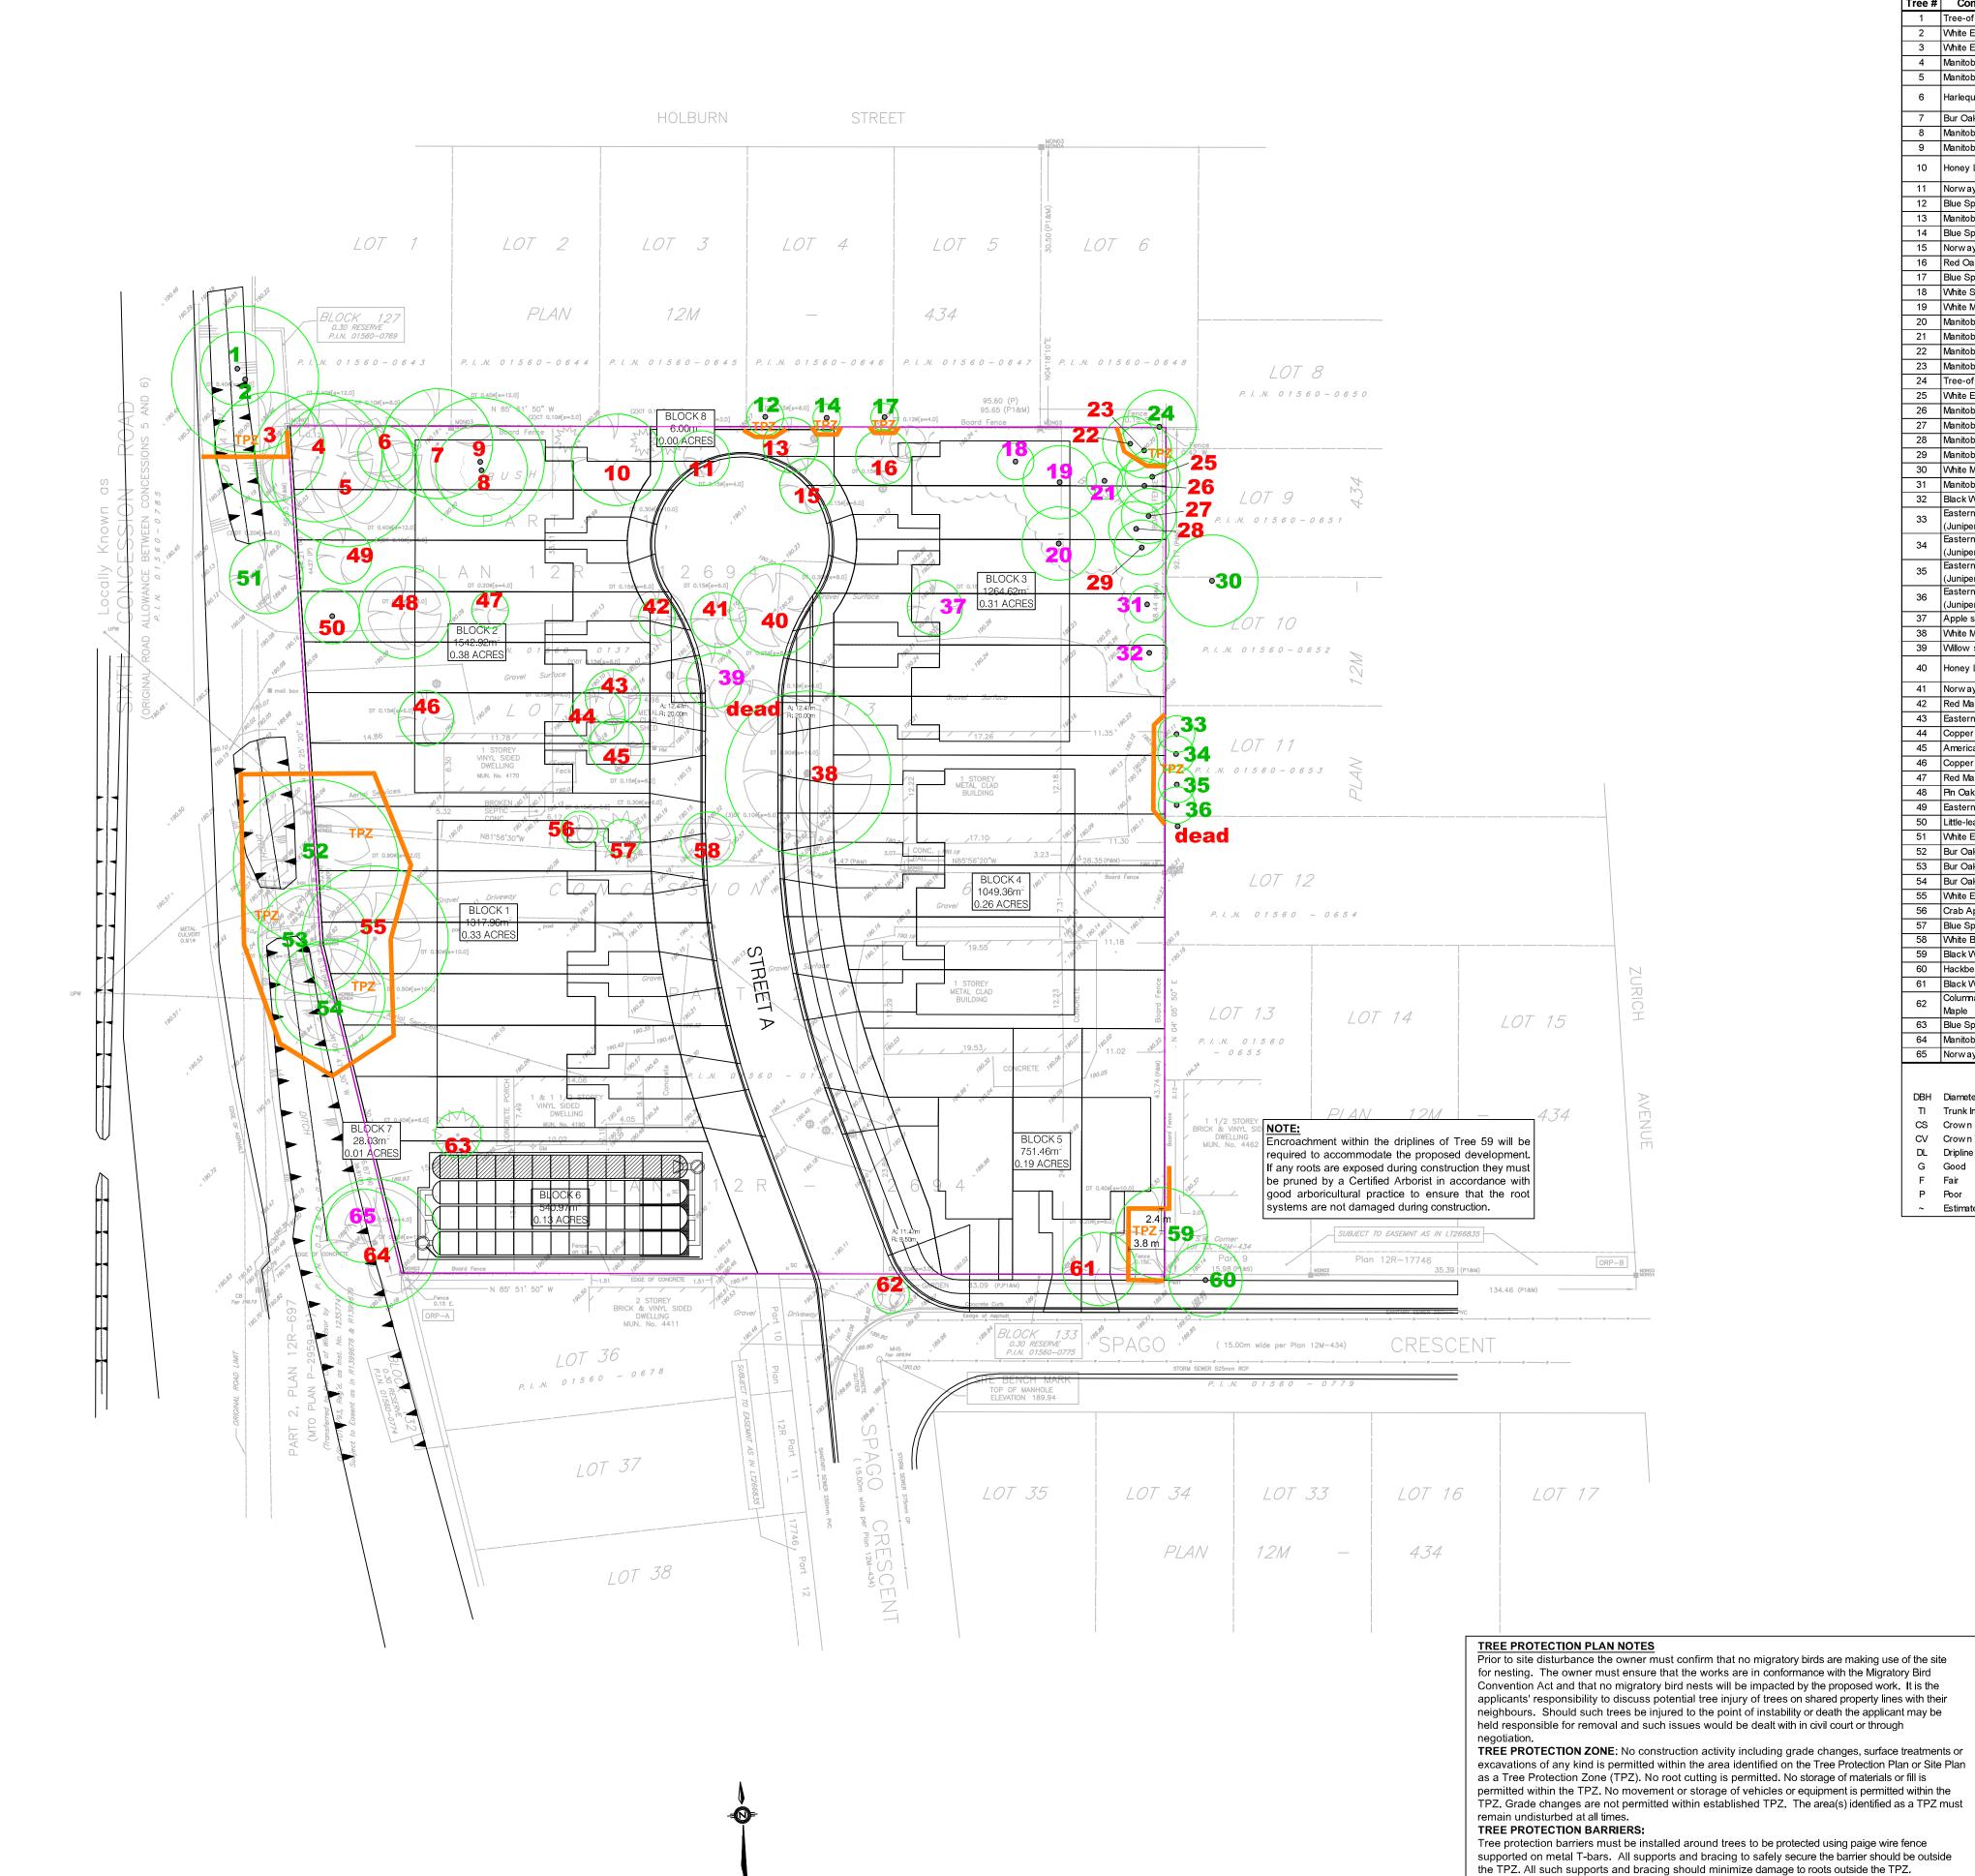
> 1.THIS DETAIL DOES NOT REPRESENT ANY PARTICULAR TREE **SPECIES** 2. NO CONSTRUCTION ACTIVITY. GRADE CHANGE, SURFACE TREATMENT, COMPACTION, **EXCAVATION OR** STOCKPILING OF ANY KIND IS PERMITTED

TREE PROTECTION **FENCE DETAIL ←**DRIP LINE (Or at Distance Specified on the Tree Preservation Plan) Data Source: Verhaegen Land Surveyors, Baird AE TREE PROTECTION BARRIER TO CONSIST **ORANGE SNOW FENCE** - PLACED ON METAL T-BARS AT 3 METRE CENTRES. T-BARS TYP.

3000 mm MAXIMUM
