3.4.5 LEVELS OF SERVICE

Class Environmental Assessment

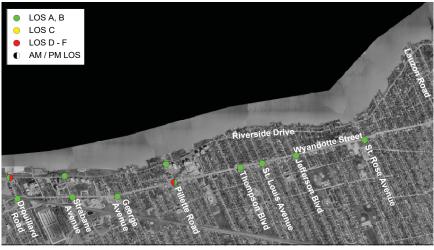
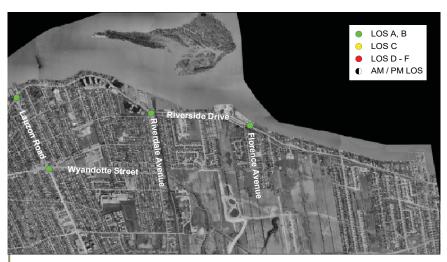
EXHIBIT 3-20: LEVELS OF SERVICE AT STUDY AREA INTERSECTIONS

The results indicate good to excellent traffic operations throughout most of the primary study area. As shown in Exhibit 3-19 and 3-20, all studied signalized intersections on Riverside Drive are operating at LOS C or better, with the exception of Montreuil Avenue and Drouillard Street². A majority of the studied intersections are operating at LOS A or B during both peak hours. All signalized intersections in the extended study area on University Avenue and Wyandotte Street are operating at LOS C or better during both peak hours. As with Riverside Drive, the majority of these intersections operate at LOS A or B. The results of the traffic modelling indicate that there are few significant delays for traffic travelling on the Riverside Drive and Wyandotte Street corridors, which is in line with the findings of the travel time runs discussed in Section 3.3.2.
