Subject: Walker Homesite Park – Approval of the Masterplan – Ward 9

WALKER HOMESITE PARK IMPROVEMENTS FUNCTIONAL DESIGN REPORT

Job Number: 22-024

Date: May 2023

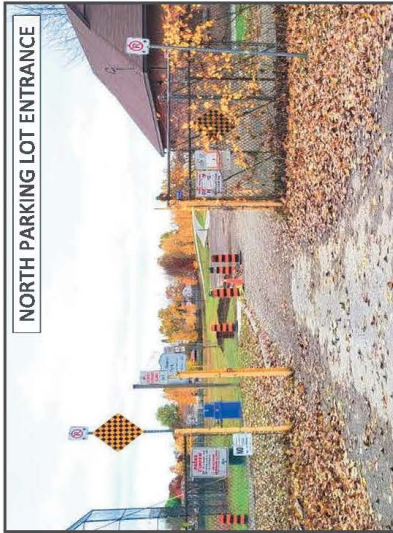
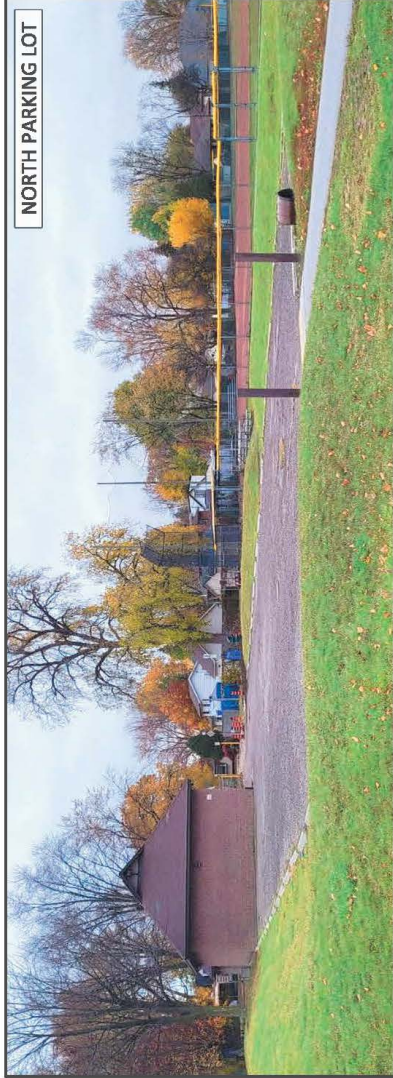
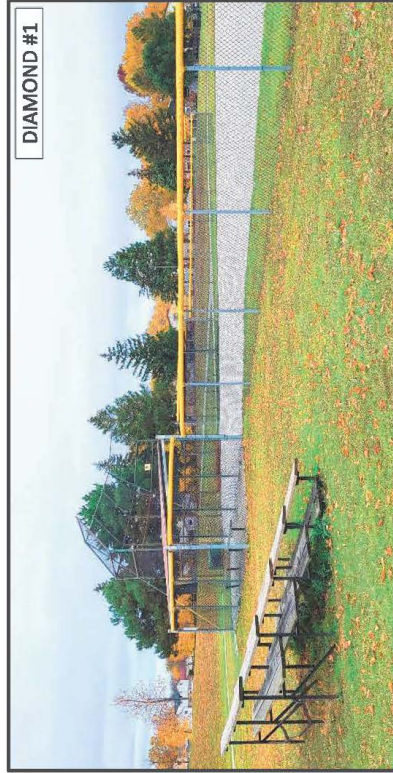
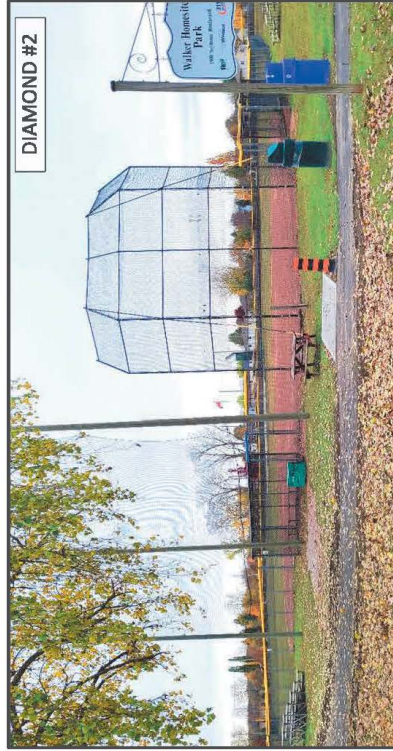
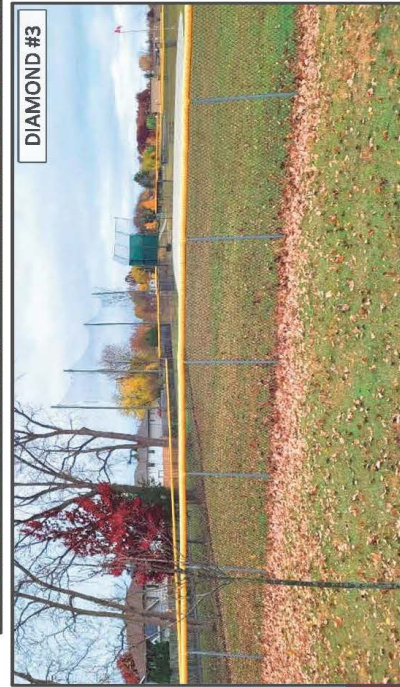
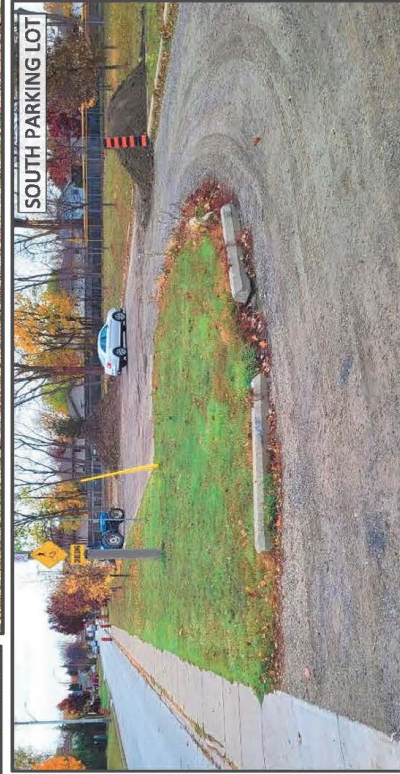
WALKER HOMESITE PARK IMPROVEMENTS

PHOTOS BY LANDMARK ENGINEERS INC., OCTOBER 2022

The following sections generally describe the existing site conditions at Walker Homesite Park. An inventory of existing site photos taken by Landmark Engineers is also attached as Appendix B.
